**2 Church Orchard,  
St.Peter's Rd.,  
Hayling Island,  
PO1 0RT**

## **PHASE 1 DAYTIME BAT SURVEY**

**DECEMBER 2023**

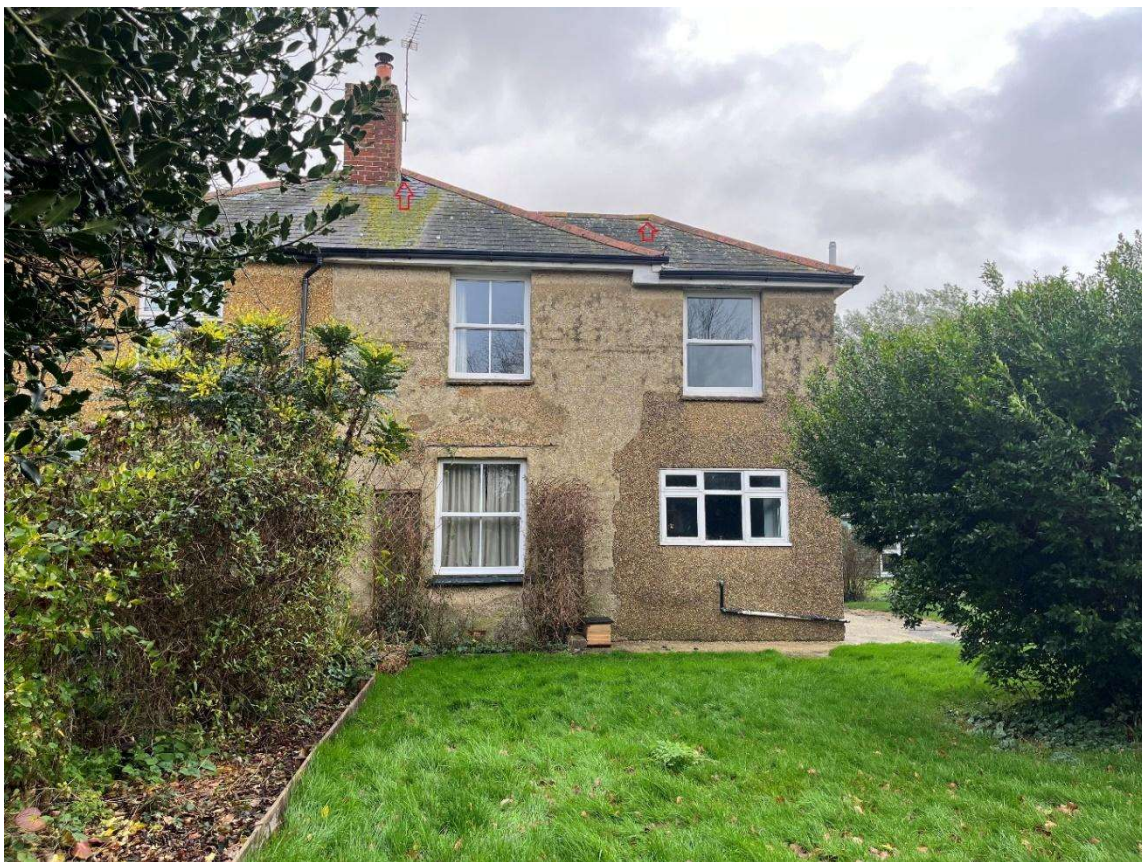
The property was subject to a full Phase 1 bat survey. It is a two-storey semi-detached brick-built structure dating to the early 20<sup>th</sup> century. The roof is complex with hips on all faces and is covered with close-fitting slates tiles which are in good order. However, there are several potential access points under the ridge tiles (see figures 1 and 2). The fascias and soffits are all in good order with no potential openings.

**Figure 1. Western elevations looking east. Red arrows indicate potential access points for roosting bats.**

The loft could not be accessed, and the roof has potential access points into the ridge tiles. Therefore, the dwelling has low potential for roosting bats and a phase 2 bat survey is recommended.

A dusk emergence survey is required to elucidate whether bats are utilising the property. These can be carried out in suitable weather between May and the end of September.

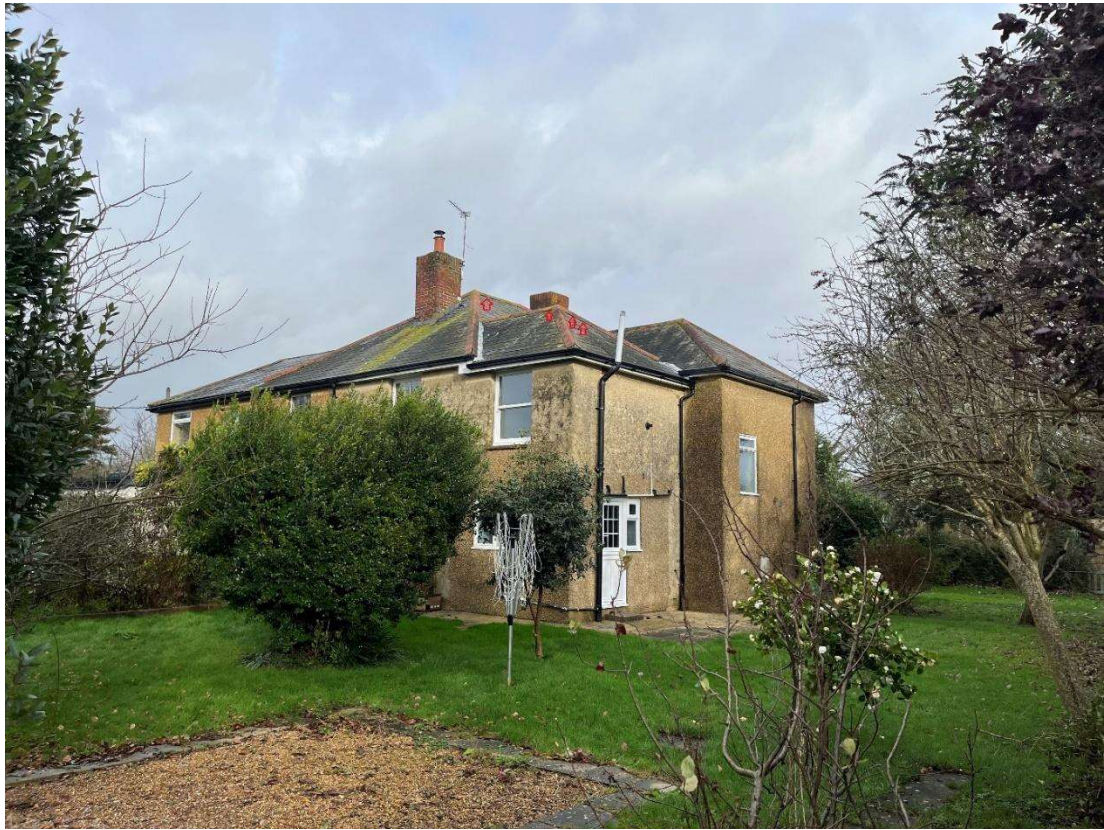
**Figure 2. Southern and western elevations looking northeast. Red arrows indicate potential access points for roosting bats.**

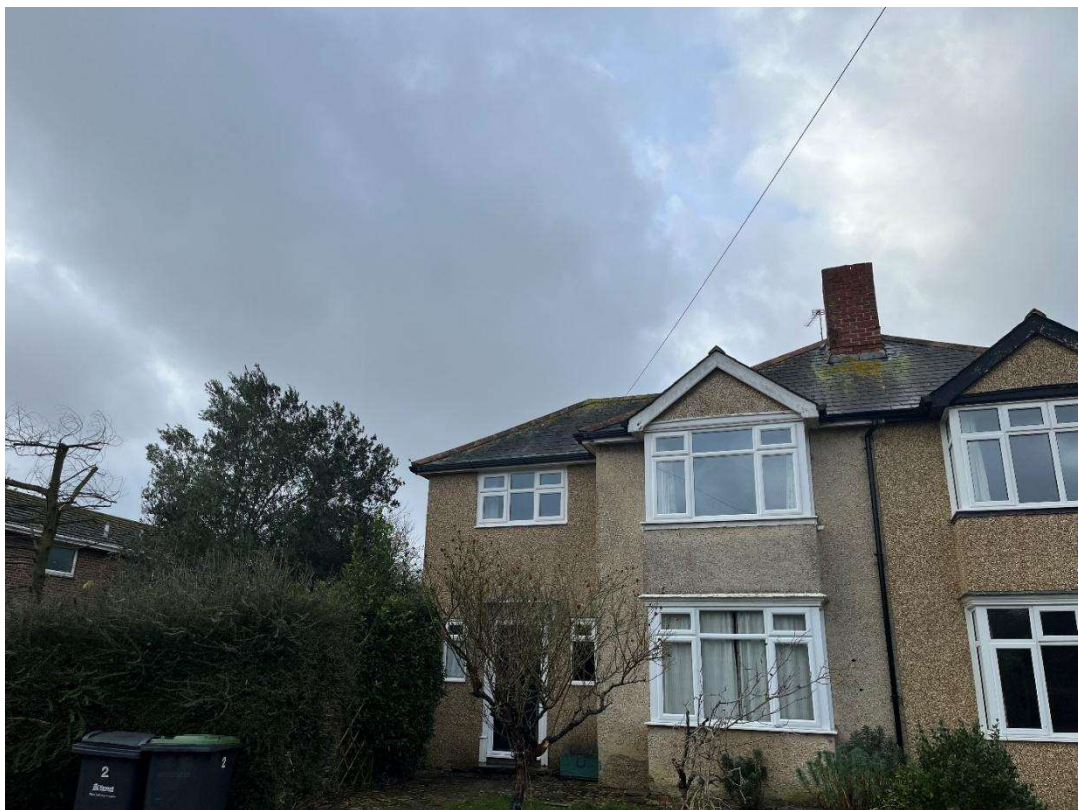
**Figure 3. Eastern elevations looking west.**

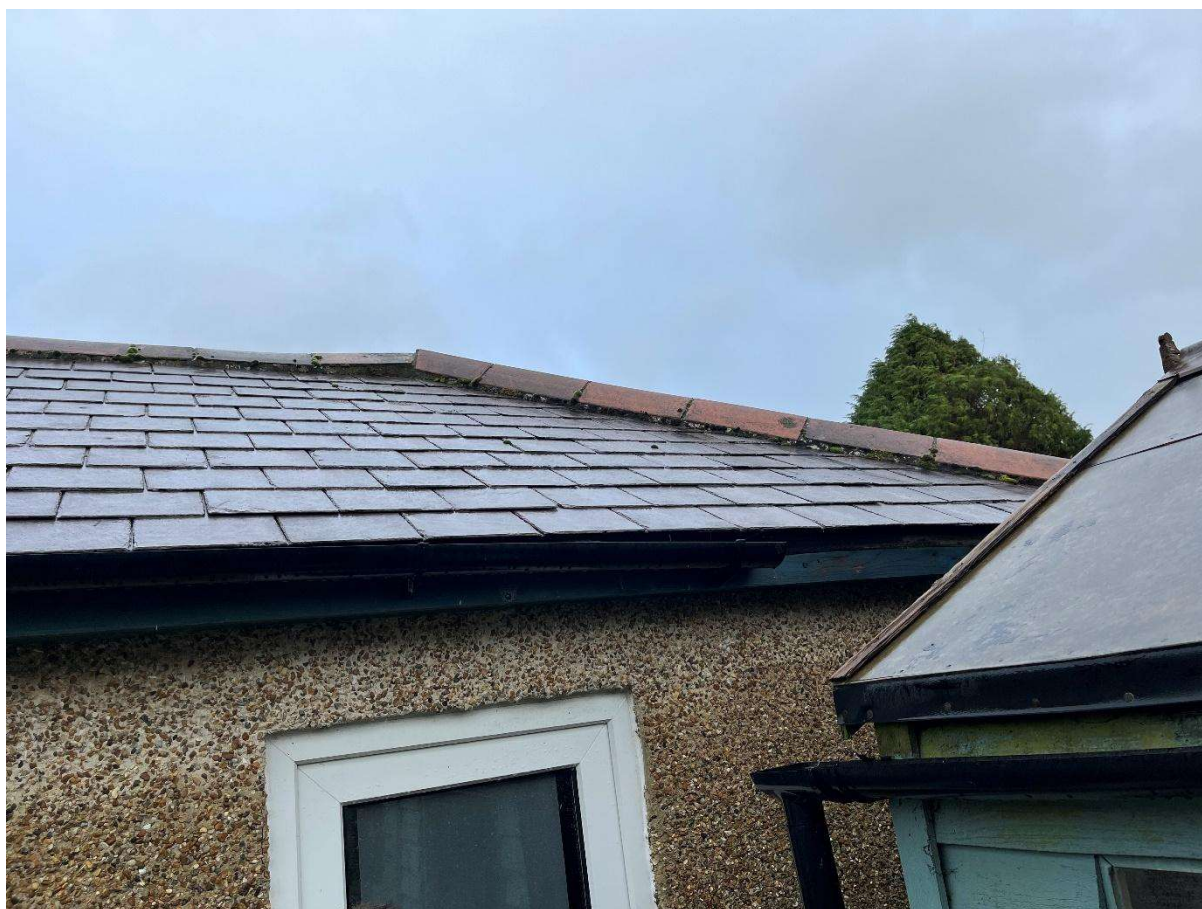
The single storey garage is situated to the southeast of the house. It is block built with rendered walls and a roof of slates with similar clay ridge tiles to the main house. The roof and fascias are all in good order with no potential access points (see figure 4). The interior roof space is open with a softwood frame with no crevices or gaps and the roof is lined with bituminous felting (see figure 5). The garage has negligible potential for roosting bats.

**Figure 4. Garage roof looking east.**
