## Bat Emergence and Re-entry Surveys

11-15 South Street, Havant, Hants, PO9 1BU

Jonathan Heather

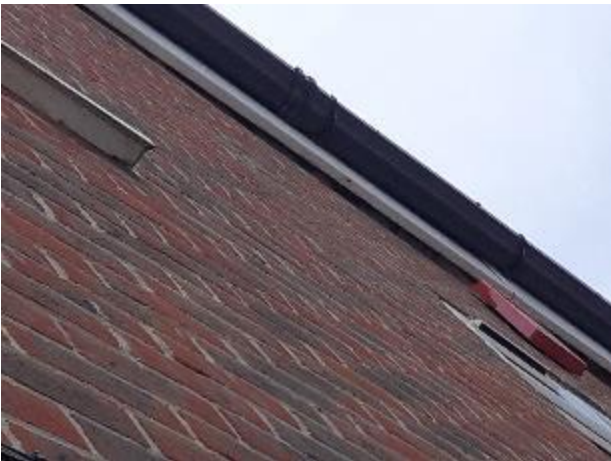
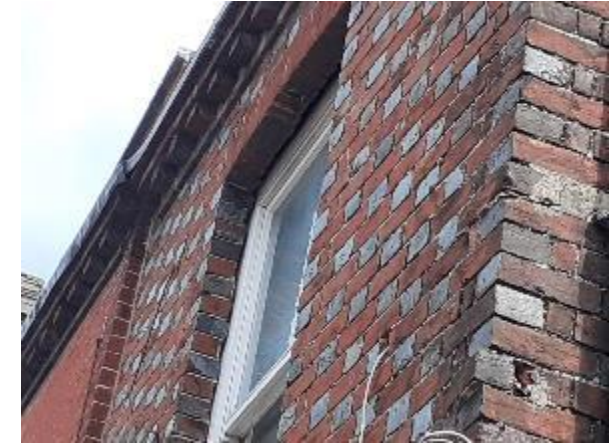
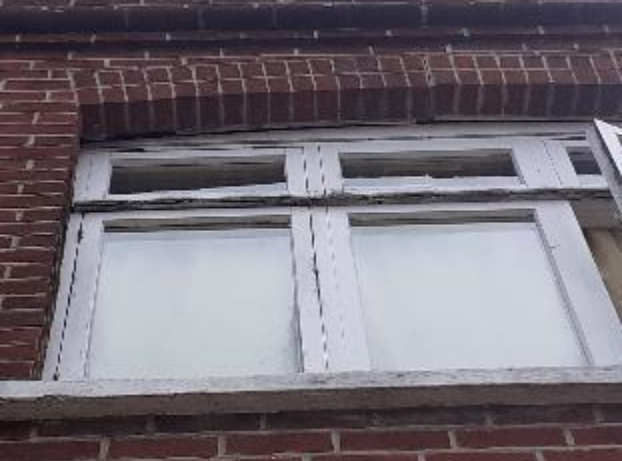
| Building inspection prior to survey | <p>No external evidence of bats was found prior to the survey. No internal inspection was conducted.</p> <p>Additional suitable roosting habitat was identified that was not initially picked up in the PRA. This included gaps in the lintels above the first floor windows of B1, and gaps under fascia boards also on B1.</p> <div></div> |

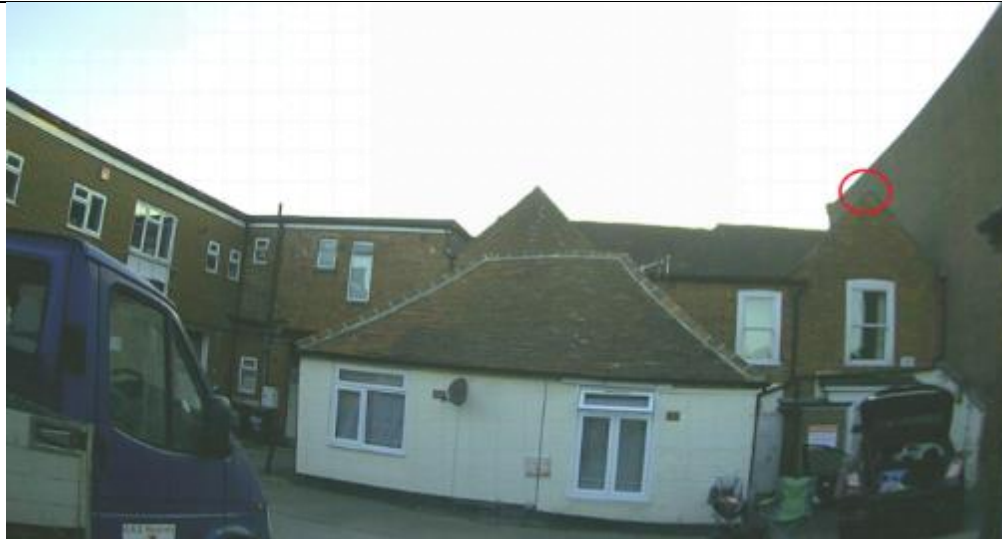
| A common pipistrelle emergence from the southern side of the north-eastern gable of B5 was recorded at 21:37 (shown below), the bat flying south over B1. | | | |

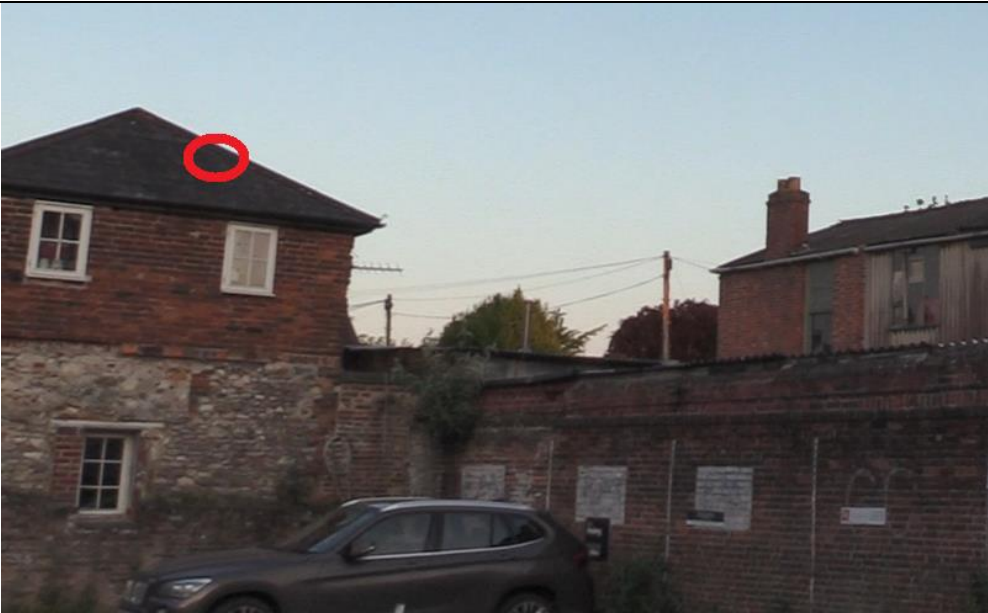
At 21:46 a common pipistrelle emergence was recorded by IR from the hip of the roof of B6 (shown below). The bat then began circling the car park to the east of the site.

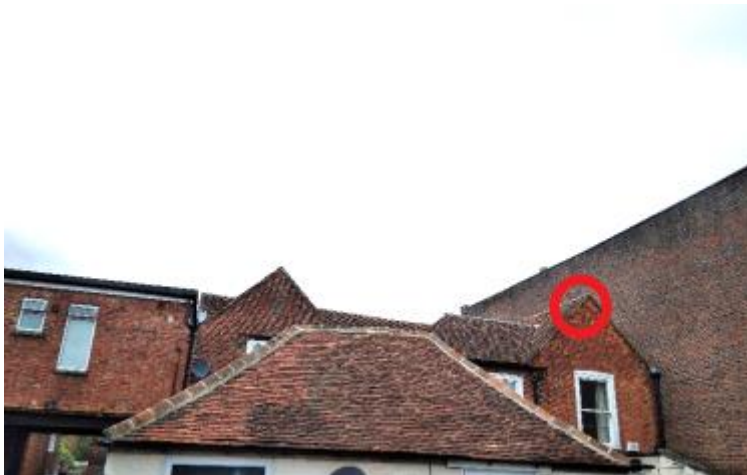
| B2, B3 | 4 | <p><b>At 21:48 a common pipistrelle emerged from the roof tiles of B5 (shown below) and began feeding in the central courtyard.</b></p> <p>Two further common pipistrelles arrived shortly afterwards from the north and all three bats fed constantly over the central yard, occasionally looping around B3 and B4 and passing surveyors 1 and 2. All activity ceased at 22:10.</p> |

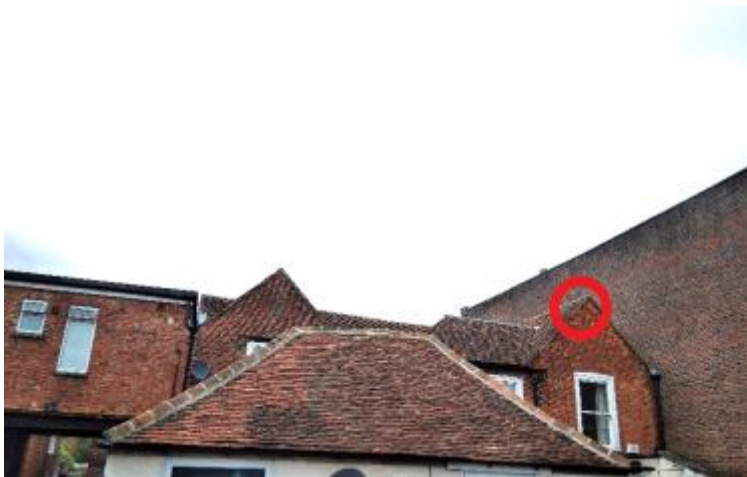
| B1, B5 | 4 | <p><b>At 21:43 a common pipistrelle emerged from the roof tiles of B5 (shown below) and flew immediately north into and beyond the car park there.</b></p> <p>A common pipistrelle arrived into the central courtyard at 21:41 and began feeding within the L-shape of building B1. At 21:47, two more common pipistrelles flew in from the north and the three bats fed in the central courtyard until 22:01 when all activity ceased.<br/>A noctule was seen but not heard at 21:51.</p> |
