**COLLEGE ROAD, CAMPDOWN**  
**Purbrook**

Desk Based Assessment

Report No. 4335L-DBA-v1.5

Archaeological Desk Based Assessment

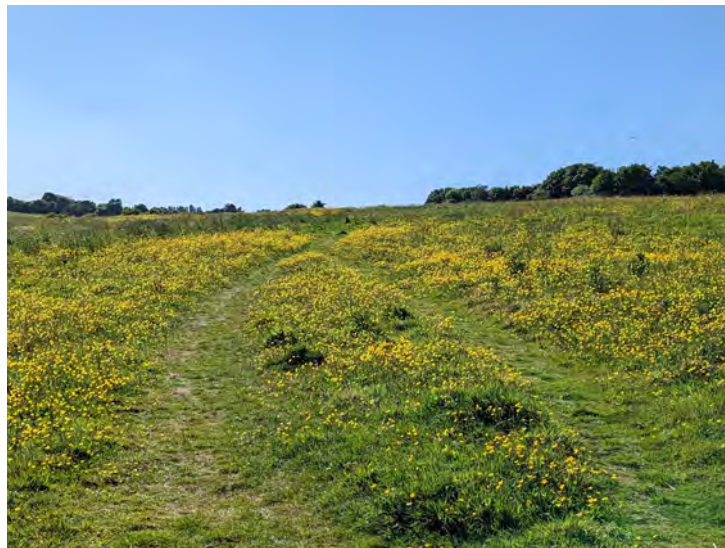
Plate 3 - View along route of Roman road looking northwest
