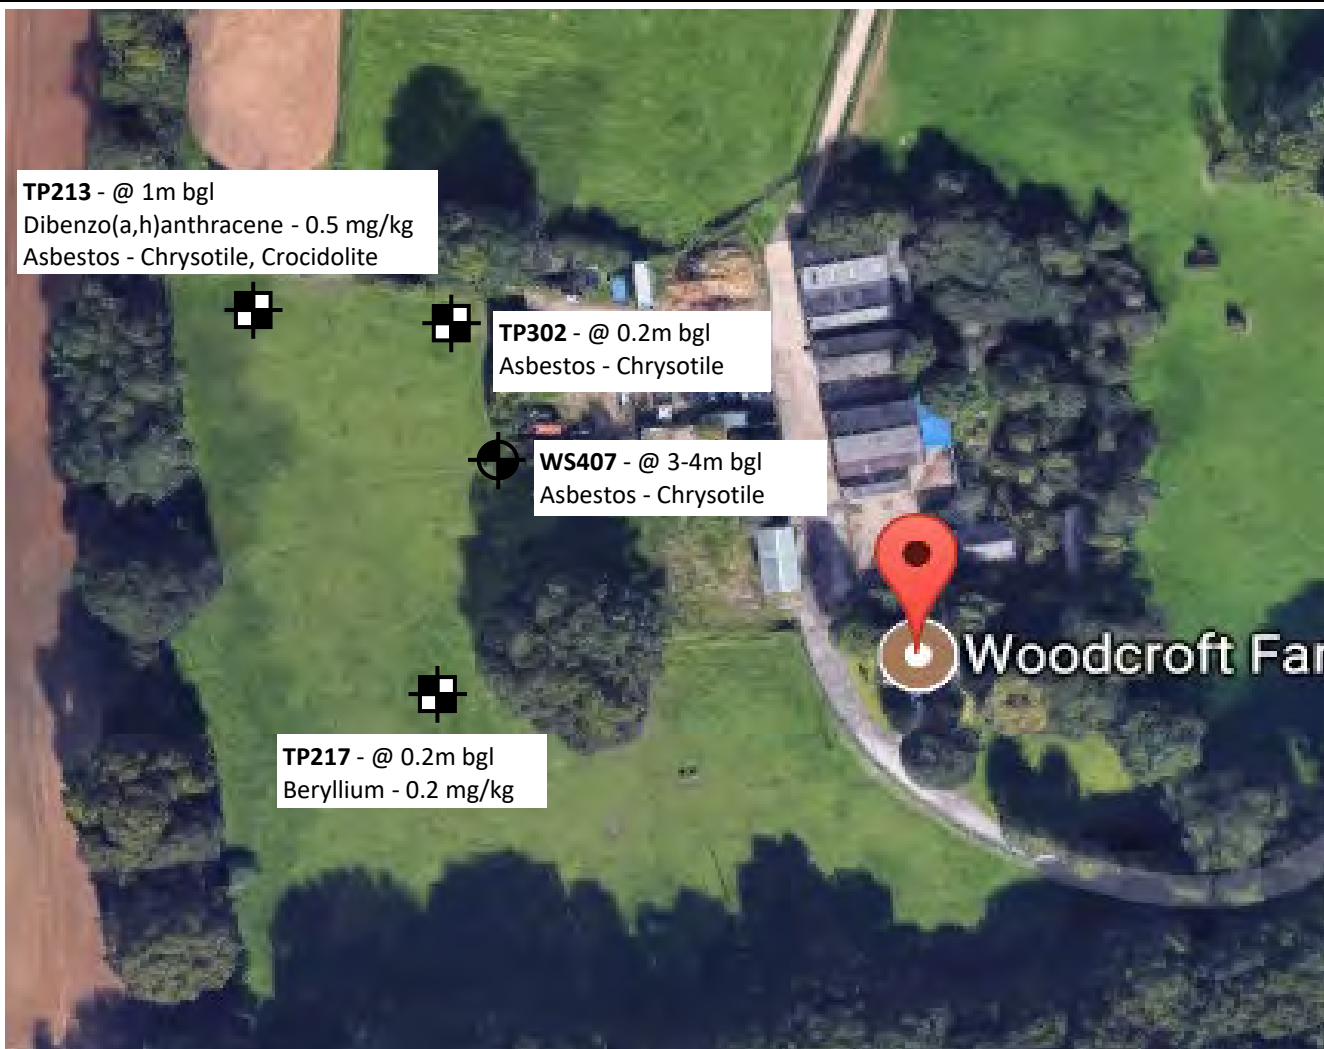
| <b>Project:</b> | Woodcroft Farm, Lovedean, PO8 9QA | | | <b>Title</b> | Soil Contamination Exceedances - Landfill Area | |

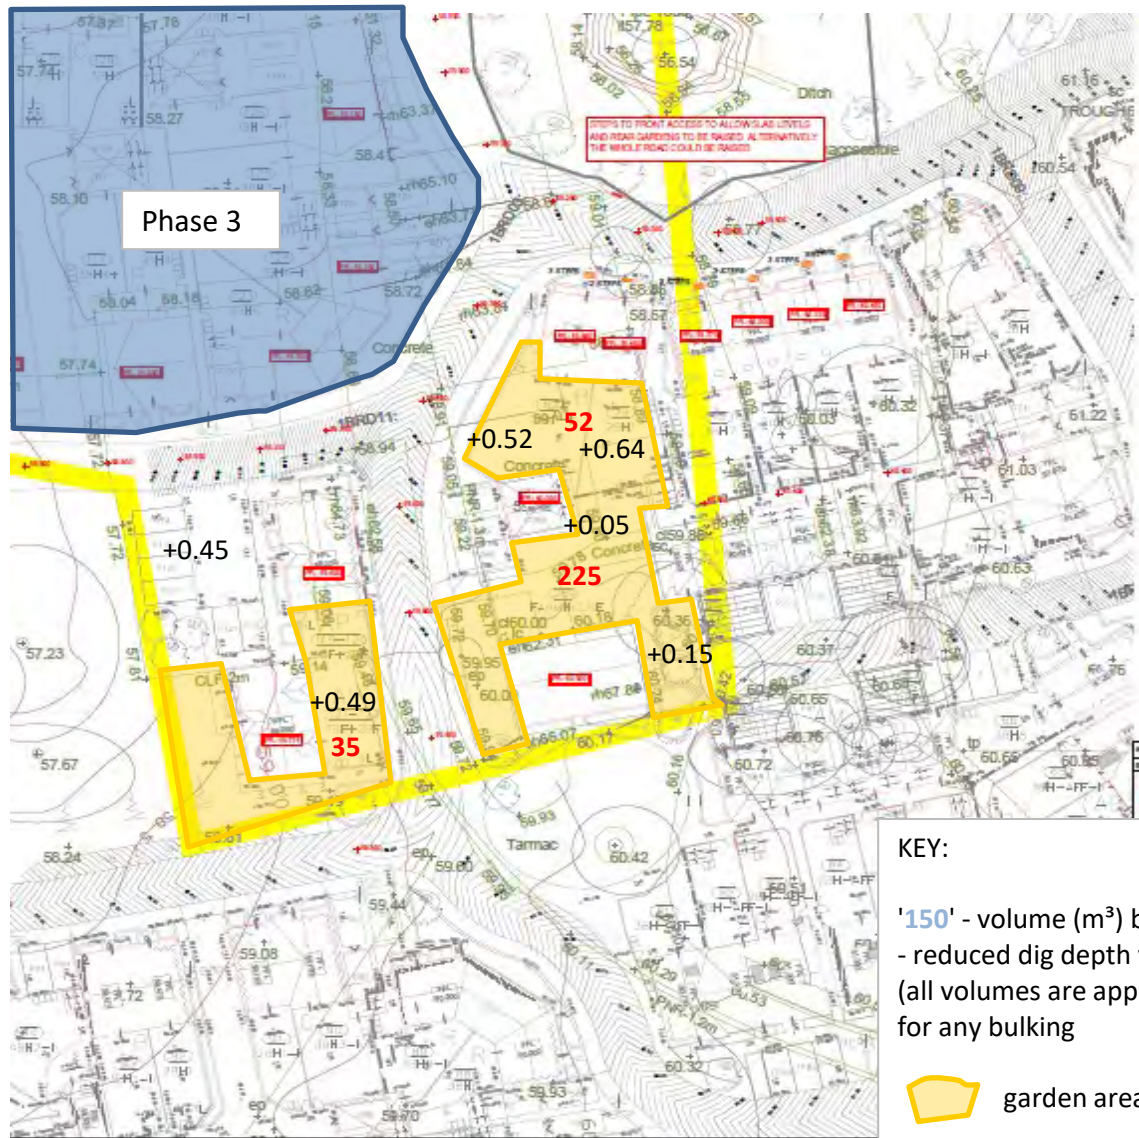
'150' - volume (m<sup>3</sup>) below soil cover system '150'  
 - reduced dig depth volume (m<sup>3</sup>)  
 (all volumes are approximate and do not account for any bulking)

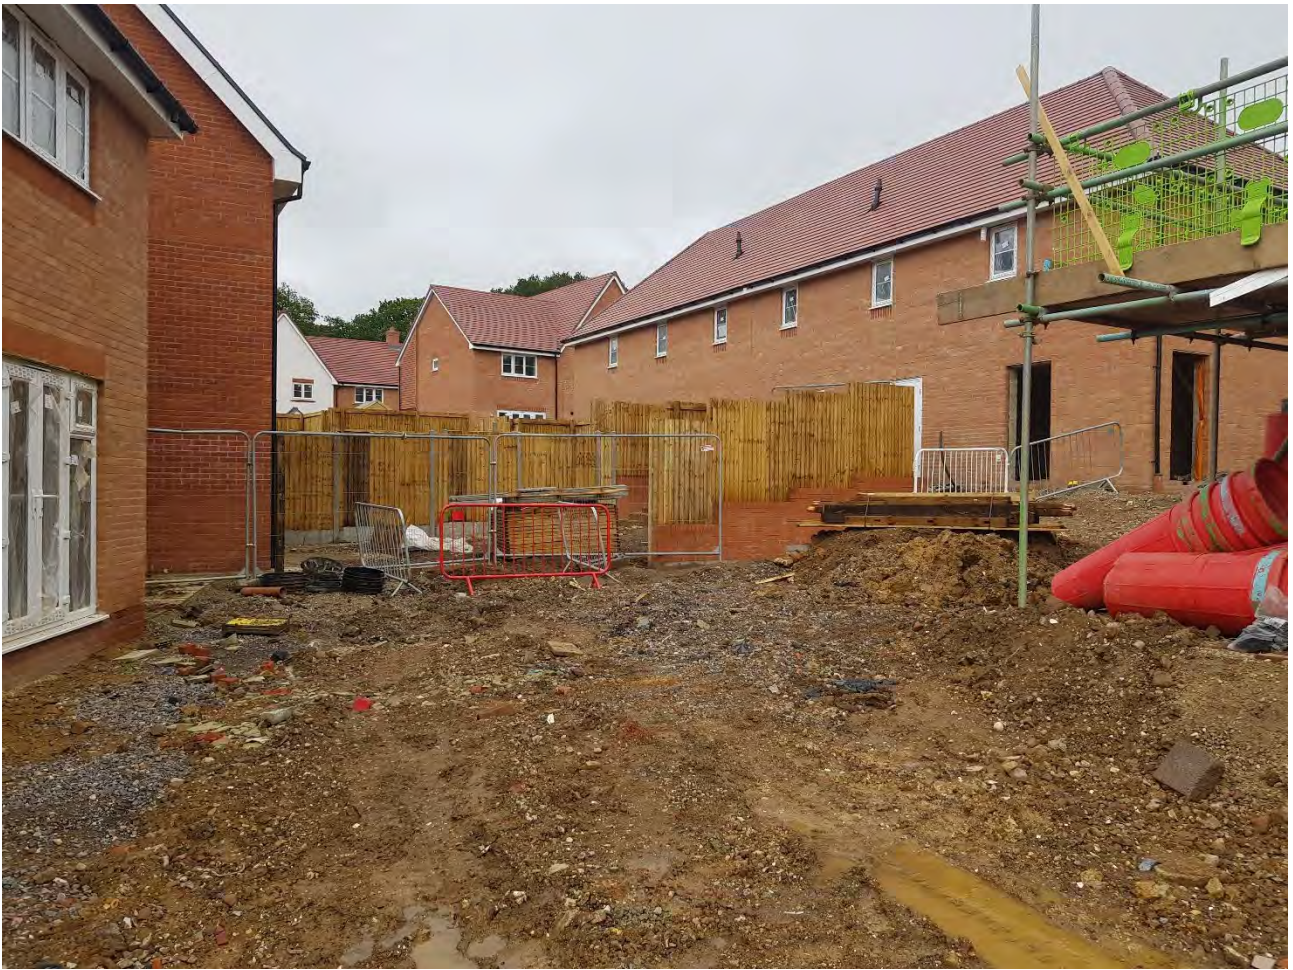
Plate 1 – 18<sup>th</sup> June 2021 – view of Plots 79-80 rear garden area prior to reduced dig

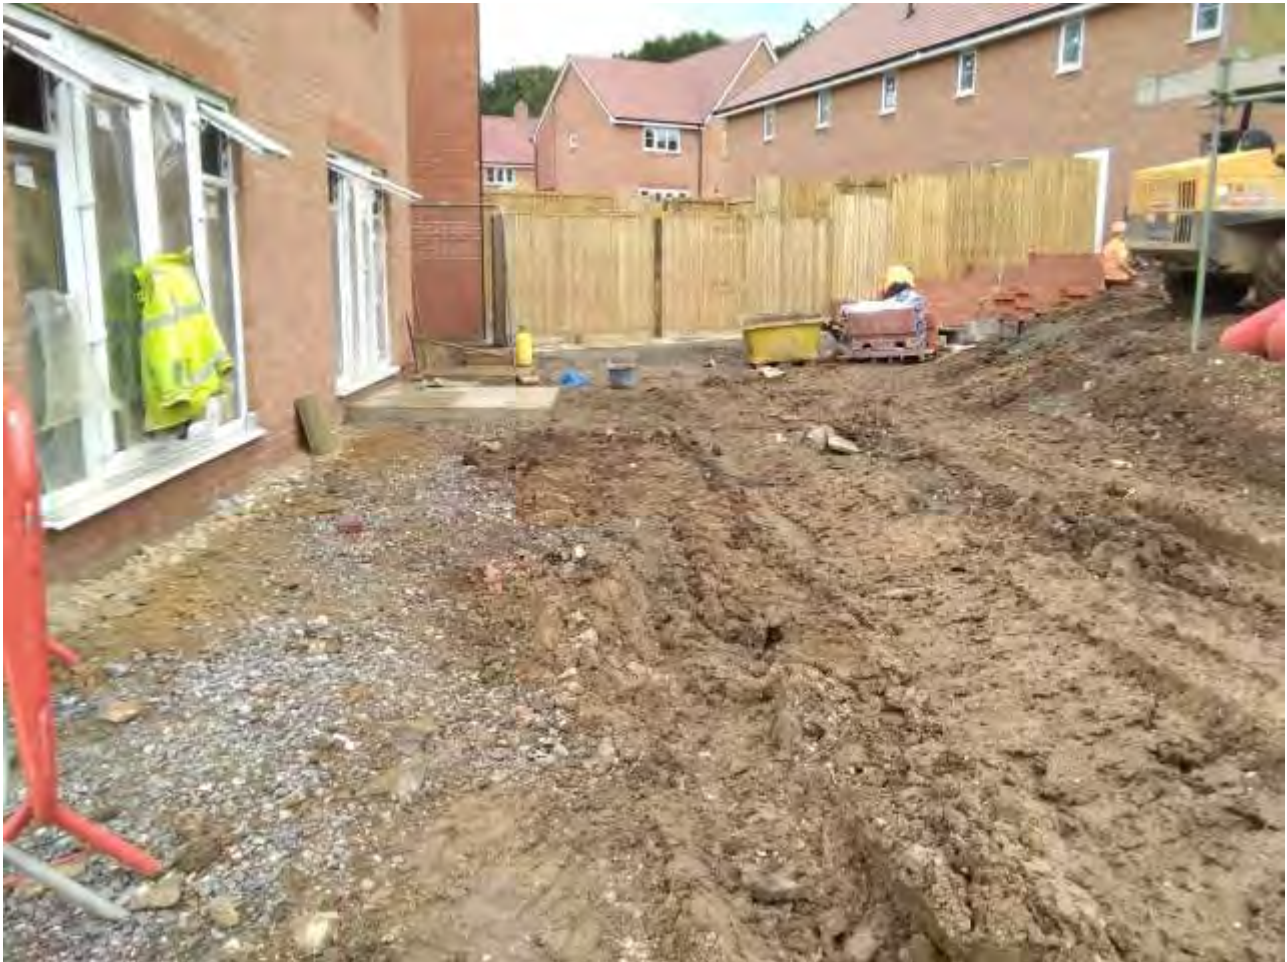
Plate 2 – 25<sup>th</sup> June 2021 - view of Plots 79-80 rear garden area prior to reduced dig

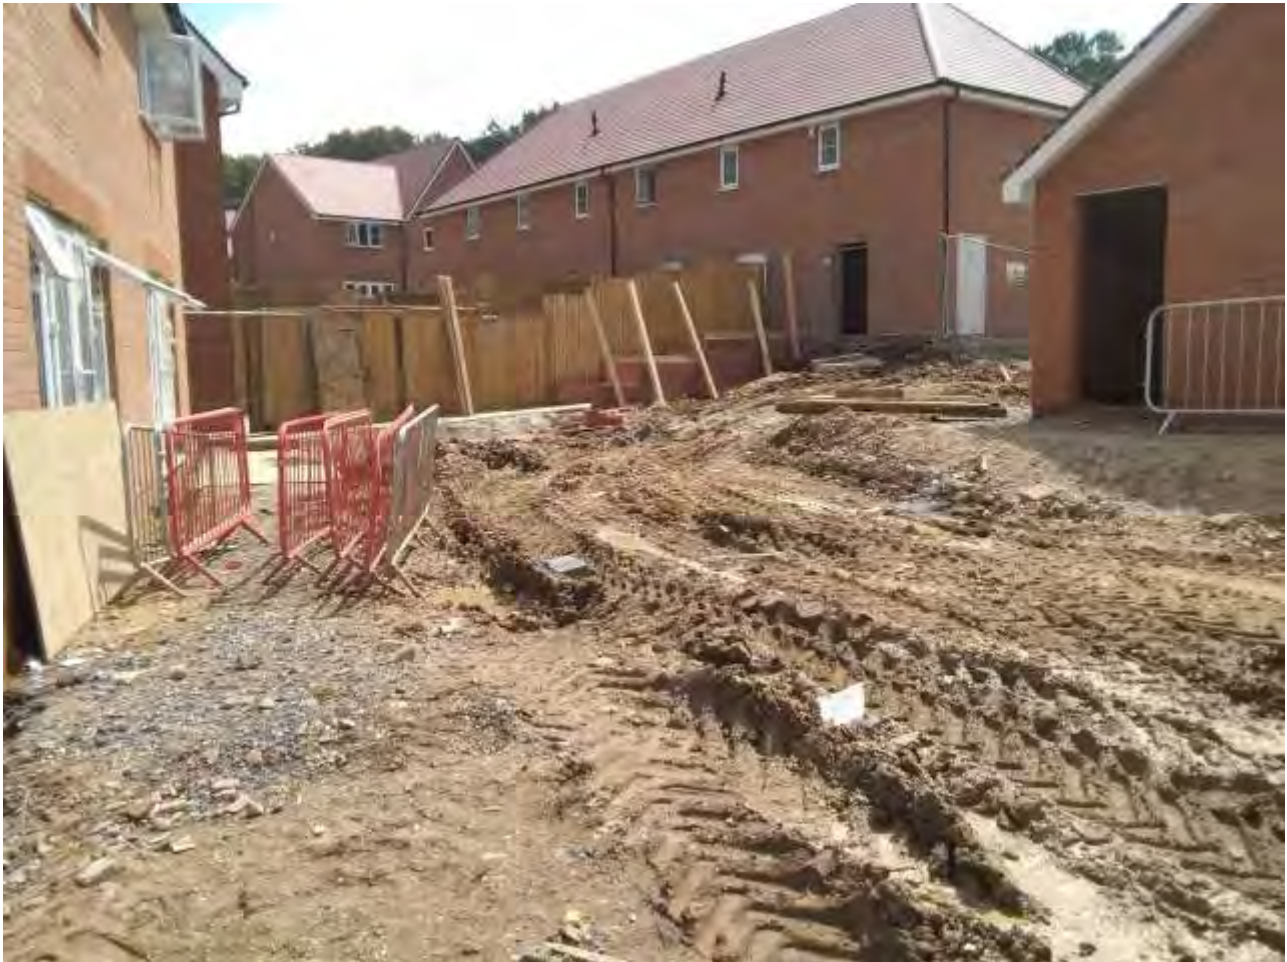
Plate 3 – 2<sup>nd</sup> July 2021 - view of Plots 79-80 rear garden area prior to reduced dig

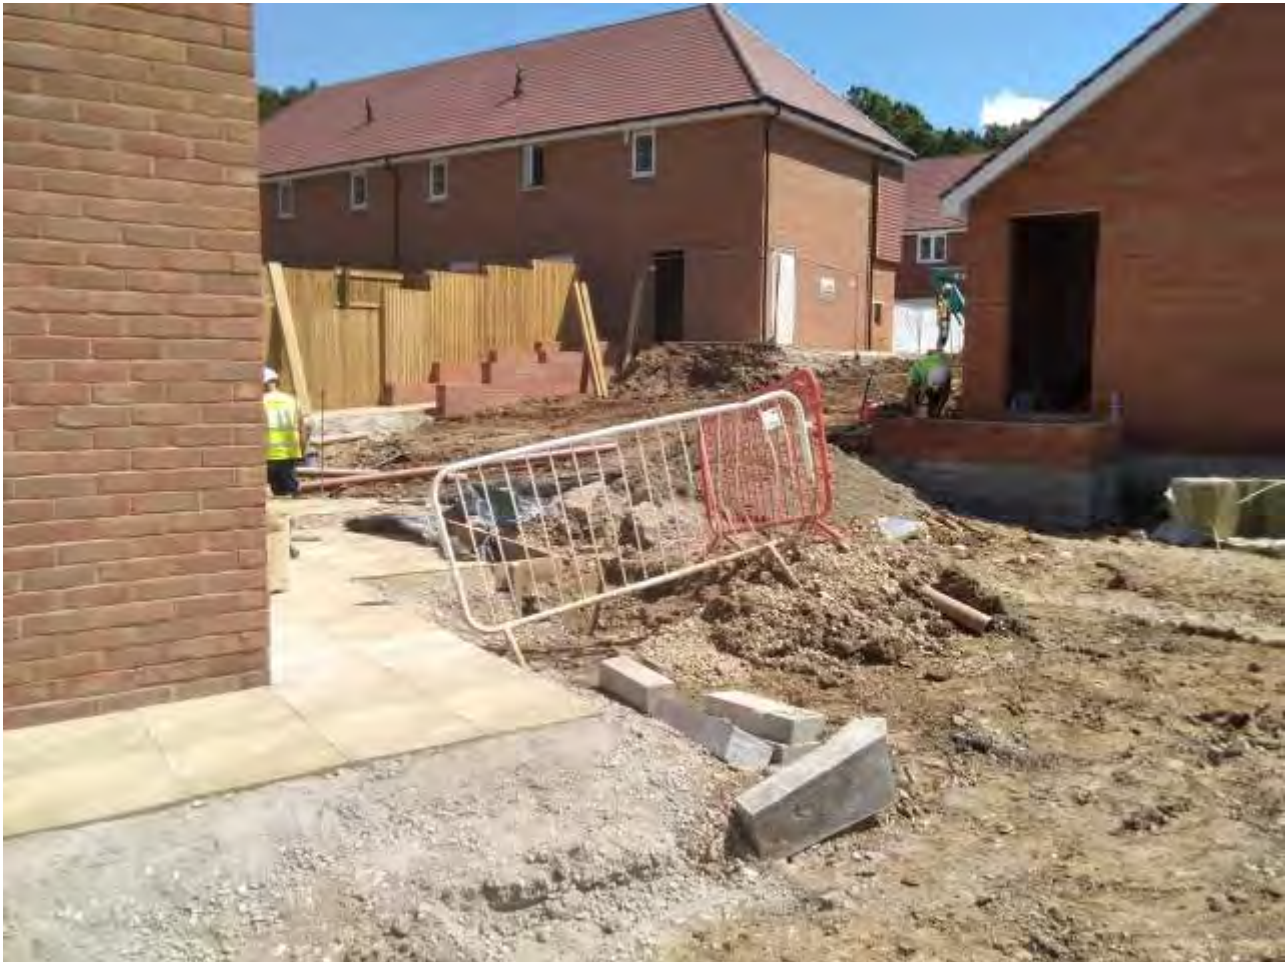
Plate 4 – 9<sup>th</sup> July 2021 - view of Plots 79-80 rear garden area prior to reduced dig  
(the patio was removed in order to undertake reduced dig)

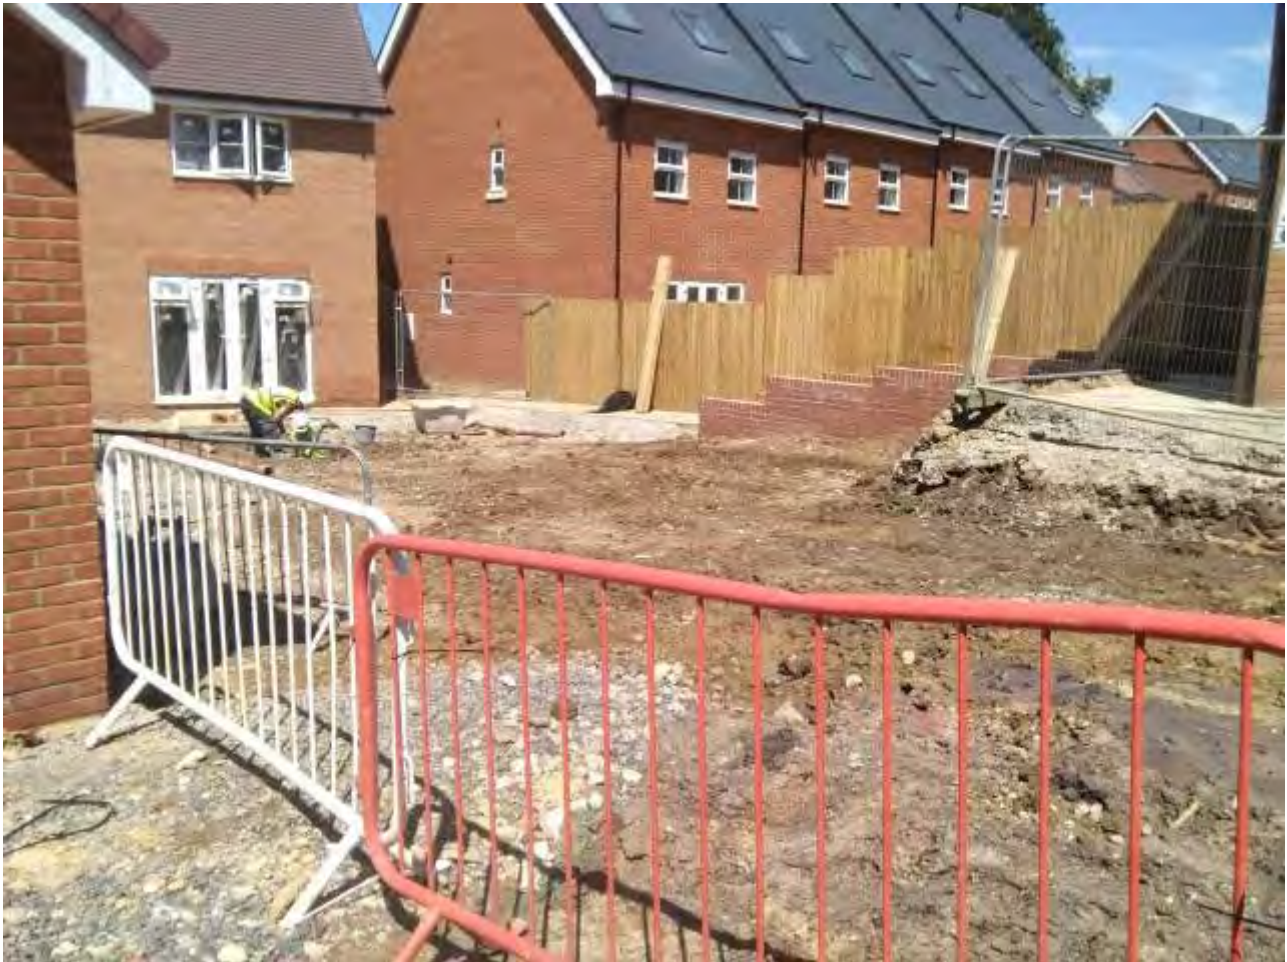
Plate 5 – 9<sup>th</sup> July 2021 - view of Plots 79-80 rear garden area prior to reduced dig

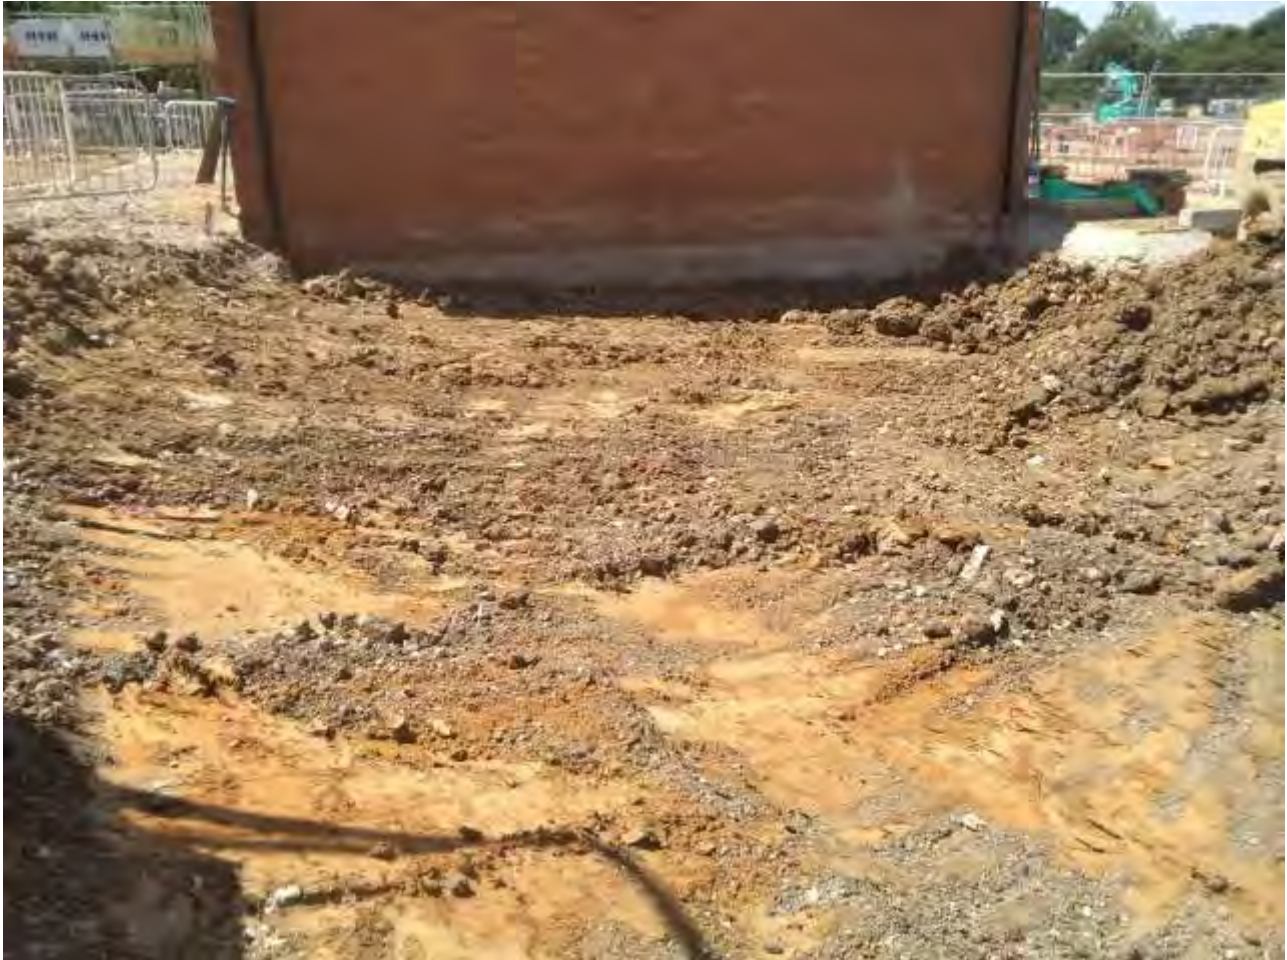
Plate 7 – 19<sup>th</sup> July 2021 - view of the reduced dig in the rear of Plots 79-80

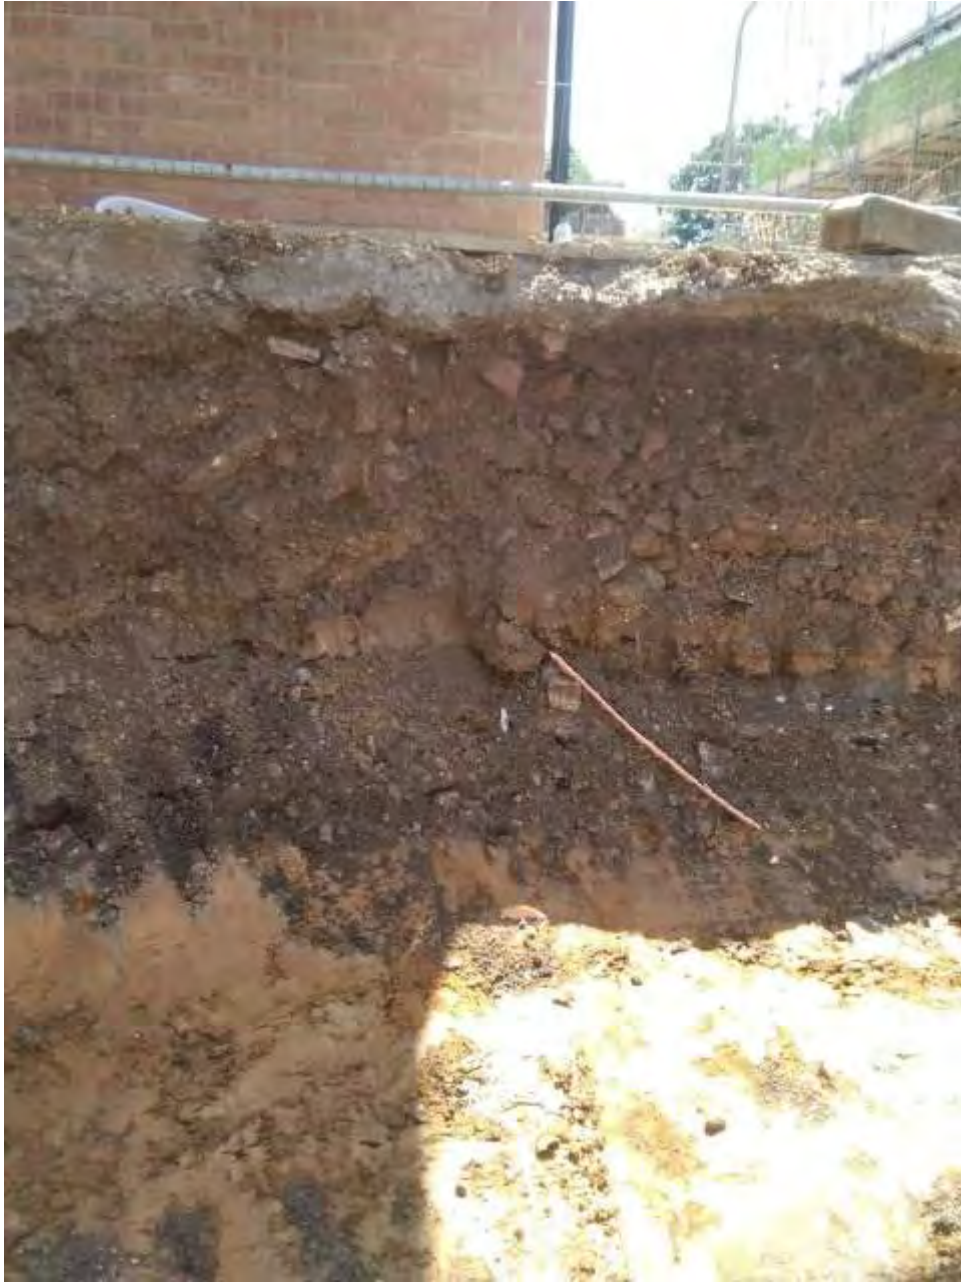
Plate 8 – 19<sup>th</sup> July 2021 - view of the edge of reduced dig compared to adjacent property

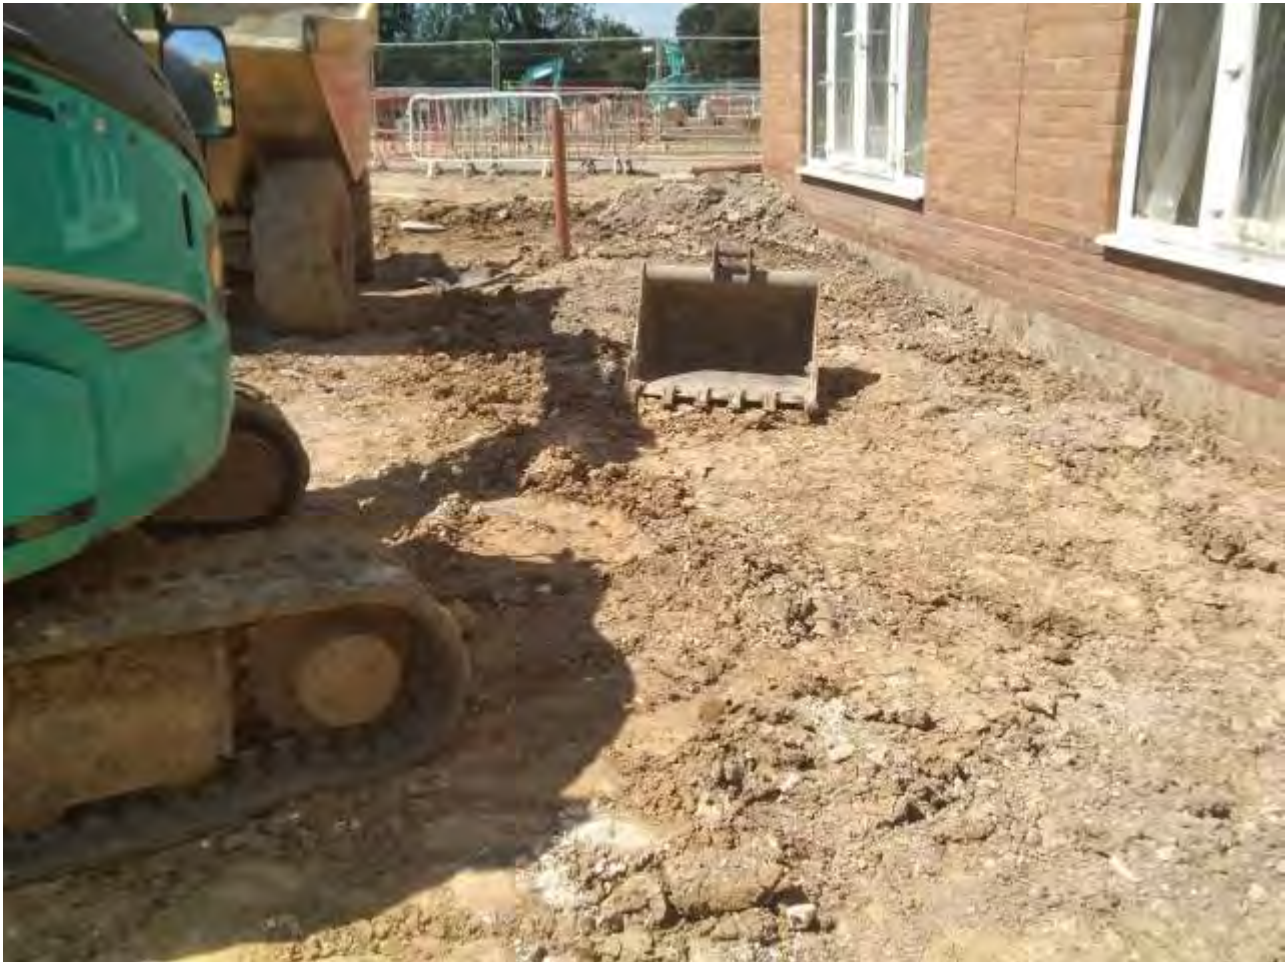
Plate 9 – 19<sup>th</sup> July 2021 – reduced dig in rear of Plots 79-80  
(previously installed patio removed)

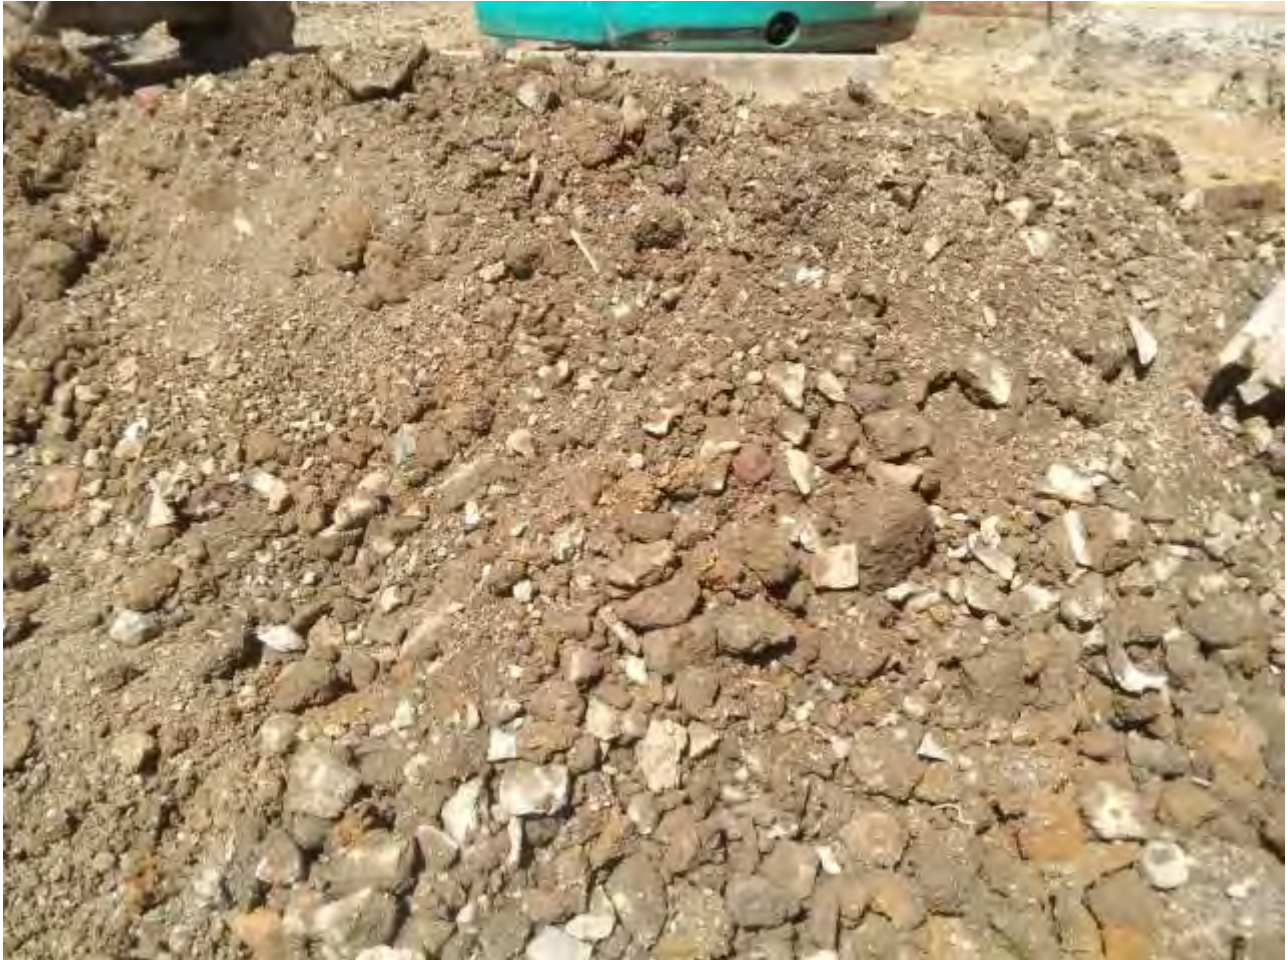
Plate 10 – 19<sup>th</sup> July 2021 – excavated material stockpiled for disposal

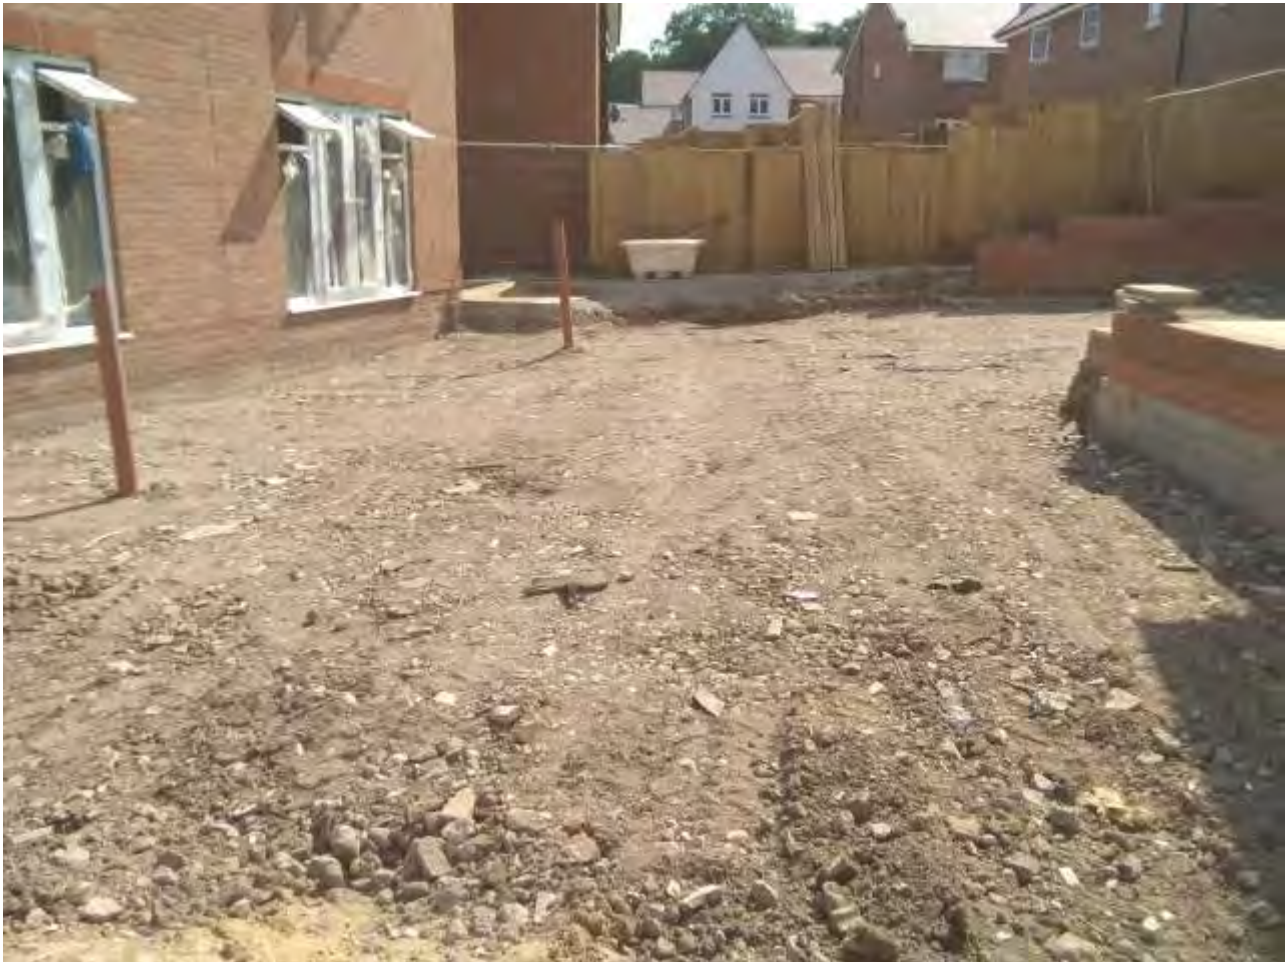
Plate 11 – 21<sup>st</sup> July 2021 – view of crushed concrete layer installed across rear of Plots 79-80

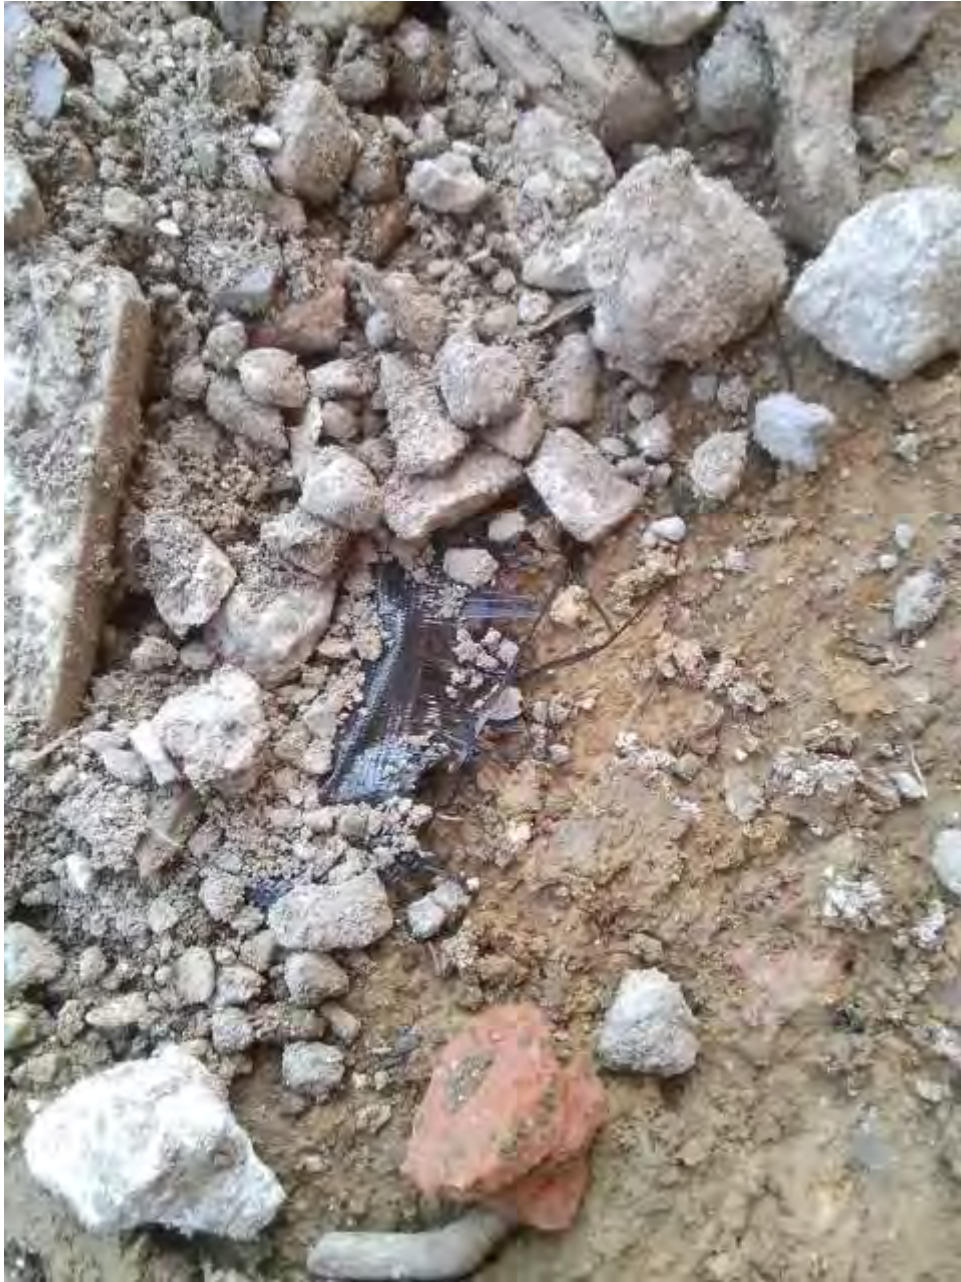
Plate 12 – 21<sup>st</sup> July 2021 – view of edge of crushed concrete layer with geo-textile visible

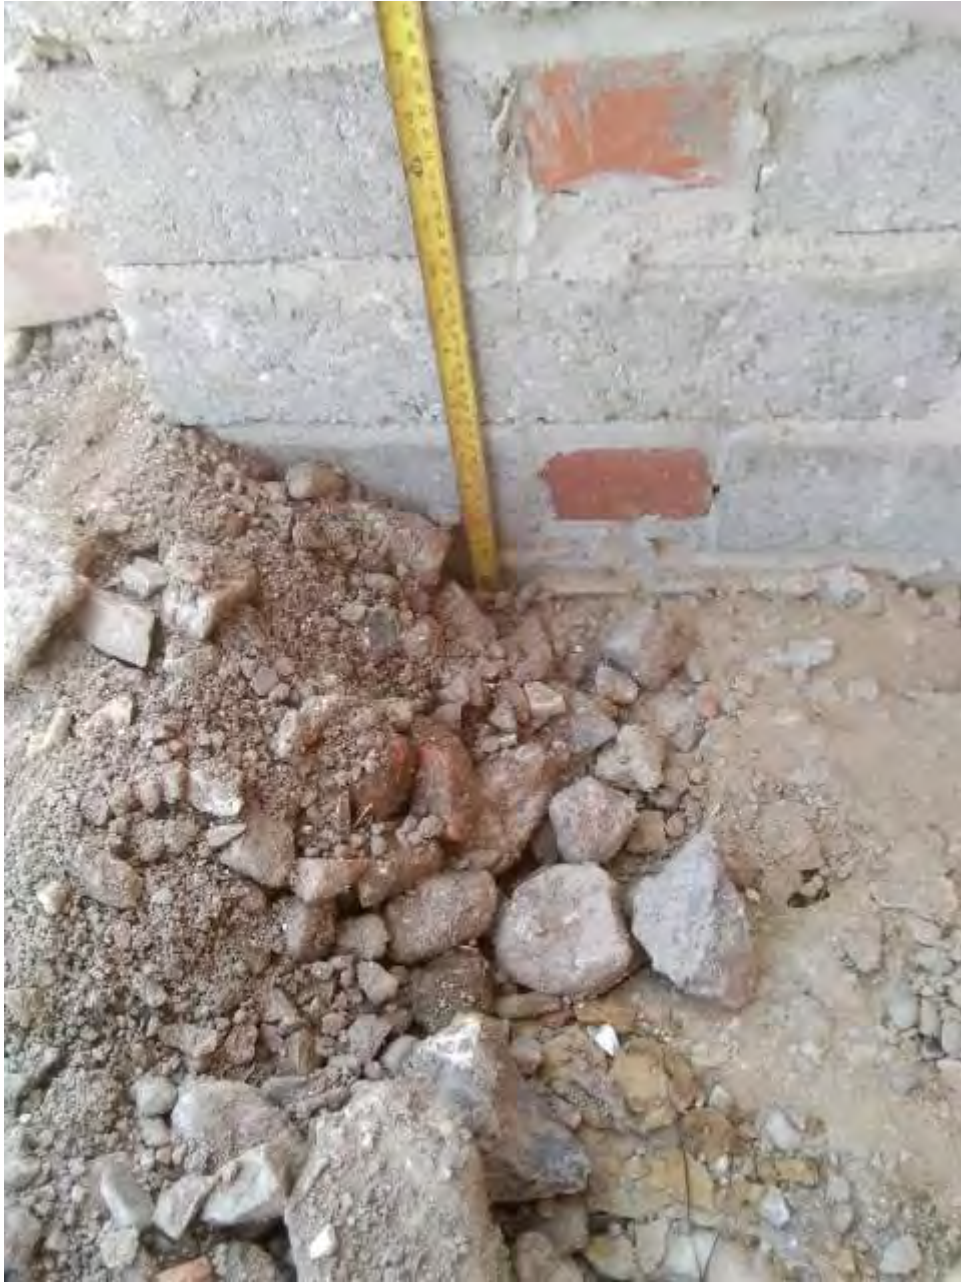
Plate 13 – 21<sup>st</sup> July 2021 – view of thickness of crushed concrete layer

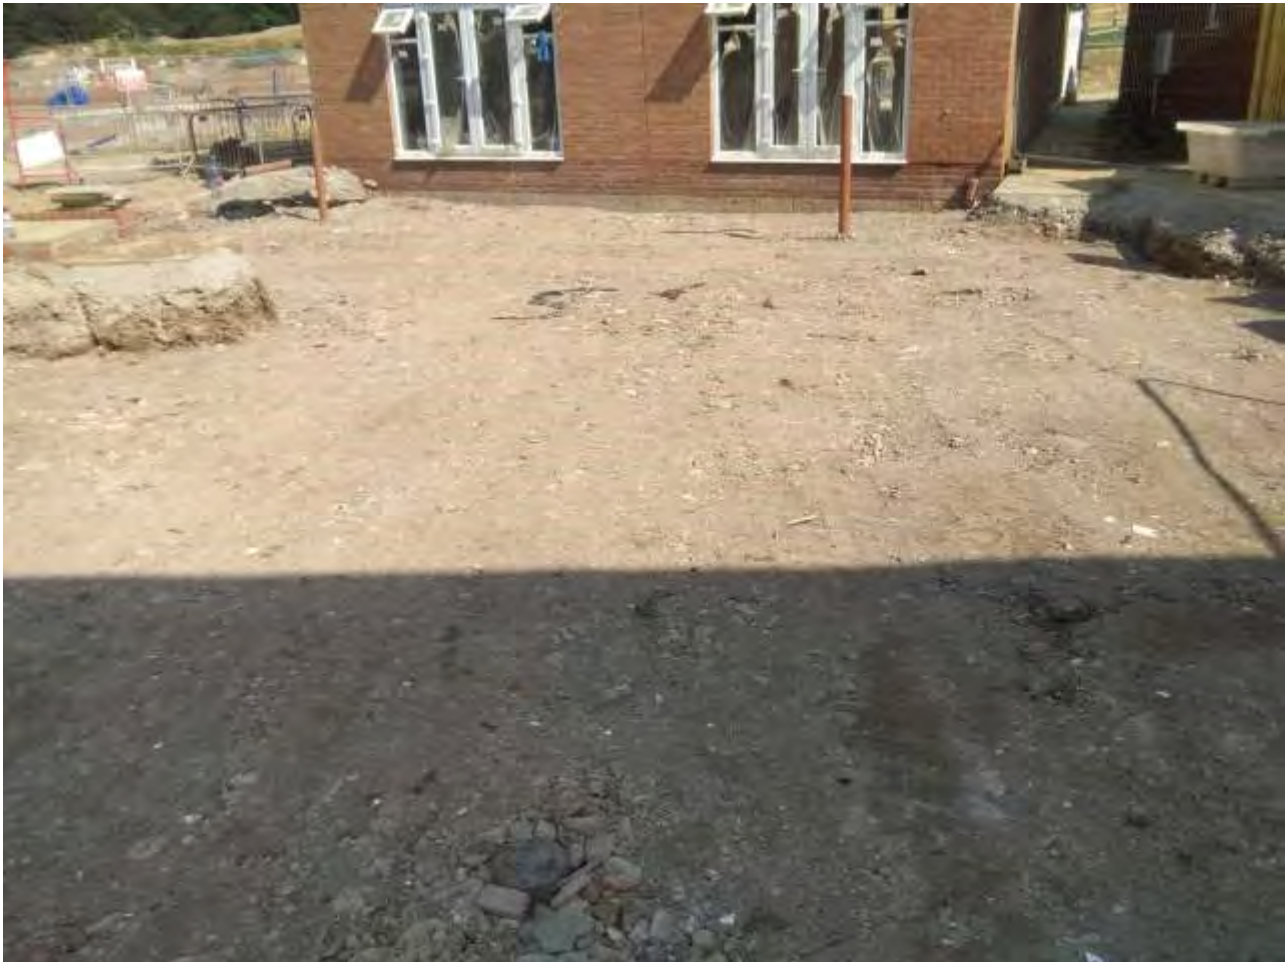
Plate 14 – 21<sup>st</sup> July 2021 – view of crushed concrete layer across Plots 79-80
