Solent Road  
Havant

## **Arboricultural Impact Assessment**

Issue No.3: 13-04-2023

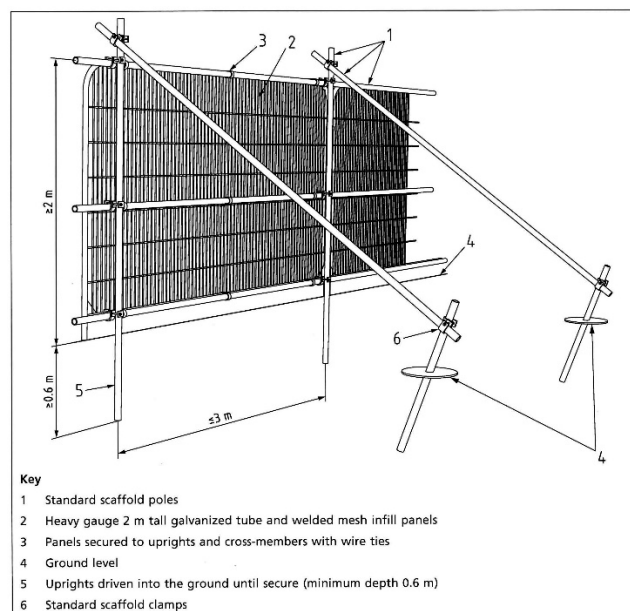
Temporary Protective Barrier

3.8.3 The recommended barrier complies with the recommendations given in BS5837:2012. Refer to Appendix 5. The protective barrier is to be erected before any demolition works commence. Signs are to be attached to this fence at 25 metre intervals which state "Protected Trees - Do Not Damage"

3.8.1 To form the Construction Exclusion Zone, ensuring protection of the existing retained trees, a protective fence will be erected prior to diverting the FW sewer and other preparatory works within the site.

3.8.2 The protective fence is to be erected as indicated in Appendix 4.

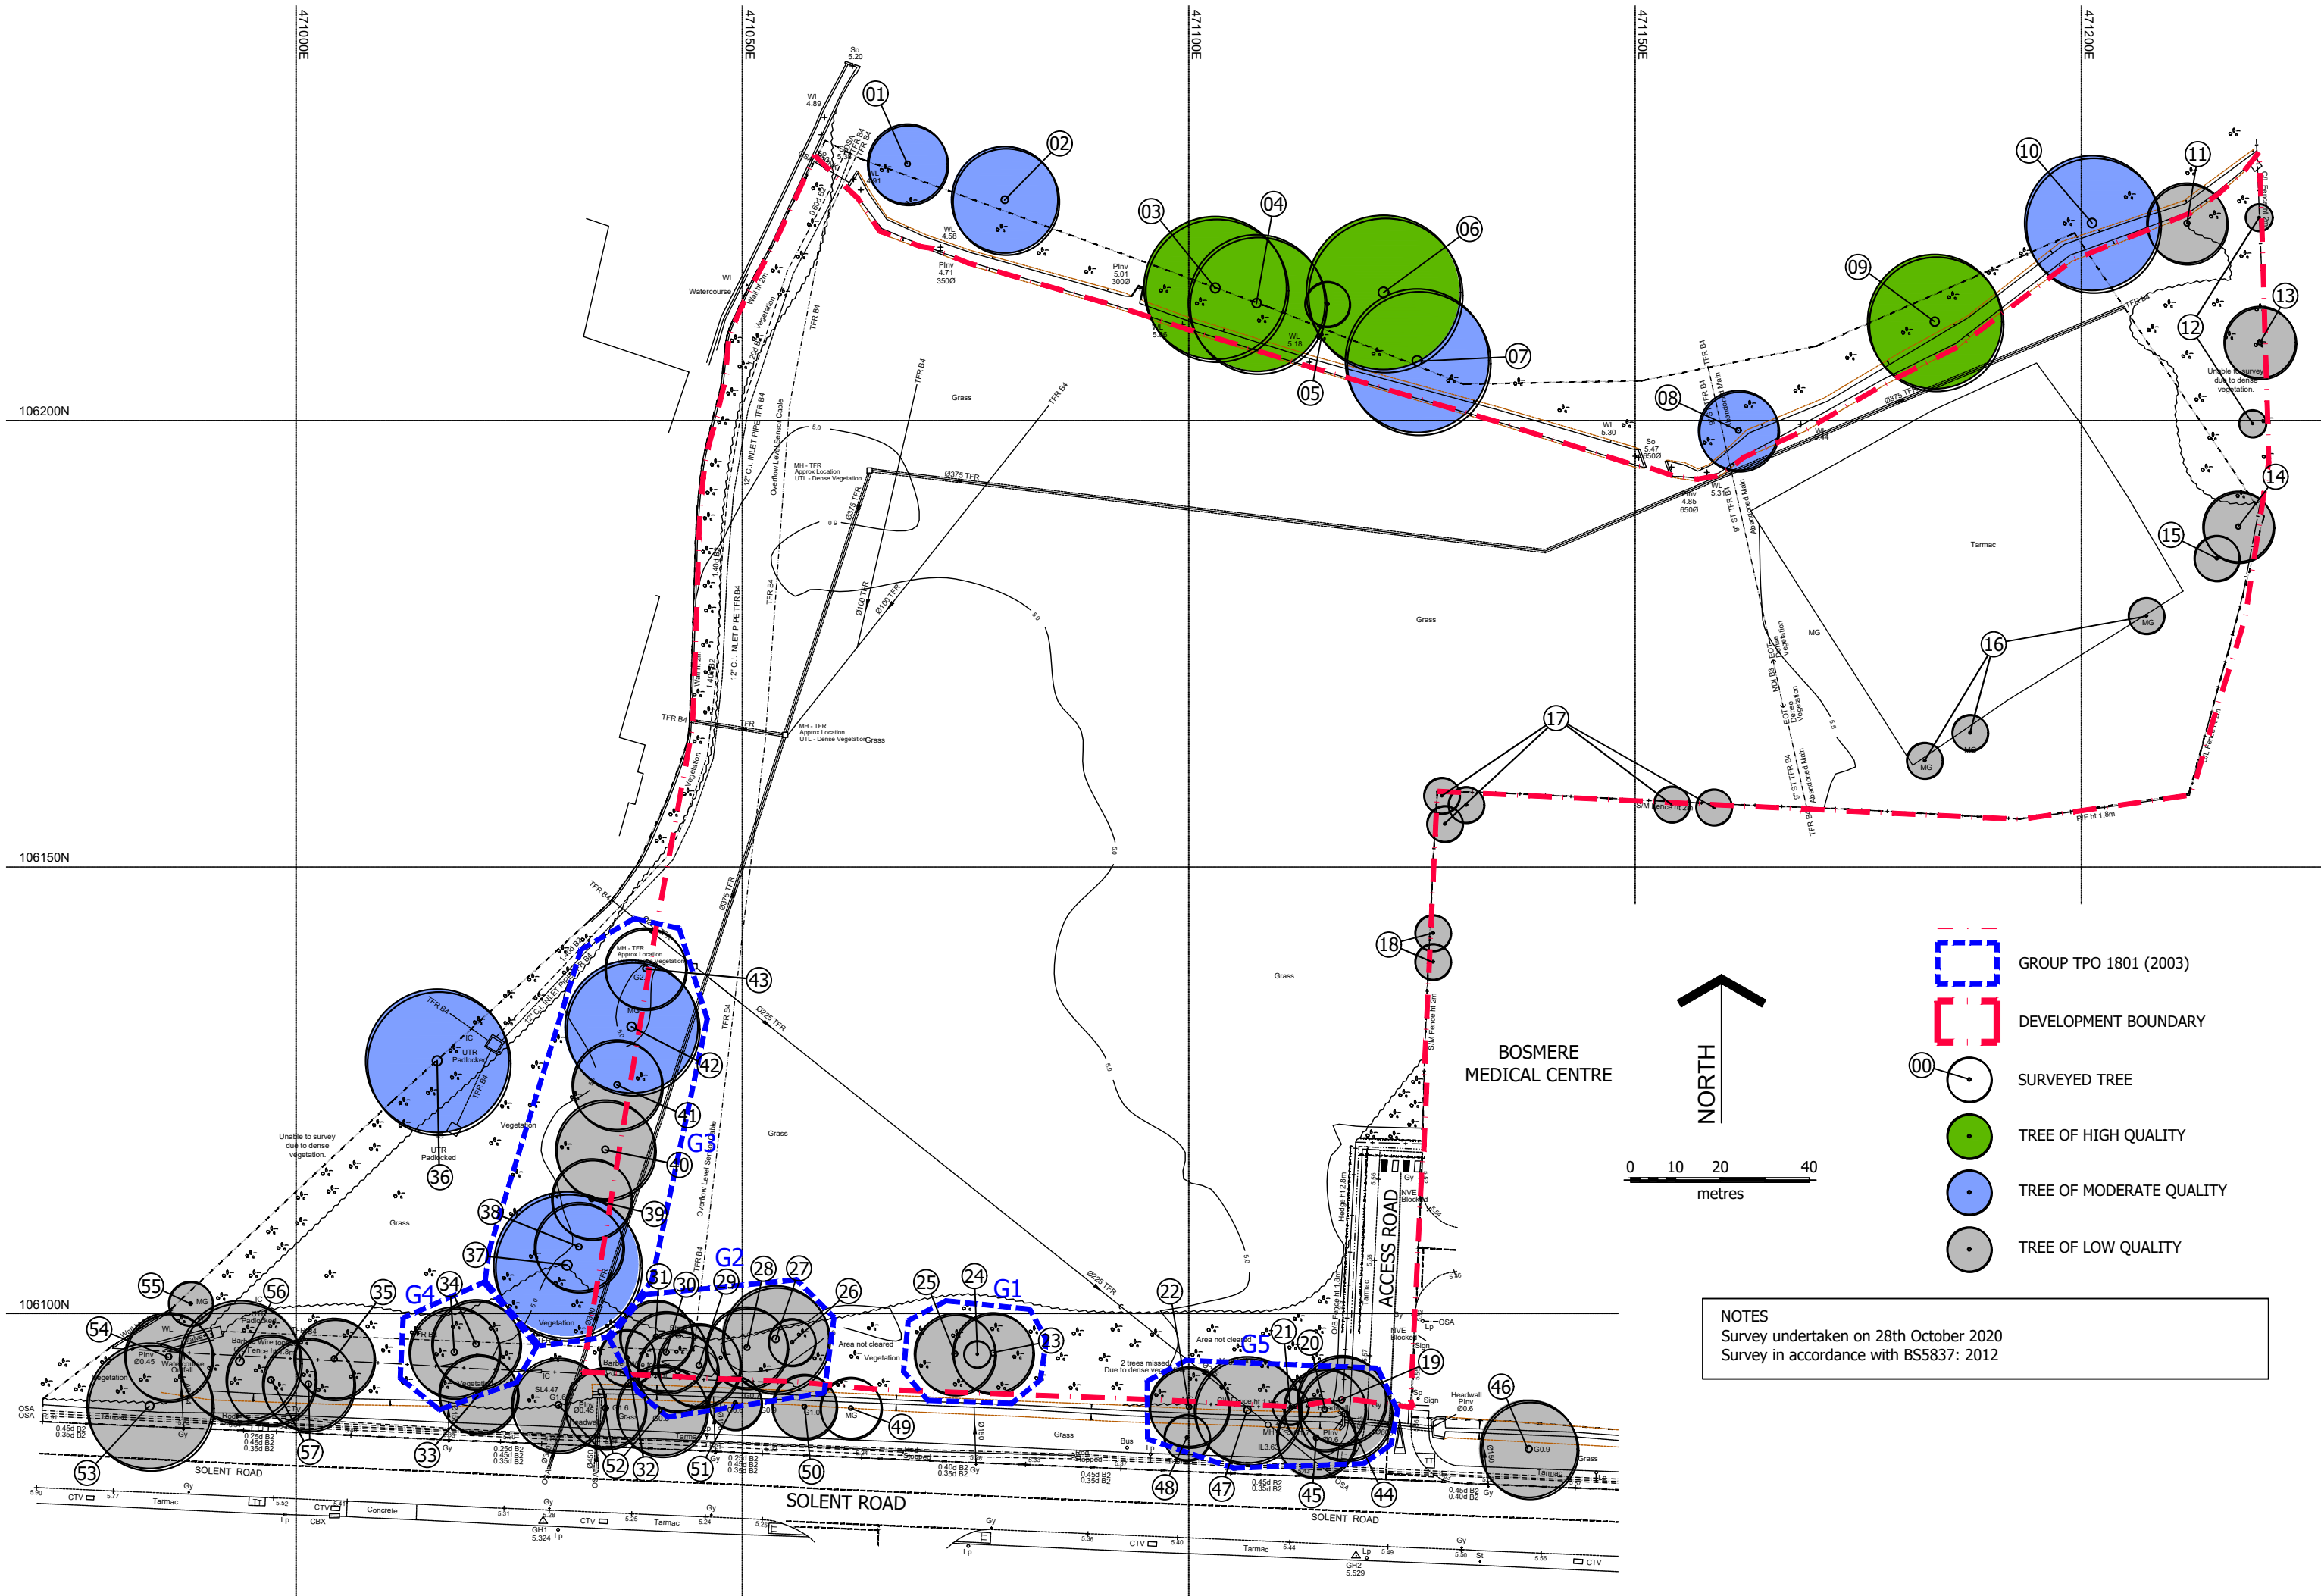
TREE SURVEY PLAN 1

- 1.1.1 A total of 70Nr. individual trees, which includes trees outside the site boundary but may be impacted by the development, have been surveyed, see Plan 1 in Appendix 2. The survey schedule prepared follows the guidance provided in BS 5837 'Trees in relation to construction' (2012). The majority of trees surveyed are in a sound condition with only 3Nr. trees where there are defective aspects to their structure. All of the trees that are to remain on site will, in the long term, require some form of maintenance work which should be undertaken by an arboricultural contractor who is a member of the Arboricultural Association or similar professional body.
- 1.1.2 This report and the attached drawings are in support of the planning application submitted by Chancerygate (Erdington) Limited.

3.1.1 The tree survey was initially undertaken on 28th October 2020. Each of the surveyed trees has been individually numbered and added to the topographical survey base. The survey information recorded includes the following:

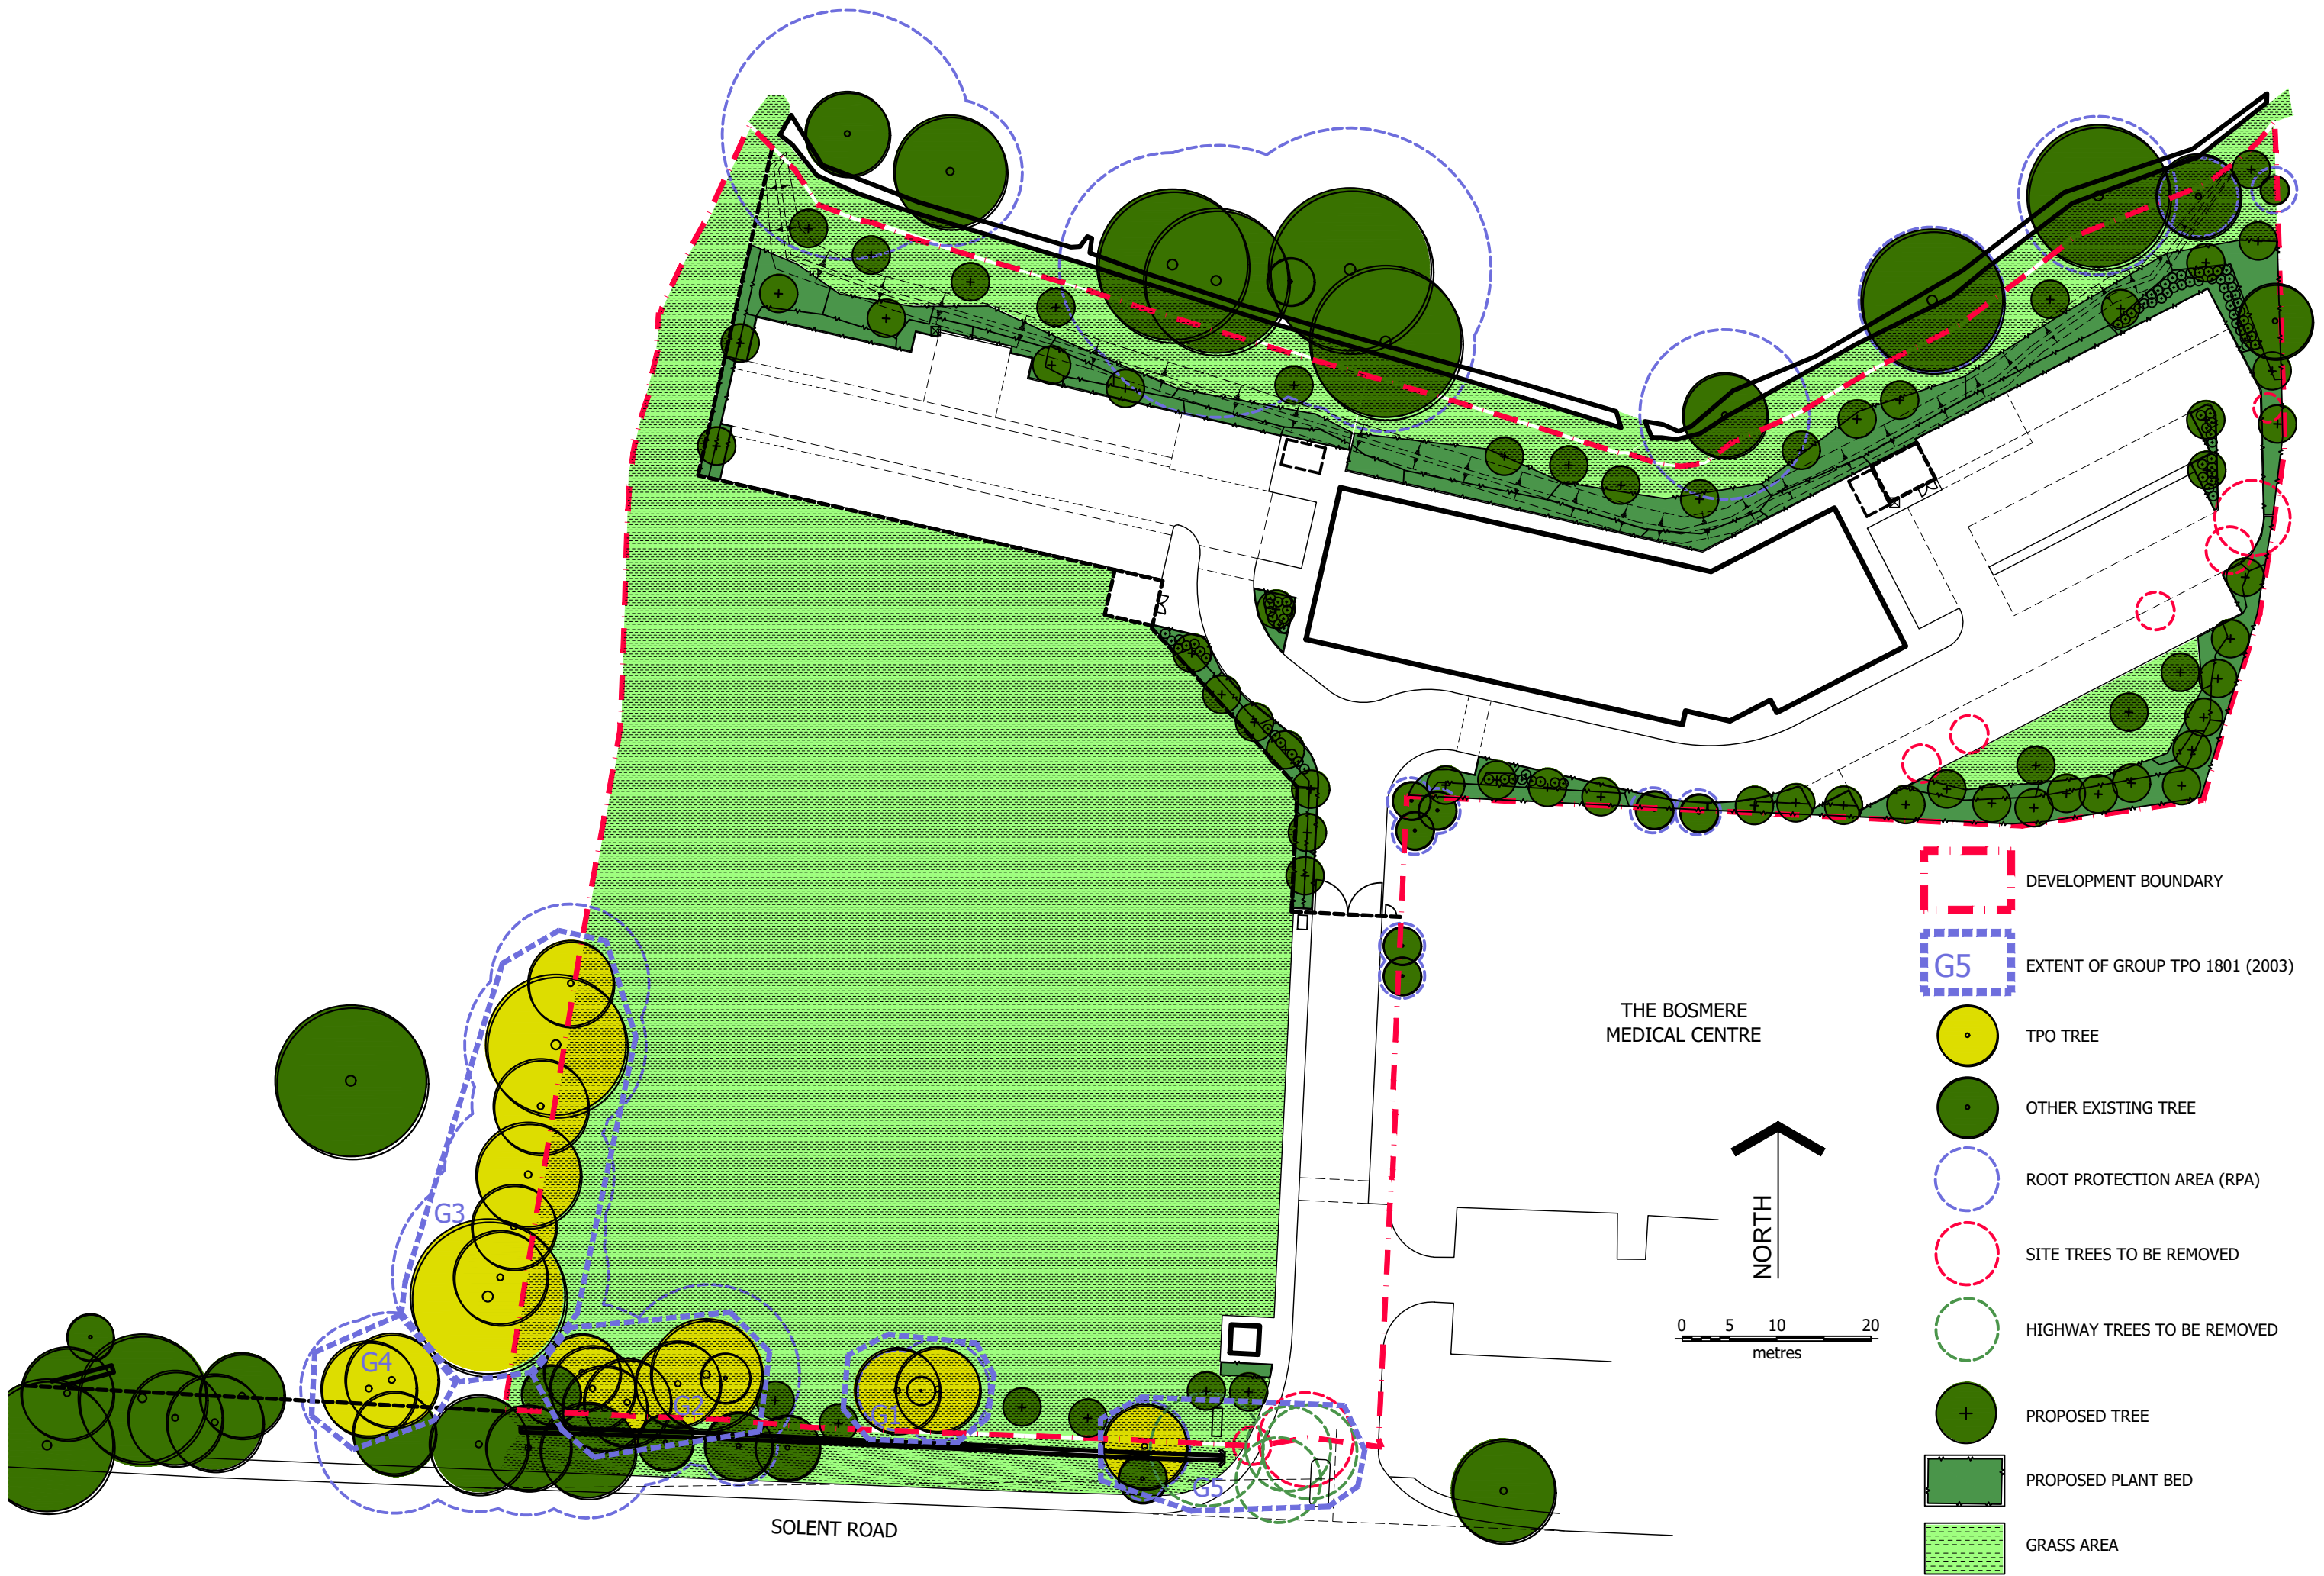
TREE IMPACT ASSESSMENT PLAN 2

- 3.4.1 The Root Protection Area (RPA) is the area shown in plan as a radius from the centre of the tree within which the tree roots must be protected from excavation and disturbance. Where disturbance cannot be avoided, such work must be monitored by an arboriculturalist and/or a Landscape Architect to ensure damage to the root system is minimised. The RPA areas have been set out in accordance with Table 2 of BS5837:2012. The RPA areas for the trees surveyed are shown on Plan 2, see Appendix 3.

- 3.6.1 The trees to be felled are indicated on Plan 2, see Appendix 3 and total 13Nr. out of 70Nr. trees surveyed. All the trees to be removed are considered low quality.
- 3.6.2 Felling and clearance works should not be undertaken during the bird nesting season from 1st March to 30th September unless an Ecologist is appointed and present to monitor for nesting activities. No nesting birds may be disturbed until all the young have fledged.
- 3.6.3 The canopy spread of trees to be retained are of a sufficient distance from the construction works and will not require additional works such as crown lifting or thinning. The Arboriculturalist may advise on removal of deadwood and crossing or weak limbs.

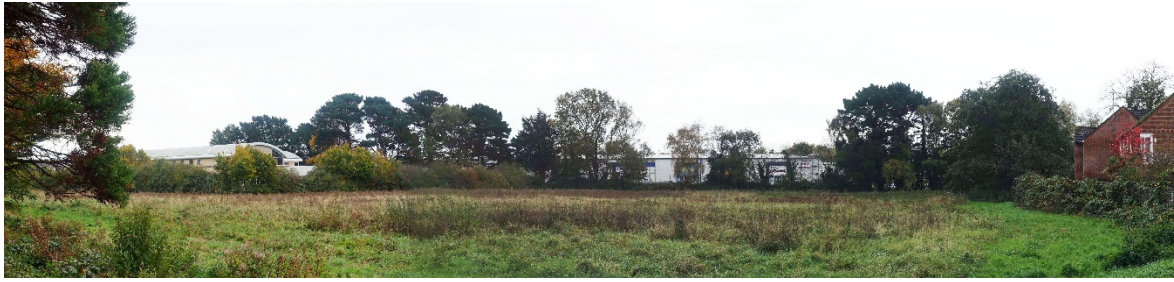
Facing south to Solent Road across the site

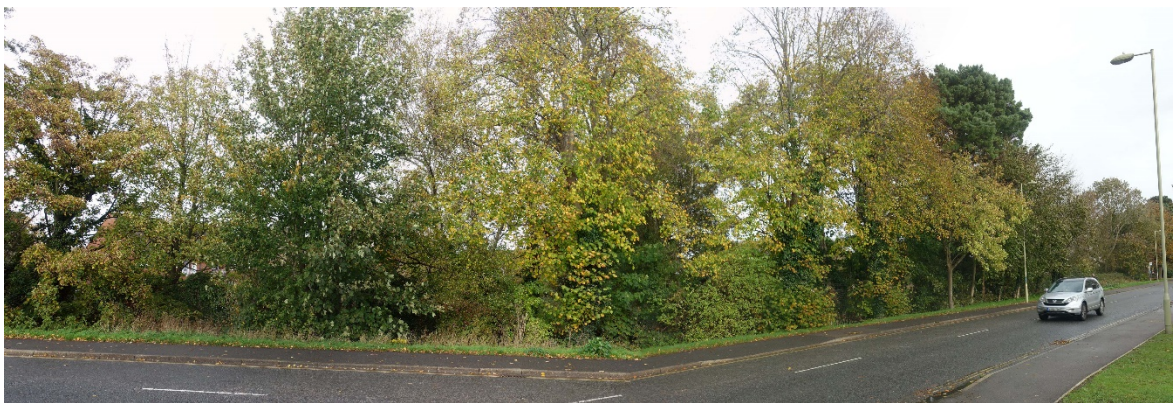
Solent Road boundary

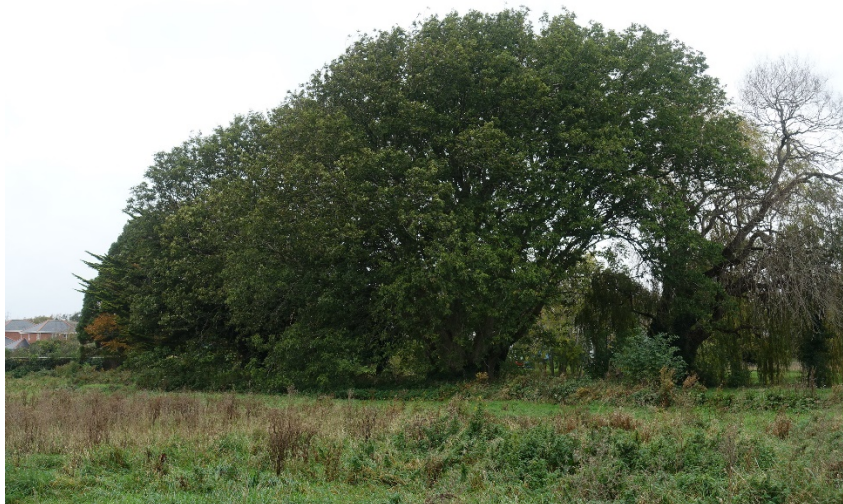
Caucasian Wingnuts adjacent to the north boundary
