# Bat Survey Report – Preliminary Roost Assessment

Springwood Junior School

For  
Hampshire County Council  
Property Services

February 2023

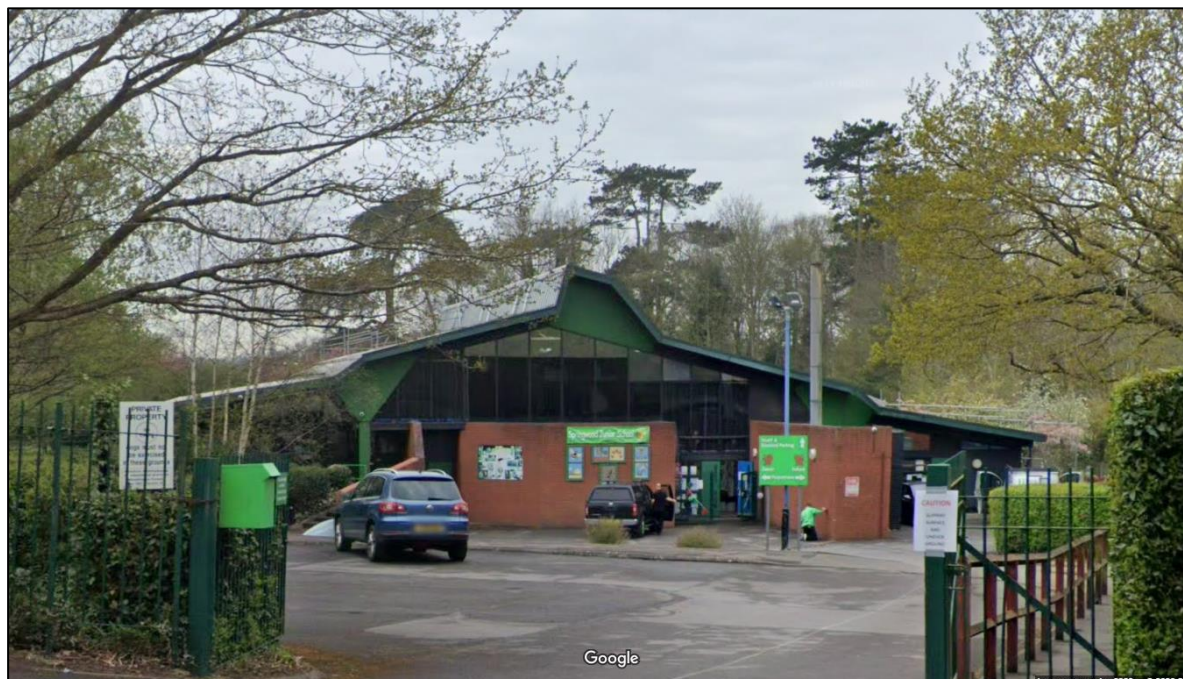
- 1.2. Springwood Junior School is located within the south-east part of Waterloooville, 550m west of the M3 motorway.
- 1.3. The site contains one main school building and four small outbuildings within grounds of hardstanding, amenity grassland and woodland areas.
- 1.4. The main school building (Photo 1, Appendix 3) was constructed in 1982 and is a listed building as a result of the unusual design. The innovative design of the school is the reason for its Grade II listing. The two-story building has an expansive, approximately rectangular roof with a shallow pitch and large overhangs at the ends. Three rows of skylights extend along the length of the roof.

**Photo 1** General view of the main school building from the east, showing expansive roof of unusual shape.

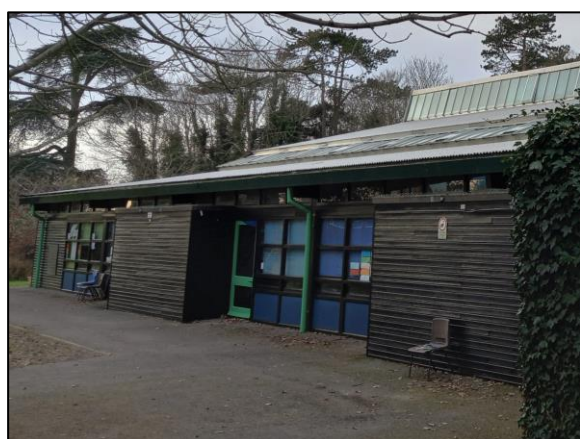
- 3.8. The walls are constructed of a mix of boarding and glazing on the long elevations, and additional areas of brick on the end elevations. The boarding is fully sealed, tightly fitting and heavily painted, with no bowing or gaps. The brickwork is in good repair, and the metal-framed glazing panels, green decorative panels and all other components of the walls fit tightly together, with no gaps present (Photos 2 and 3). The vents shown in Photo 3 serve the kitchen and are unsuitable for bats.

- 3.9. There are a few small, single-story protrusions from the main building, predominantly the classroom stores along the long elevations (Photo 2) and the boiler room on the eastern aspect. These sections have a felt roof, which is in good repair and there are no gaps between the wall and lip of roofing felt.

**Photo 2** View from the south, showing typical wall construction, with a mix of boarding and glazing.

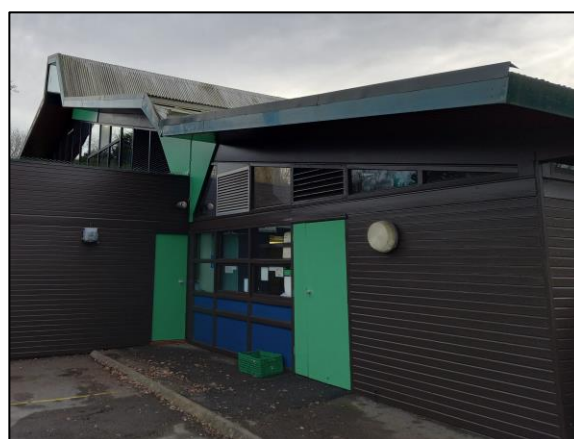
**Photo 3** View from the north-east, showing tightly-fitting wall components and two large vents into the kitchen.

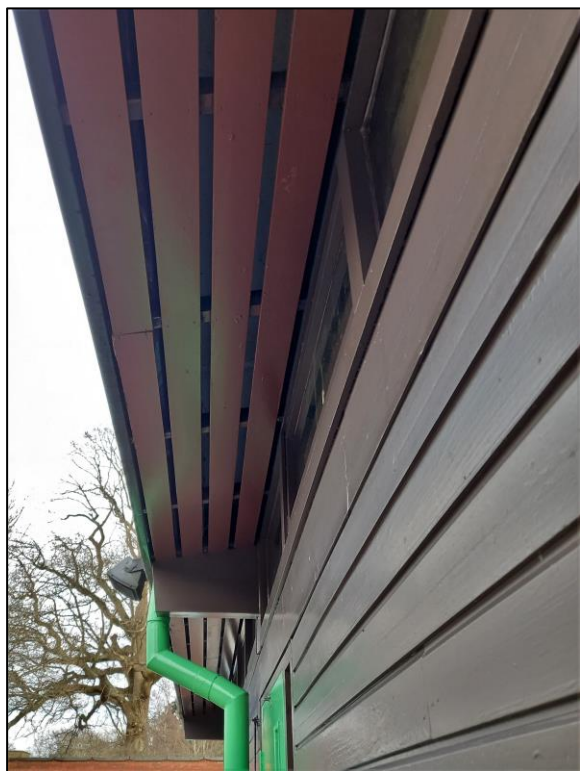
- 3.10. Large roof overhangs are present on all sides of the main building. The soffits are constructed of parallel planks with spacing of c. 2cm between each (Photos 4 and 5). These gaps provide access into the eaves; however, the underside of the roof is smooth metal, and the space is large and very draughty. The eaves are therefore considered unsuitable for roosting bats due to the lack of places to grip, and the minimal thermal stability.

**Photo 4** Cavity within the eaves, lined with smooth metal.

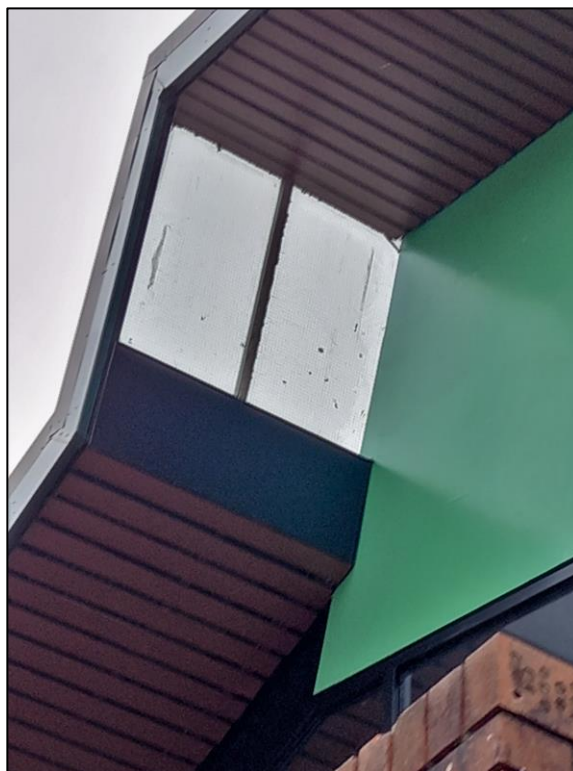
**Photo 5** Large overhang at the ends of the building, same construction as the eaves.

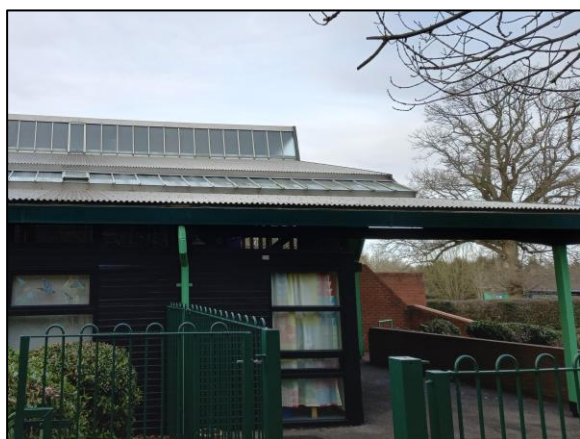
- 3.11. The main roof is constructed of corrugated metal sheets, with a central line of ridge-light windows and the skylights (Photos 6 and 7). From the ground it was unclear if the ends of the corrugations are blocked, however the temperature underneath the metal panels would be very variable, and of negligible suitability for roosting bats.

**Photo 6** General view of the roof from the south.

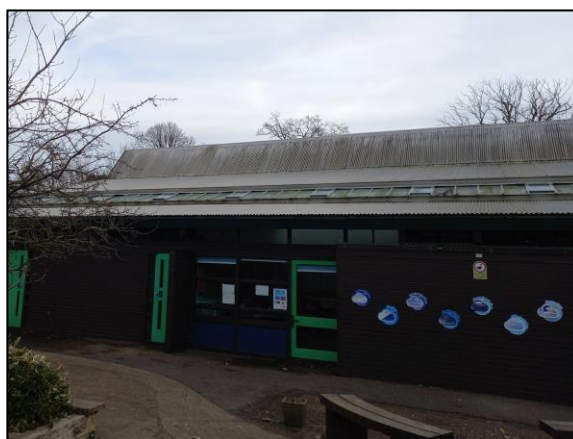
- 3.12. At the highest point of the skylights is lead flashing, and where it extends over the occasional openable windows it is lifted in the corners, providing a small space between the flashing and the glass of adjacent glazing panels (Photo 7). From inside the building these can be viewed through the glazing. Similar to the other areas of the roof, these are considered unsuitable to support roosting bats due to the thermal instability, lack of grip and high levels of light.

**Photo 7** General view of the roof from the north.

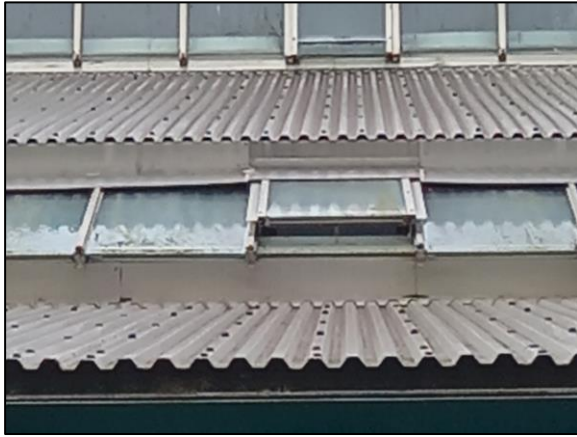
**Photo 8** *Detail of corrugated metal roof, glazing and flashing.*

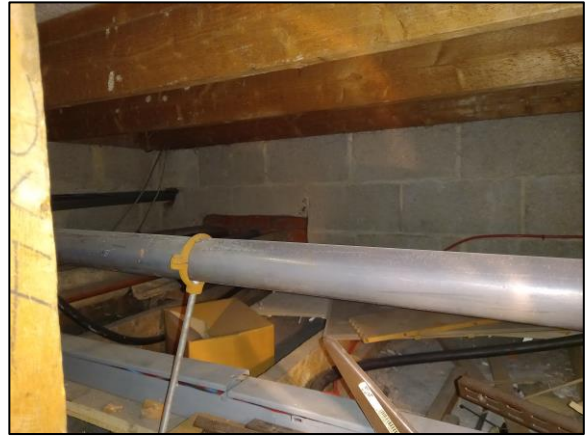
- 3.13. Internally, the majority of the building is one open space all the way up to the roof level, without enclosed areas such as lofts. The only enclosed area is above the caretaker's office on the north-east corner of the building. This space is constructed of breezeblocks, and the ceiling is boarded with plywood. No potential entry or exit points to the outdoors were found, and no evidence of bats such as droppings or staining was present.

**Photo 9** *Inside the loft space above the caretaker's office.*
