# Arboricultural Implications Assessment & Arboricultural Method Statement

Site Address:  
40 Horndean Road, Emsworth, PO10 7PT

Ref: KTML-25520 -AIA & AMS

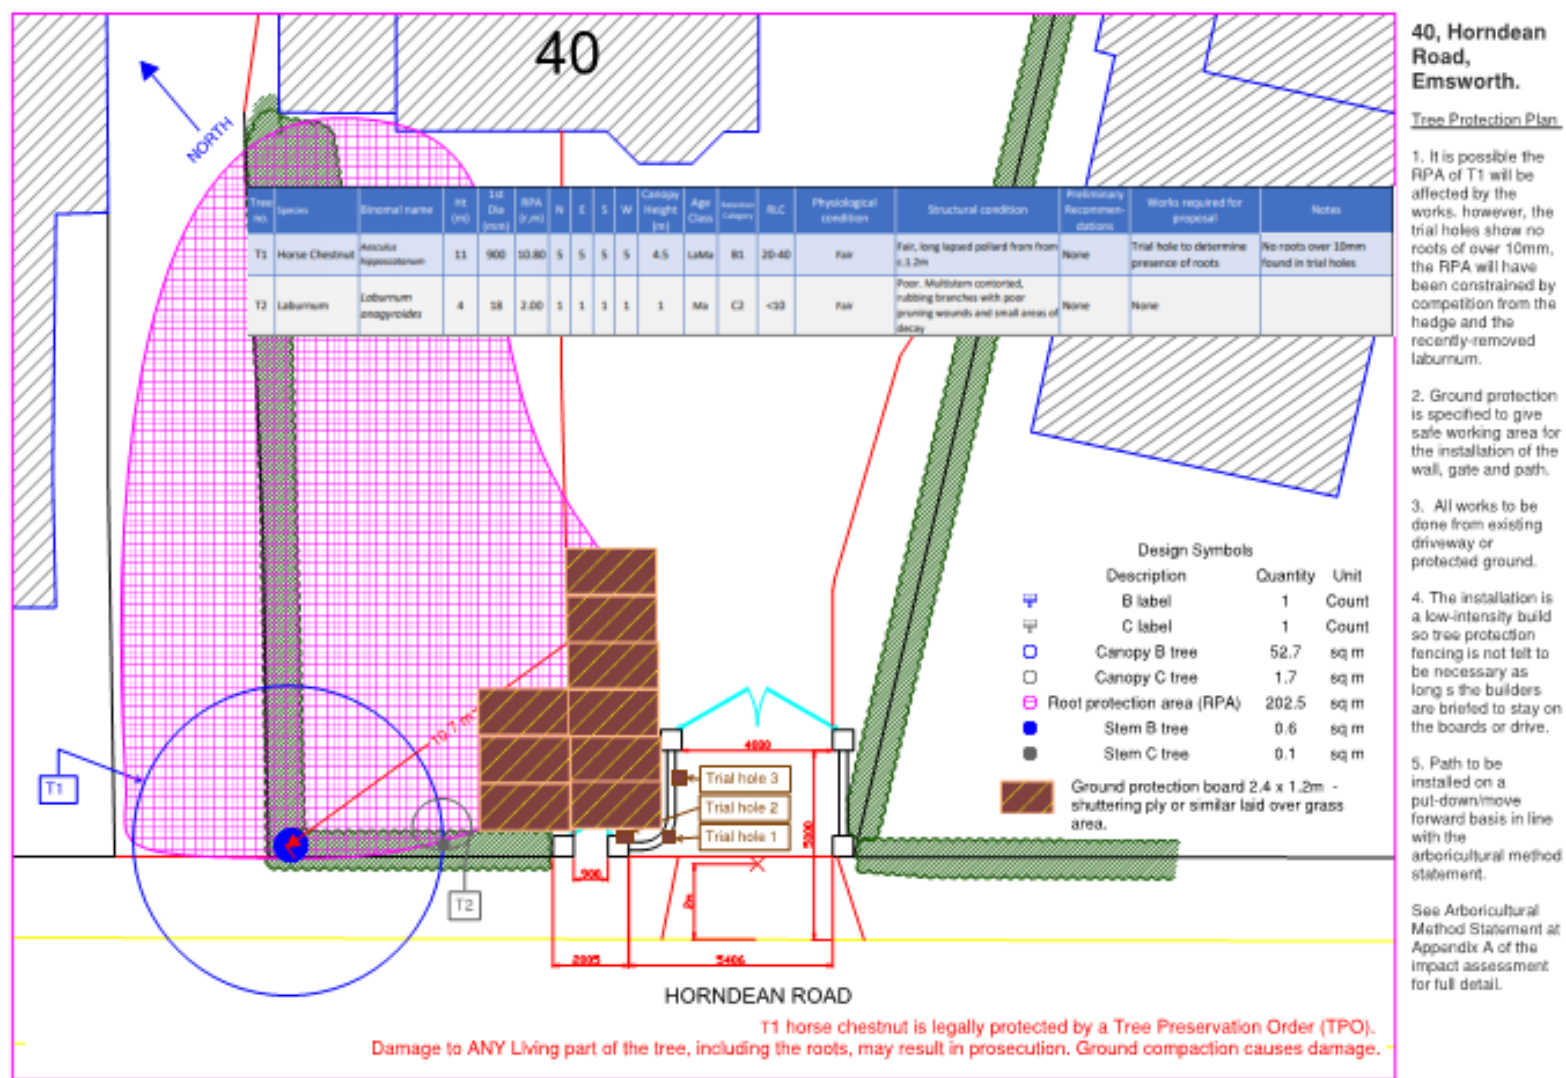
| <b>Appendix C</b> | <b>Tree Protection Plan.....</b> | <b>8</b> |

The Tree Protection Plan shows 8-off 2.4 x 2.1m sheets which is a standard size but an equivalent area must be protected.

Prior to works starting, ground protection in the form of load-spreading boards shuttering ply, sterling board or similar rigid board is suitable.

All works must be done from the protected ground to prevent compaction which will harm tree roots. It will also reduce damage to the lawn.
