# **Report on (Phase 2) Ground Investigation**

Land to the rear  
MANOR OAKS  
(Manor Road Nurseries)  
MANOR ROAD  
HAYLING ISLAND  
PO11 0QL

Report Ref: 667 / R02 9 (Rev1)

Dated: 25<sup>th</sup> January 2021

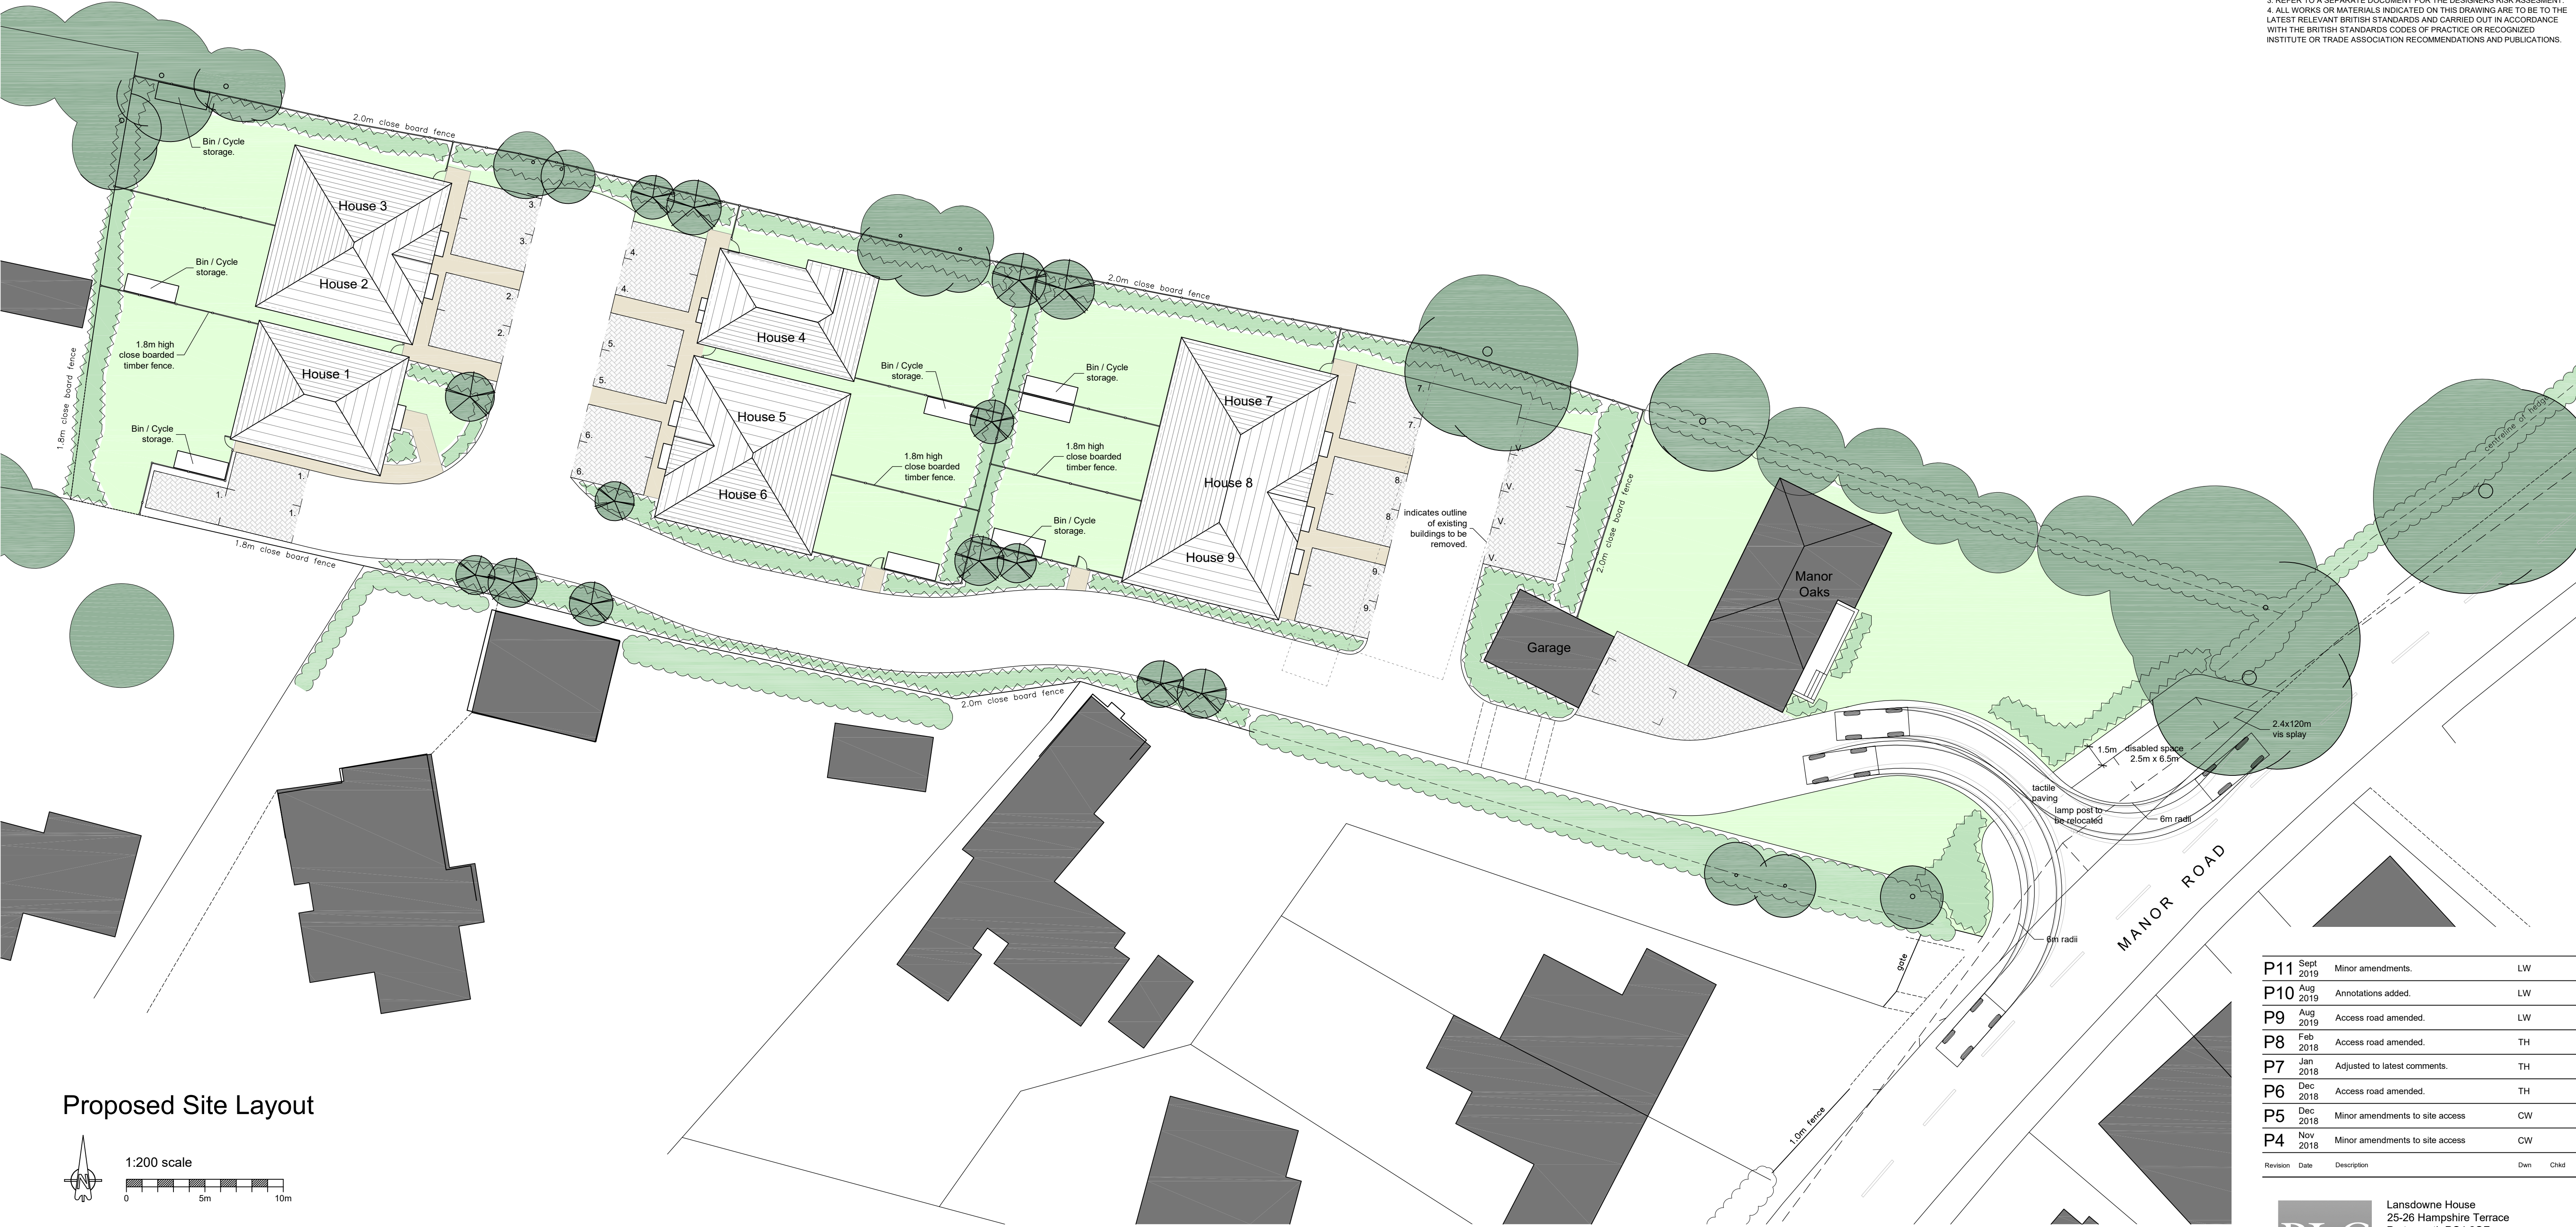
Proposed Site Layout

Drawings showing the proposed development are enclosed as **Appendix A**. Nine new dwellings are proposed with driveways and associated landscaping. Each house shall have a private domestic garden.
