## Ground Investigation Report

11 Queen Annes Drive

Bedhampton

**Report Ref: B1575/20**

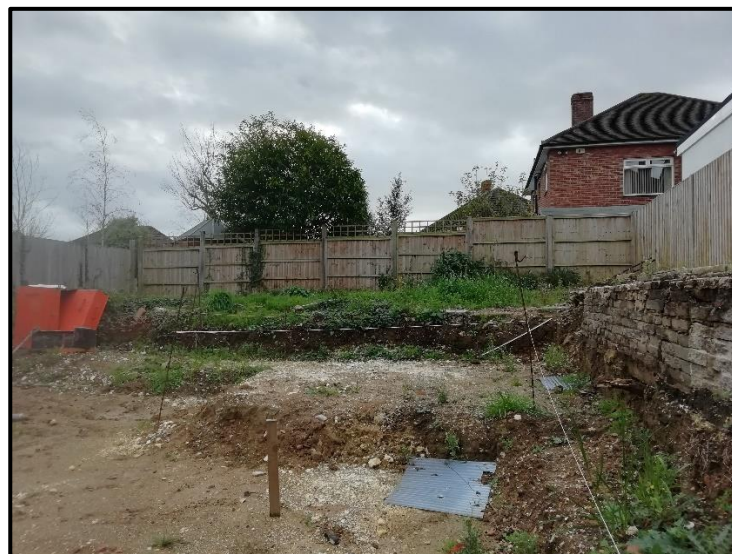
**Figure 2 – General Site Photograph**

At the time of the investigation the site was a disused/derelict piece of land, as shown in the general site photograph below.
