# **Yachthaven Harbour, Hayling Island**

## **Eelgrass Survey 2020**

**Alpine Homes Ltd**

**7 August 2020**

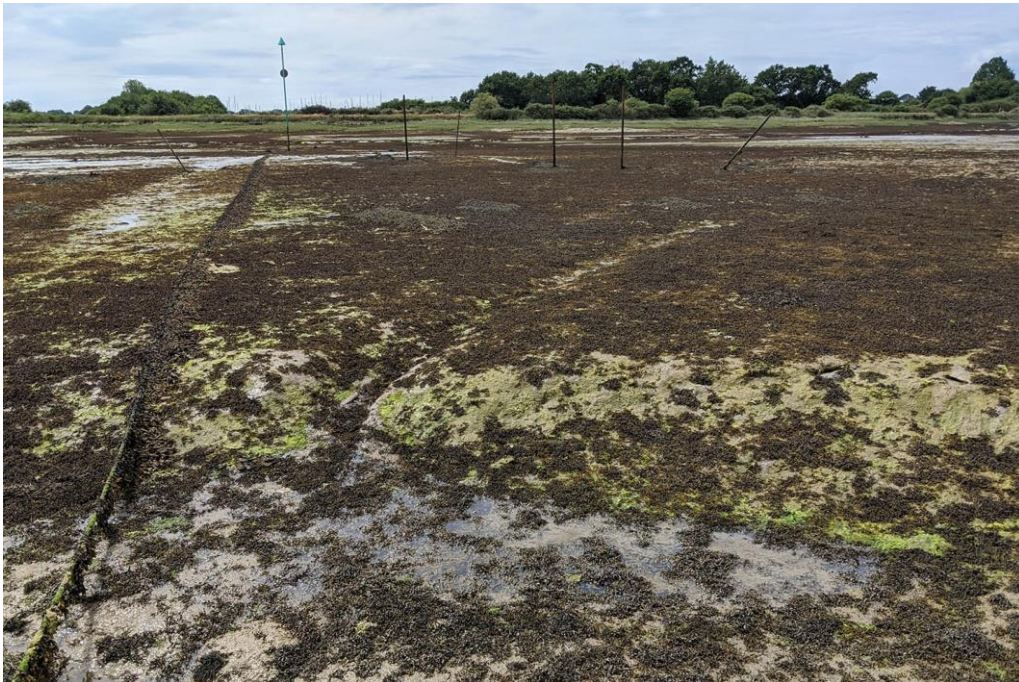
- 3.4 The proposed pontoon site consists entirely of an elevated section of muddy substrate which is strongly dominated by bladder wrack seaweeds (**Photos 1-2**), as is the adjacent area to the east, including the area under the existing jetty/pontoon and either side of the small channel which runs from here to the main channel (**Photo 3**). Similar vegetation was observed in 2011 and there has been no change in vegetation on the new pontoon site. The main areas of dense eelgrass in the creek are shown in **Photos 5-7**. The nearest of these lies 81m from the edge of the pontoon site (as mapped in Figure 1) at its closest point.

**Photo 1.** View of proposed pontoon site, showing dominance of bladder wrack seaweed on muddy substrate.

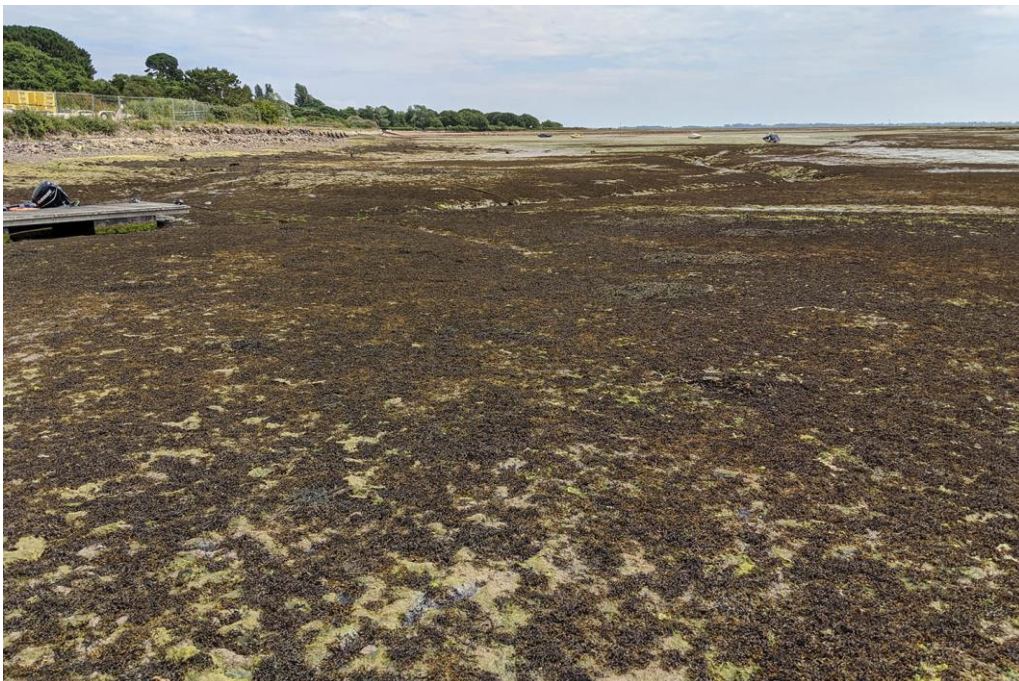
**Photo 2.** Northern part of proposed pontoon site in foreground, viewing east; existing jetty visible on left side.

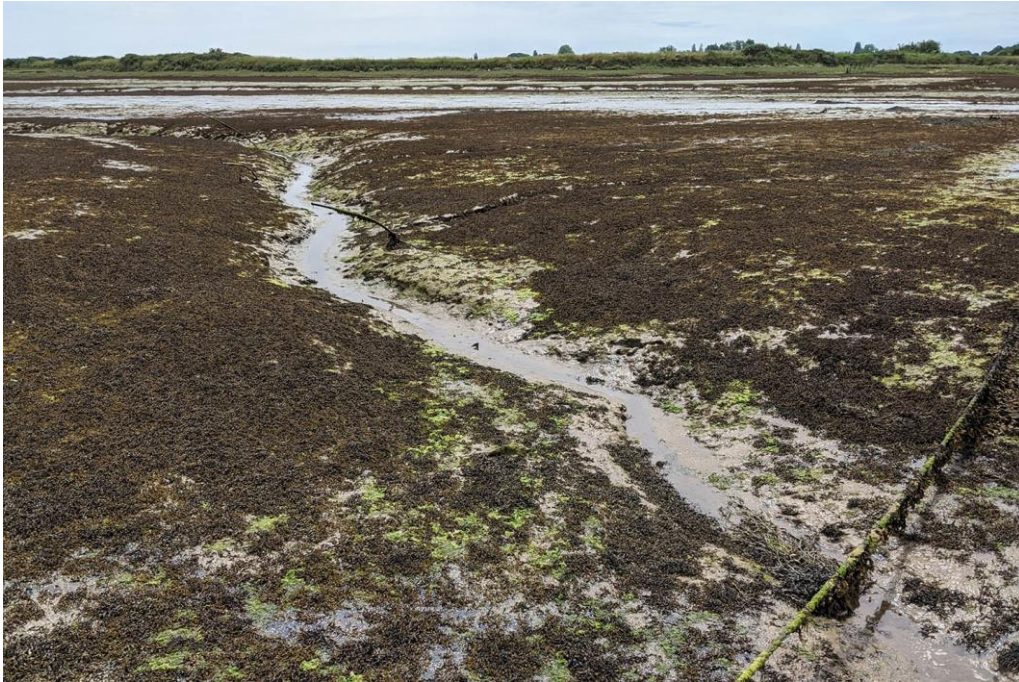
**Photo 3. Channel leading into harbour from existing jetty, showing absence of eelgrass in this area.**

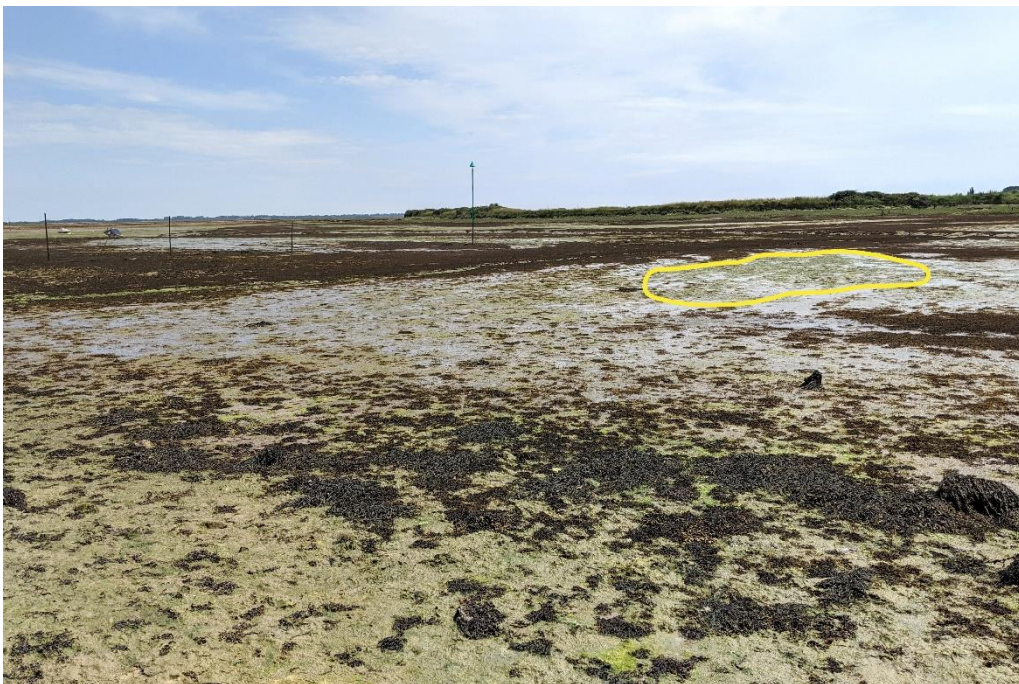
- 3.5 There are one or possibly two small areas of eelgrass in close proximity to the proposed pontoon site. The first of these was visible from the shore and is shown in **Photo 4**, measuring 160m<sup>2</sup>. The second mapped to the south of the pontoon (c.110m<sup>2</sup>) was not visible from the shore and is difficult to say for certain whether it definitely supports eelgrass or not. However, previous surveys do show eelgrass in this general area.

**Photo 4. Patch of eelgrass (yellow line) adjacent to the south-west corner of the proposed pontoon area (see Map 1).**

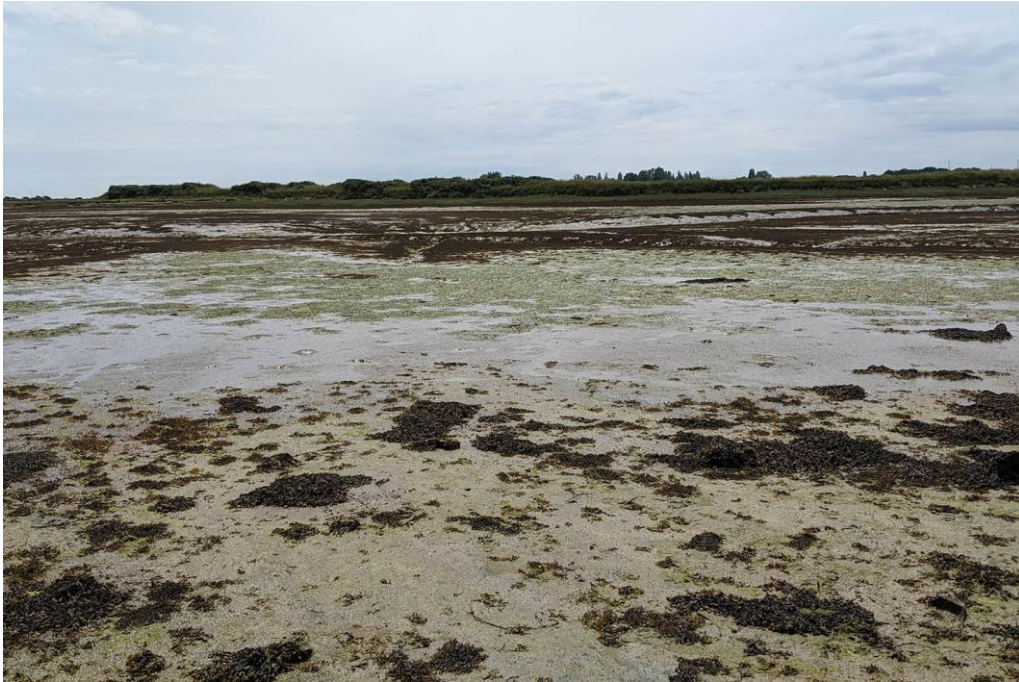
**Photo 5. View across creek from first slipway, 130m east of the proposed pontoon. Here, some dense areas of eelgrass are clearly visible as dark green patches on the mud, but form a narrow zone.**

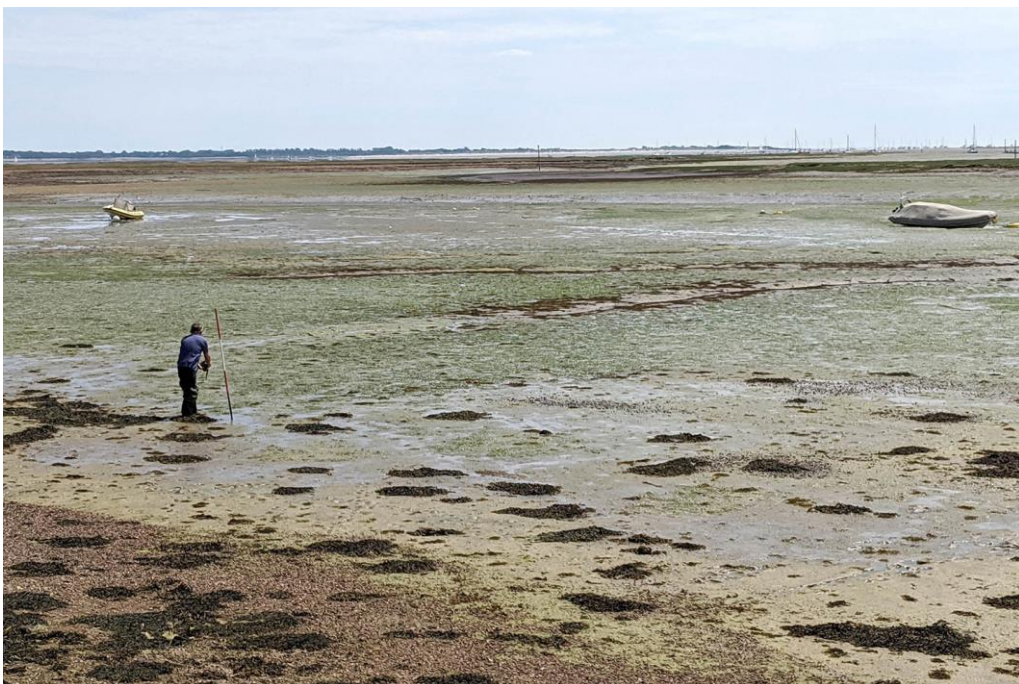
**Photo 6. View from first slipway looking south-east. The eelgrass beds widen out here and almost reach the shingle areas on the upper part of the shore.**

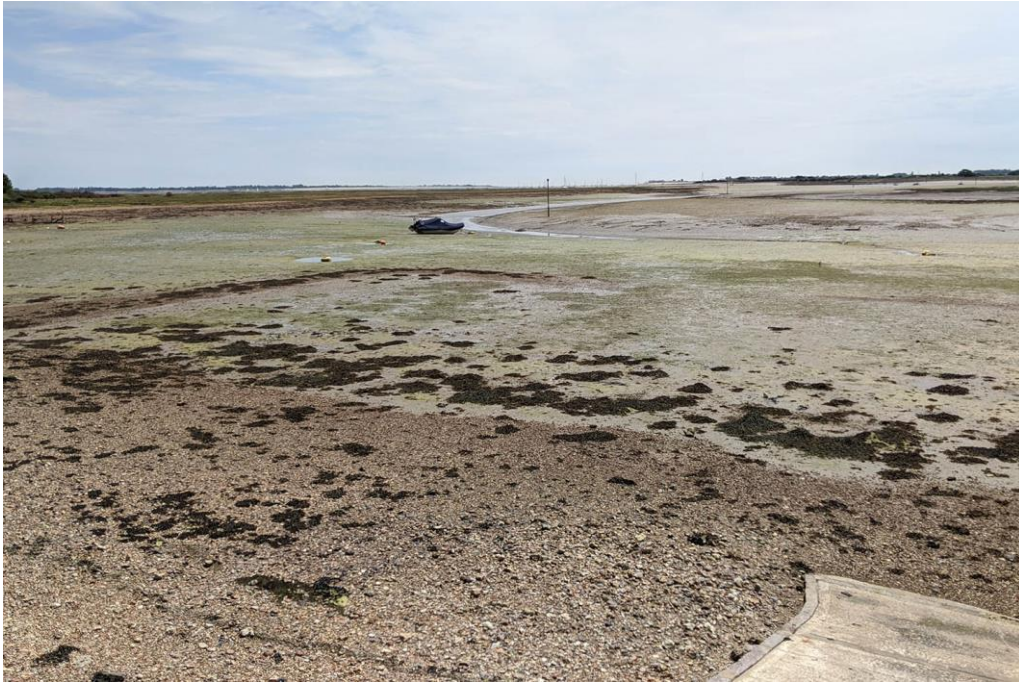
**Photo 7. View south-east into the creek from the third slipway, 320m east of the proposed pontoon. Most of the greenish colouration is probably eelgrass beds.**

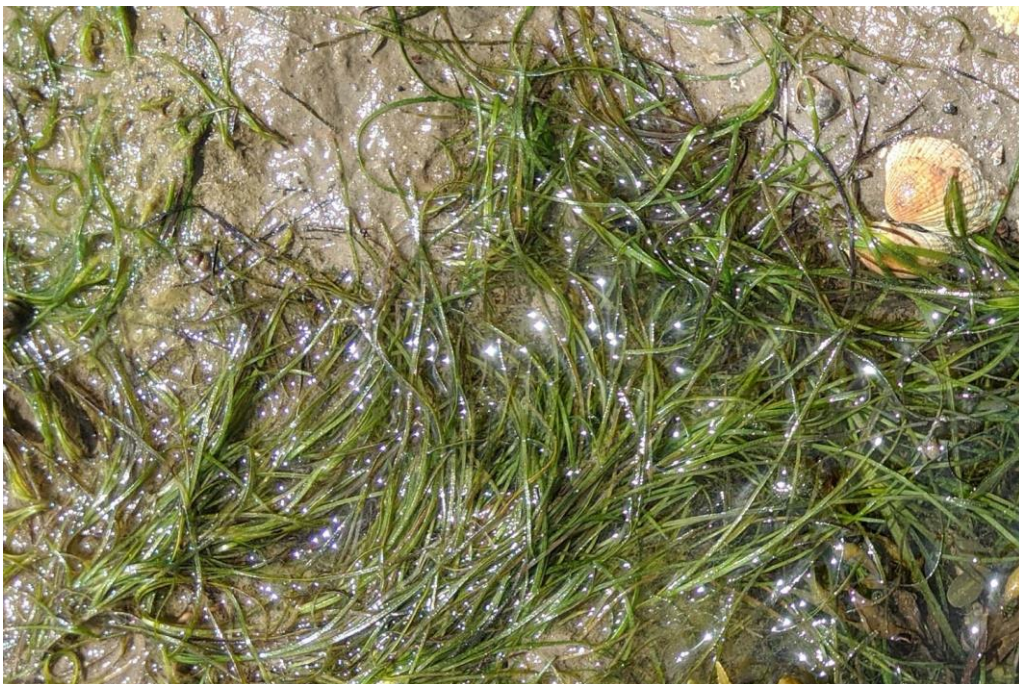
**Photo 8. Eelgrass (*Zostera marina*) in typical muddy substrate.**
