**MILL RYTHE HOLIDAY VILLAGE,  
HAYLING ISLAND, HAMPSHIRE**

**BAT SURVEYS**

Report No: RT-MME-153320

Date: November 2020

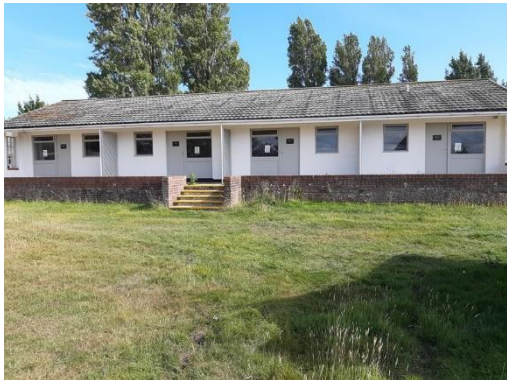
The survey area possessed a large number of accommodation chalets scattered across the western half of the surveyed area. These chalets ranged in age from older type units up to more modern and recently installed units. The older chalet units were brick buildings with rendered walls and pitched roofs with interlocking concrete tiles and uPVC soffits (Plate 4.1). Wooden framed windows and doors were set into the various elevations and were observed to be in overall good condition with no obvious features recorded around the frames that could provide potential access points for bats into interior areas. The areas of external brickwork and render were noted to be in generally good condition and similarly provided no potential access points for bats into roosting areas.

**Plate 4.1: Older accommodation chalets – front elevation**

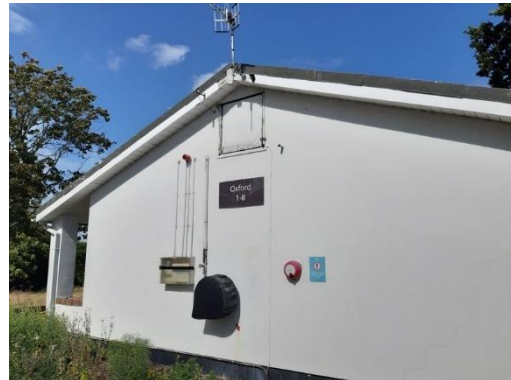
Units possessed canopy features held up by rendered brick pillars and steel uprights (Plate 3). Located high within the gable end walls of the various accommodation chalet blocks were a series of small access panels/doors providing an inspection point into the void spaces of the various units (Plate 4.2). These were generally noted to be tightly fitted into their frames and were considered to offer negligible access potential for faunal species including bats. Soffit areas were tightly fitted to wall tops and provided no obvious access points for bats into roosting locations.

**Plate 4.2: Gable end elevation with inspection hatch present in apex**

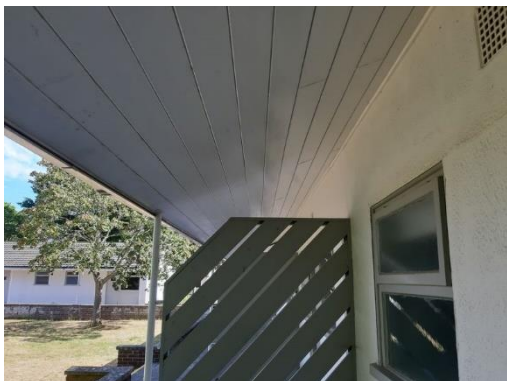
**Plate 4.3: Canopy feature on frontage of accommodation chalets**

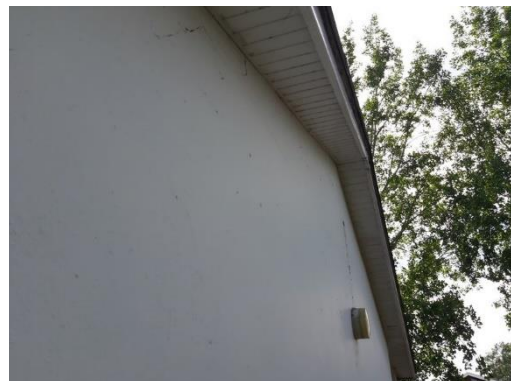
**Plate 4.4: Tightly sealed soffitleave area accommodation chalets**

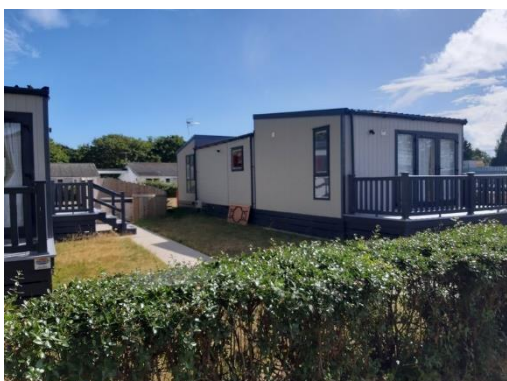
In addition to the older type of chalets, the surveyed area included a selection of more modern units and deluxe chalets with individual car-parking areas and hot tub and outdoor space (Plates 4.5 and 4.6). These features were in excellent condition, primarily constructed from uPVC with pitched and half-pitched roofs of interlocking tiles and 'tile-effect' plastic sheeting. These units were observed to provide no access or roosting locations for bats.

**Plate 4.5: Most recent accommodation chalets in north of holiday complex**

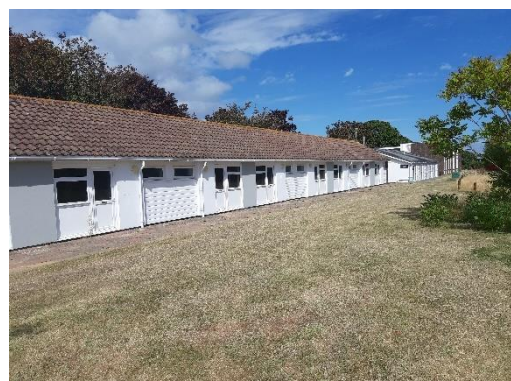
**Plate 4.6: Row of more modern chalets on southern edge of holiday complex**

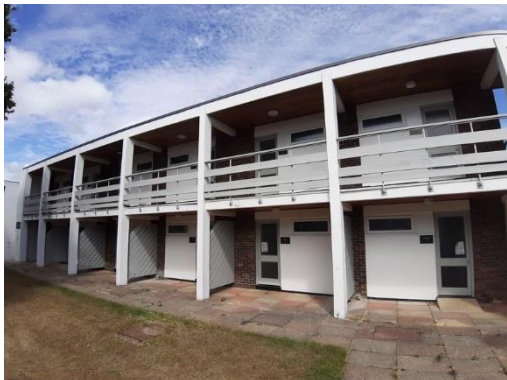
Some of the elevations possessed balcony features on their upper floors which possessed roofing sections which were boarded out on their ceilings. The weatherboarding around the upper storeys of these sections was largely close-fitting to the walls, although in one or two areas was noted to possess a narrow aperture. Through binoculars these gaps were largely observed to be densely cobwebbed with dirt and debris also present indicating no recent use by faunal species.

Overall, the two-storey accommodation units were generally in good condition with negligible potential for use by roosting bats and few features visible that could provide access points to roosting locations.

**Plate 4.7: Two-storey accommodation chalets – front elevations and balcony areas**

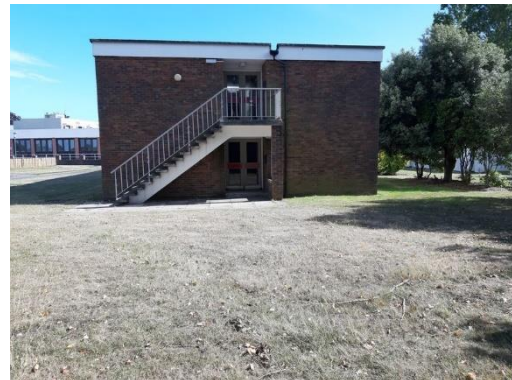
**Plate 4.8: Gable end of two-storey accommodation block with access stairs**

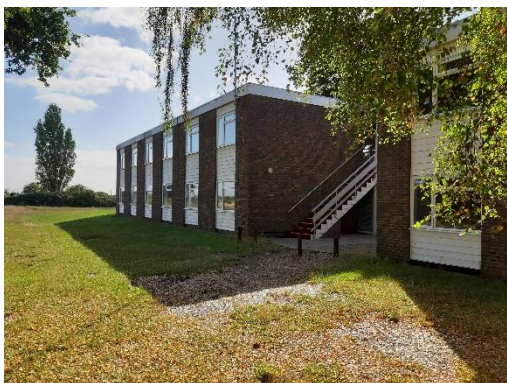
**Plate 4.9: Two-storey accommodation blocks in south-eastern corner of survey area**

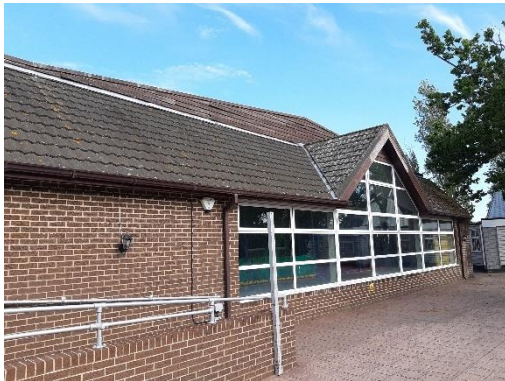
**Plate 4.10: Main entrance/reception area into entertainment complex**

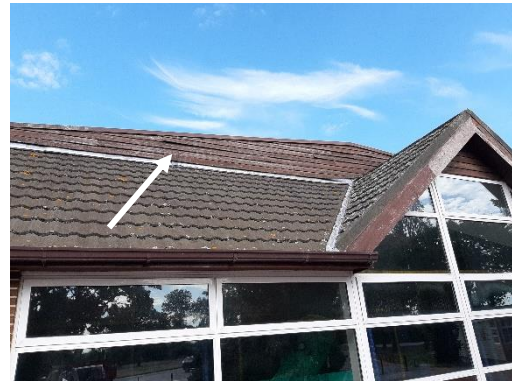
A range of features were present around this complex that could provide potential access points into roosting locations, including lifted boarding and lead flashing, gaps in brickwork and loose metal fascias (Plates 4.11 and 4.12). It was not possible to inspect these features due to the height at which they were located and as such it was not possible to establish if bats had used these features to enter a roost location at the time of surveying.

**Plate 4.11: Damaged/lifted wooden boarding (arrowed)**

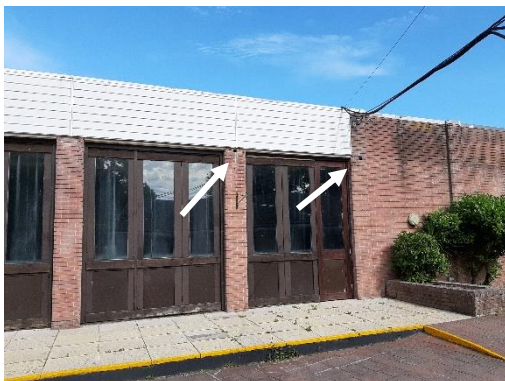
The gaps in the brickwork had accumulated bird droppings on the brickwork beneath and internal nest material was visible, indicating their use as nesting locations for birds. No evidence of roosting bats was identified during the external assessment of this building complex.

**Plate 4.12: Gaps in brickwork (arrowed)**

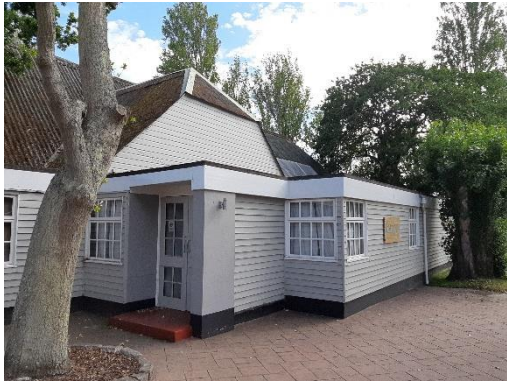
This large structure in the south-west of the survey area was multi-faceted, with pitched and flat roof sections (Plate 4.13). The exterior walls were composed of horizontal wooden panels. These were generally in good condition although at the rear of the structure occasional damaged and missing sections of wooden panelling were recorded, which were considered to offer potential access locations into interior areas for bats (Plate 4.14).

The roof areas were largely composed of corrugated metal/asbestos sheeting, which was observed to be very well weathered and covered with moss/lichen, dirt and organic debris. The flat sections were covered in what appeared to be close-fitting bitumen felt. The potential features suitable for use by bats could not be accessed due to the height at which they were located. No evidence of roosting bats was identified during the external assessment of this structure.

**Plate 4.13: The Boathouse – north-western elevation**

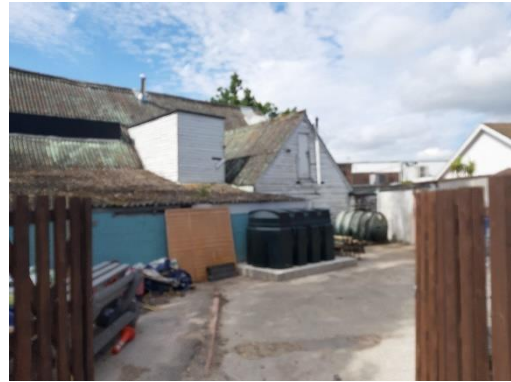
**Plate 4.14: The Boathouse – rear (south-eastern) elevation**

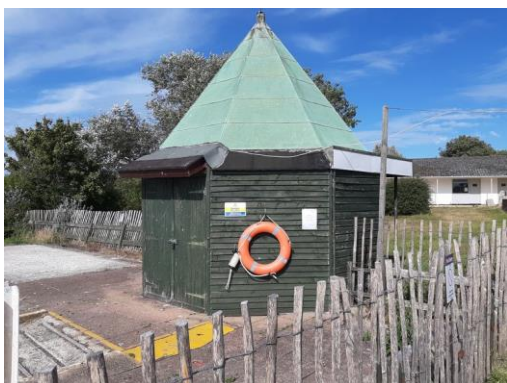
A small unit was located towards the north-eastern corner of the boating lake in the north-western corner of the survey area (Plate 4.15). This irregularly shaped wooden structure possessed a hexagonal pyramid roof structure covered in a bitumen felt material that was noted to be tightly fitted and provided no access or roosting potential for bats. The overall structure was weathered and worn but provided no obvious features that could be exploited by roosting bats and no evidence of their presence or usage was recorded during the field survey.

**Plate 4.14: Boat House – viewed from south**

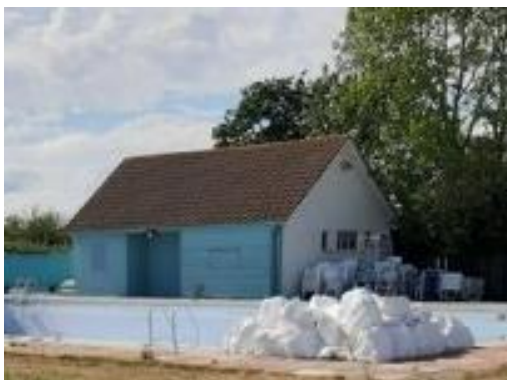
This comprised a single storey rendered building with a pitched roof covered by interlocking concrete tiles (Plate 4.15). This structure appeared to be in overall good condition and was considered to provide negligible bat roost potential.

**Plate 4.15: Outdoor swimming pool building**

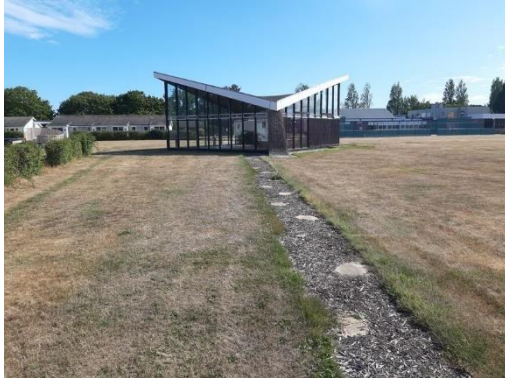
Located within the north of the holiday complex and surrounded by closely mown amenity grassland, this medium-sized structure was largely composed of large glazed window panels set into wooden frames and with an angled roof covered in tight fitting bitumen felt (Plate 4.16). This building was considered to provide negligible bat roost potential and no evidence of their presence or usage was recorded during the field survey.

**Plate 4.16: Coffee Lounge Building**

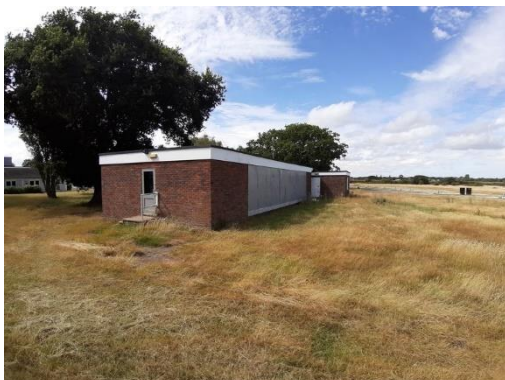
This comprised an 'L' shaped structure located at the eastern end of the holiday complex. This building was single storey constructed from brick with uPVC fascias, trims and weatherboarding. The majority of the windows were enclosed by security panelling/boarding. The roof was covered in close fitting bitumen felt and the brickwork was noted to be in overall good condition. The weatherboarding was noted to be tightly fitted to the brickwork and overall the building was considered to provide no bat roost potential.

**Plate 4.17: Former Performing Arts Club Building**

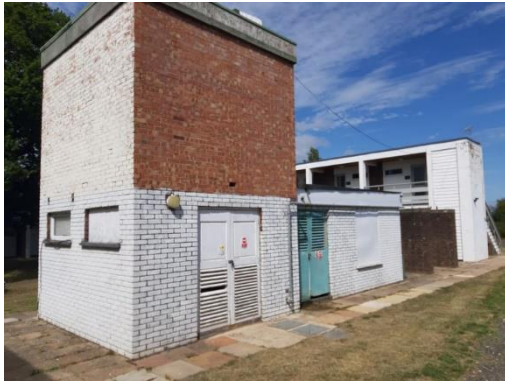
The survey area possessed four boiler houses scattered across the main holiday complex area (Plates 4.18 to 4.20). These structures possessed external brick walls, some of which were rendered, with both flat and pitched sections of roof covered in bitumen felt. The brickwork was in reasonably good condition, although the southern boiler house possessed missing bricks in places with loss of mortar and weep holes also recorded.

Around the eaves of the boiler house structures gaps were evident between the weatherboarding/fascia areas. These were inspected and were observed to largely possess cobwebbing, dirt and debris between the boarding and the brickwork and it was therefore concluded that no faunal species had accessed these areas in the recent past. Lower features where bricks were missing and gaps evident, particularly on the southern pumphouse feature, were inspected with a torch and endoscope and found to possess no evidence of usage by bat species. Some features were present at a height which could not be accessed for purposes of survey and it was therefore concluded that they may have some potential to provide roosting locations for bats.

**Plate 4.18: Southern boiler house – southern elevation**

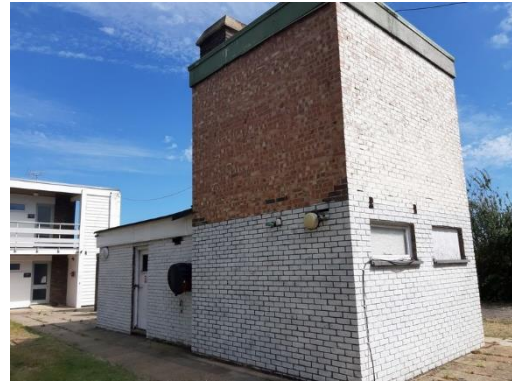
**Plate 4.19: Southern boiler house – northern and western elevations**

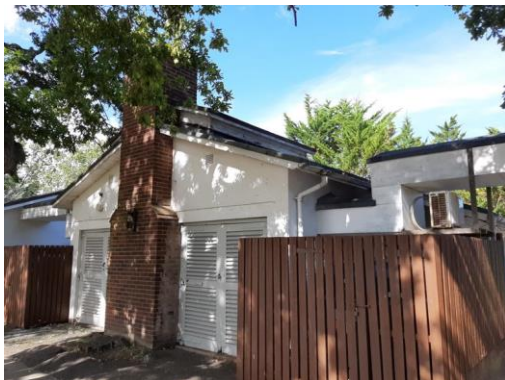
**Plate 4.20: Western boiler house**

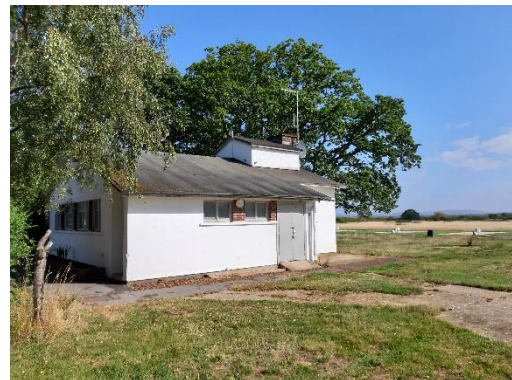
**Plate 4.21: Eastern boiler house**

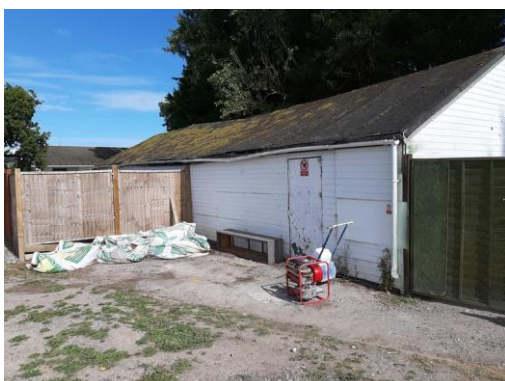
This structure was a medium-sized rectangular building, single storey and constructed from wooden panelling with a pitched roof covered in very well weathered bitumen felt covered extensively in moss/lichen (Plate 4.22). This structure was rather poor in places with damaged sections of soffit/eave providing a potential access point into the interior for faunal species (Plate 4.23). No evidence of bat presence/activity was recorded during the external survey of this structure. There was a noticeable chemical odour emanating from this structure and therefore it was concluded that it was sub-optimal to support roosting bats. Although internal access was not possible it could be seen through eave gaps that the internal structure was rather simple with the roof located directly onto a simple wooden framework.

**Plate 4.22: Maintenance workshop building**

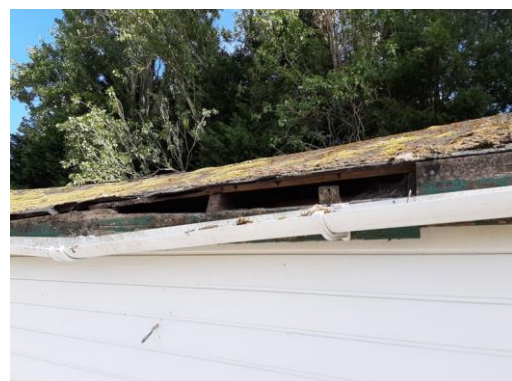
**Plate 4.23: Damaged eave section on maintenance workshop building**

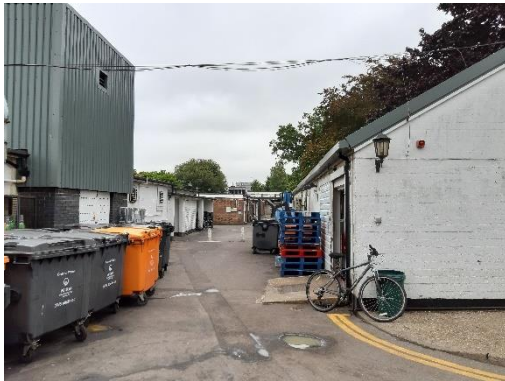
This structure was located immediately to the east of the main reception/entertainment complex and comprised a brick structure with a steeply pitched corrugated metal roof (Plate 4.24). This structure was in overall good condition with tight/soffit eave areas and with uPVC trim, doors and window frames. It was considered that this structure provided negligible bat roost potential and no evidence of bat presence/usage was recorded during the external assessment.

**Plate 4.24: Kitchen/Diner Unit on right hand side of image**

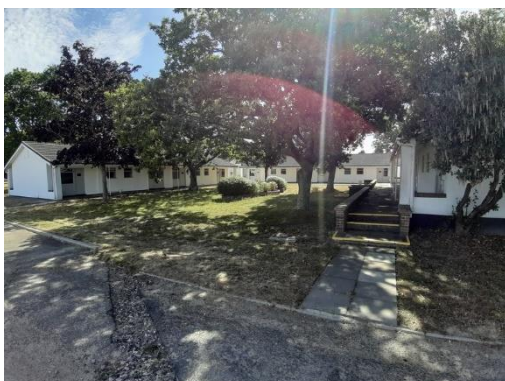
Scattered trees were present within the western extent of the holiday complex occurring on the areas of mown amenity grassland and adjacent to the various buildings and structures (Plates 4.26 to 4.29). Species included aspen *Populus tremula*, Leyland cypress *X Cupressocyparis leylandii*, cedar *Thuja* sp., Norway maple *Acer palanoides*, field maple *Acer campestre*, white poplar *Populus alba*, oak *Quercus* sp., pine *Pinus* sp., ash *Fraxinus excelsior*, cherry *Prunus* sp. and apple *Malus* sp. Trees ranged in age from semi-mature to mature and were largely in overall very good condition, with no obvious features that could be used by roosting bats.

**Plate 4.26: Scattered trees adjacent to chalets – well manged and in good condition**

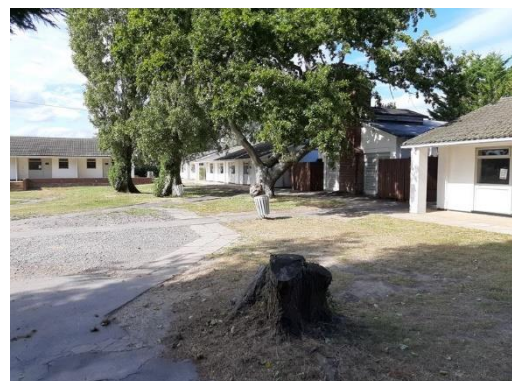
**Plate 4.27: Mature poplars and oak adjacent to chalets**

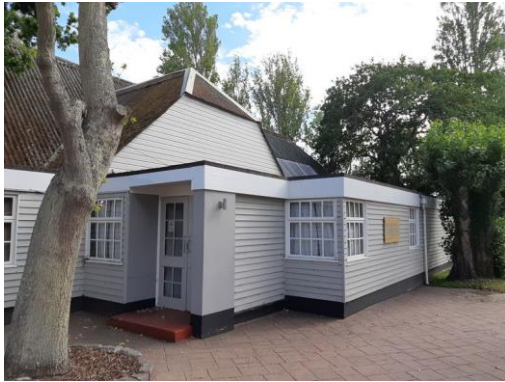
**Plate 4.28: Mature and well managed oak tree adjacent to The Boathouse**

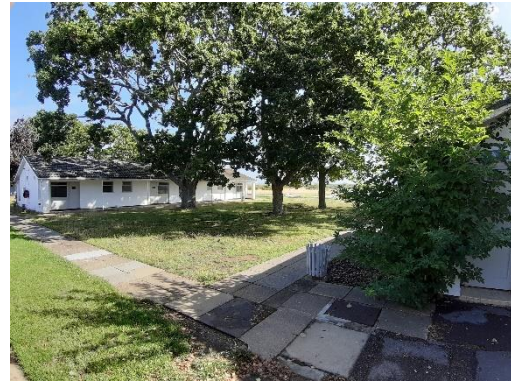
**Plate 4.29: Landscaped trees over amenity grassland adjacent to chalets at the eastern end of the holiday complex**

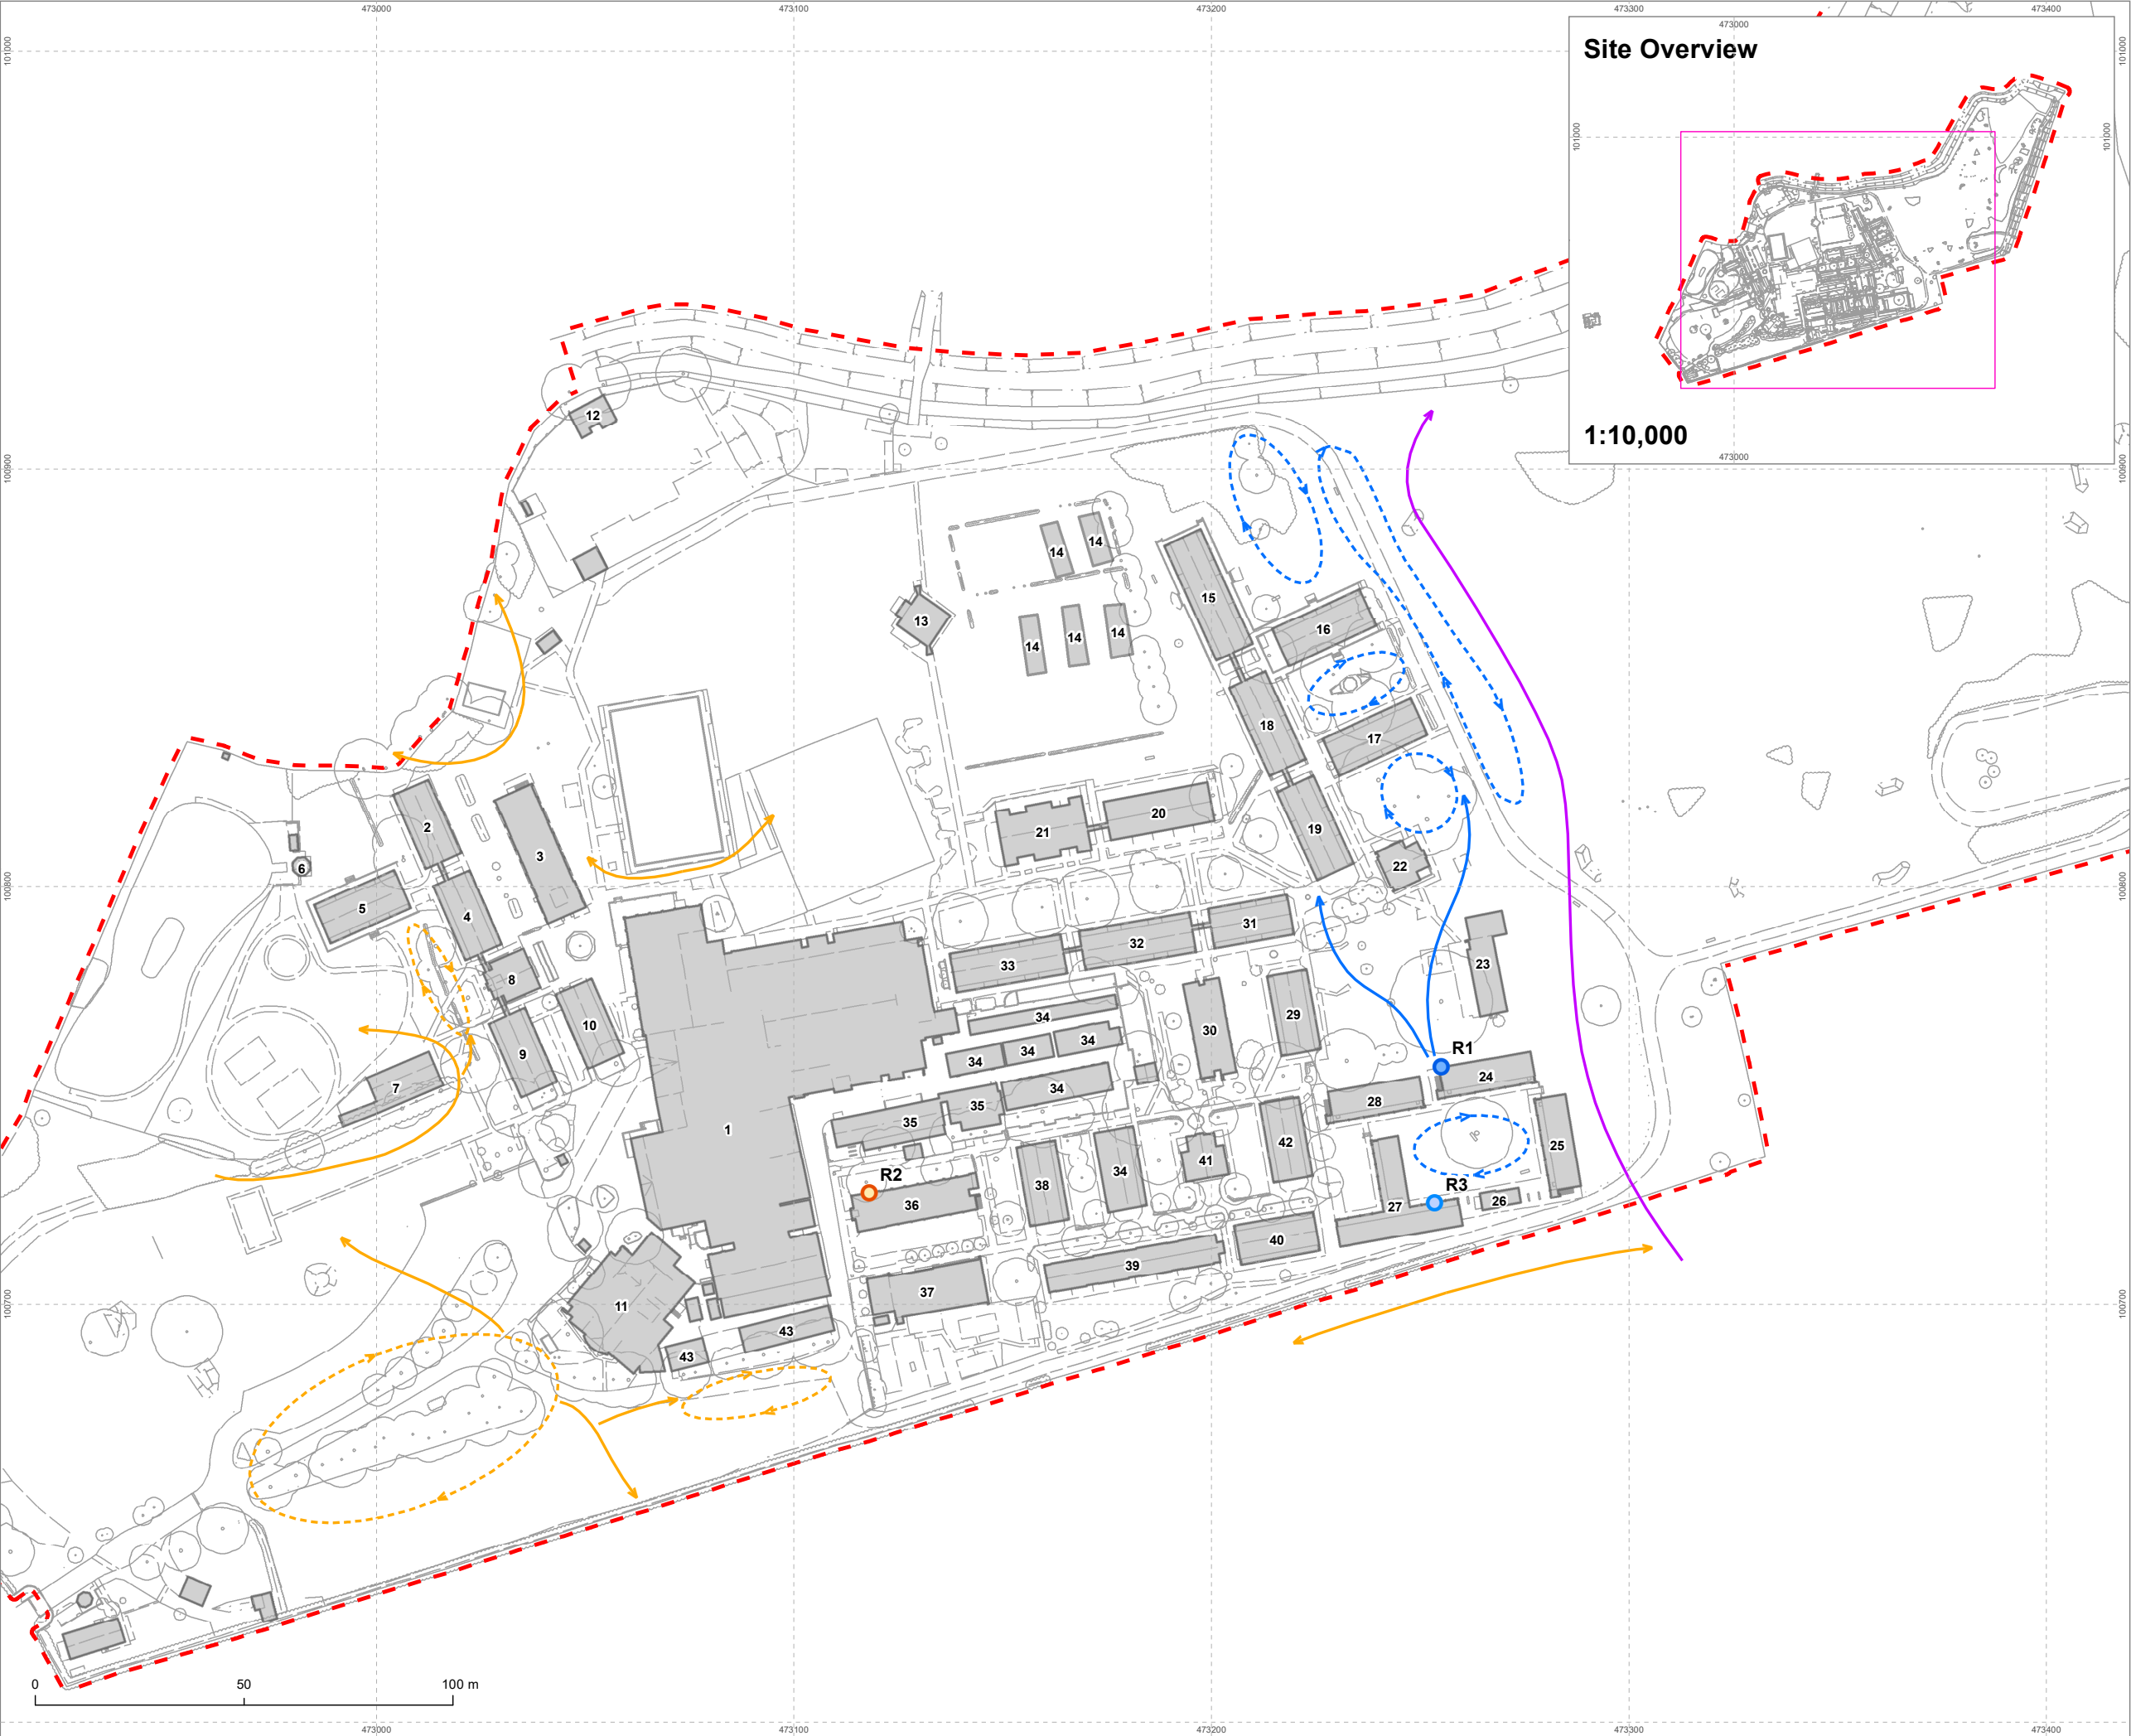
Following the suite of survey work undertaken on site it can be confirmed that three of the surveyed properties contain bat roosts. Two roosts are used by soprano pipistrelles and one property contains a bat roost used by common pipistrelle. Therefore, no unlicensed works can be undertaken which are likely to impact the buildings containing the roosts. A recommendation regarding the licence application to Natural England is made in Chapter 5.

Drawing C153320-02 – Summary of Bat Survey Activity and Roost Locations
