**FIGURE 17**

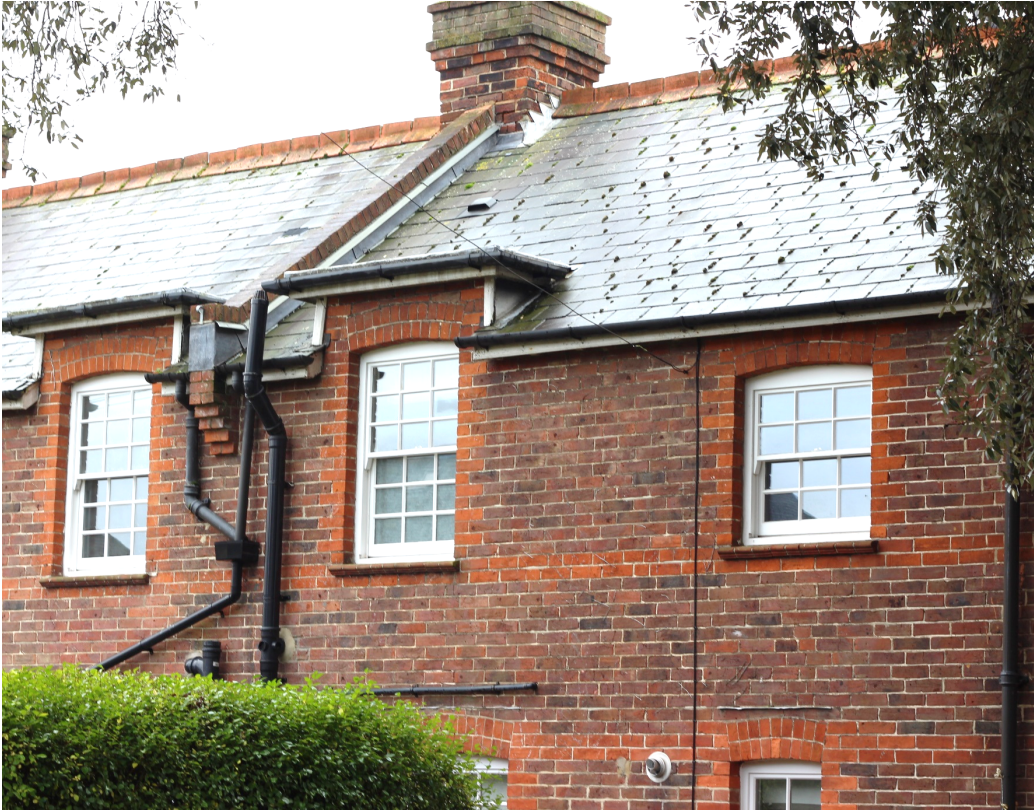
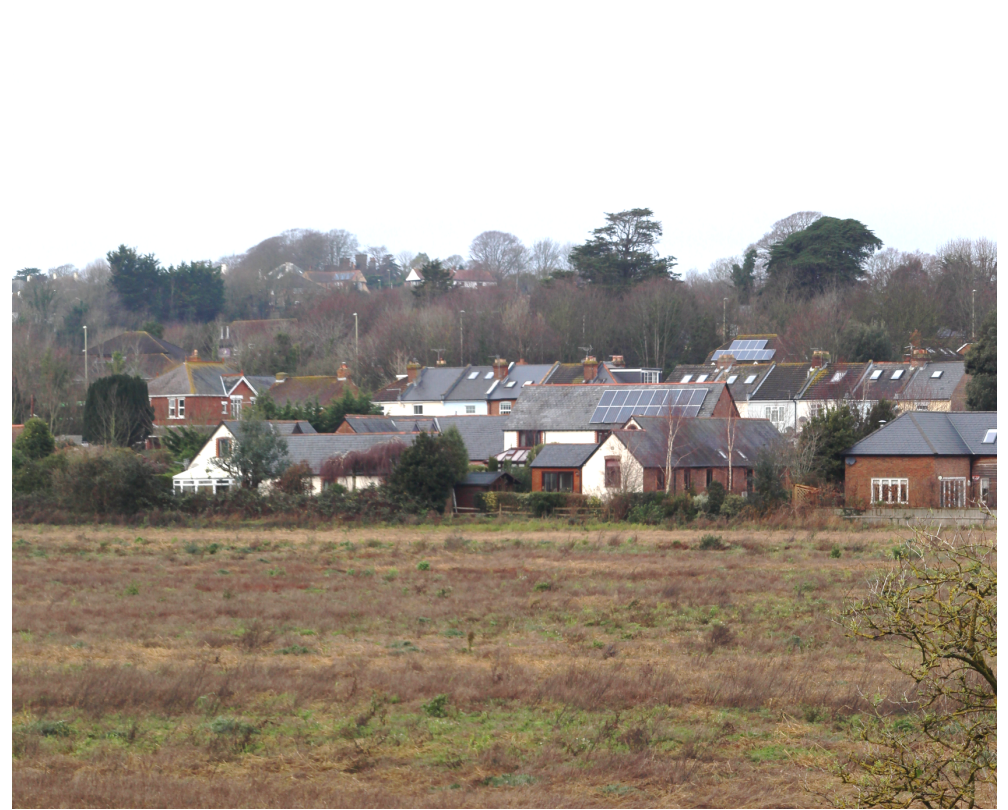
*Illustration of different degrees of architectural integrity and significance between the front elevations and rear elements of Old Manor Farm. Left – Traditional architectural detailing of the workers' cottages as seen from Lower Road; Right - Adapted and extended rear elements of the former farmstead as seen from within the proposed development site*
