# PHASE 2 GROUND INVESTIGATION

Lidl Great Britain Ltd  
Purbrook Way, Havant

Client: Lidl Great Britain Limited

770.02.02  
October 2020

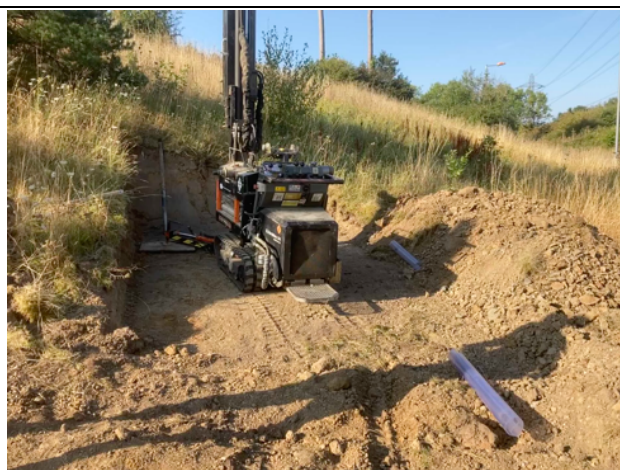
Slope levelled to enable window sampler at WS1. The ground level at the window sample position was reduced by approximately 1m.

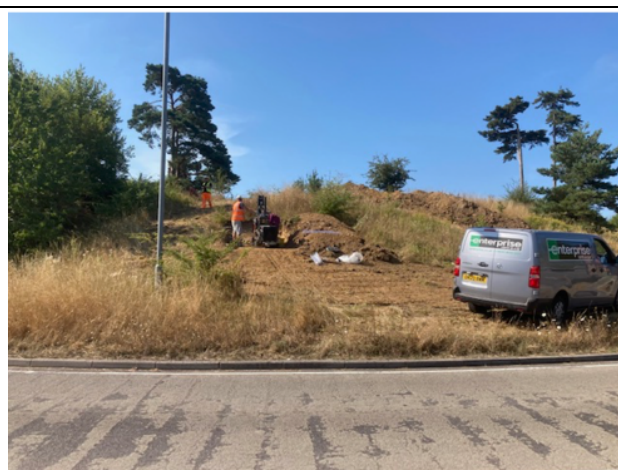
Slope levelled to enable window sampler at WS5. A ramp was formed to the right of WS5 to enable access to exploratory positions at the top of the fill.

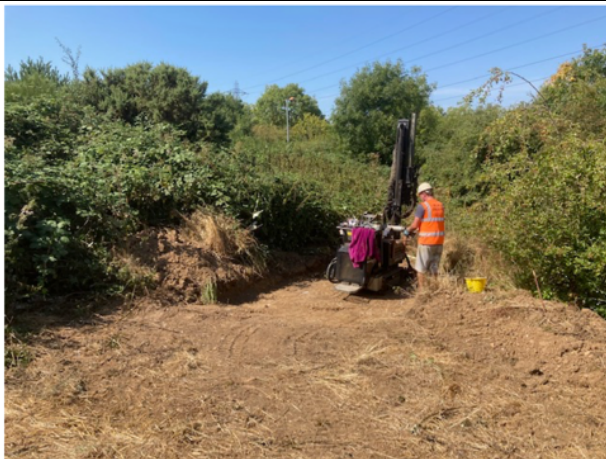
Vegetation clearance to give access to WS2

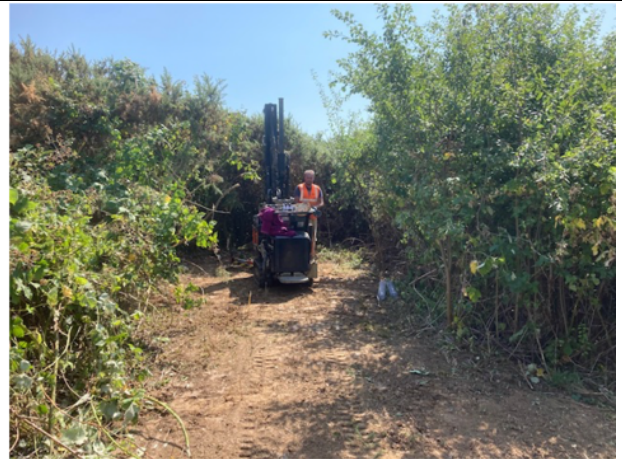
Vegetation cleared to give access to WS3

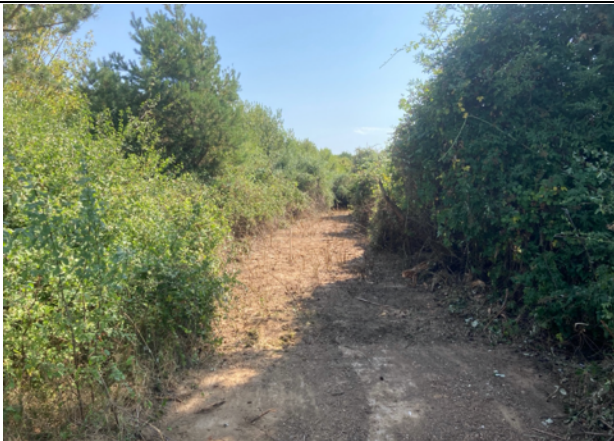
Access route through cleared vegetation to  
Cabletool Holes (CP1 & CP2)

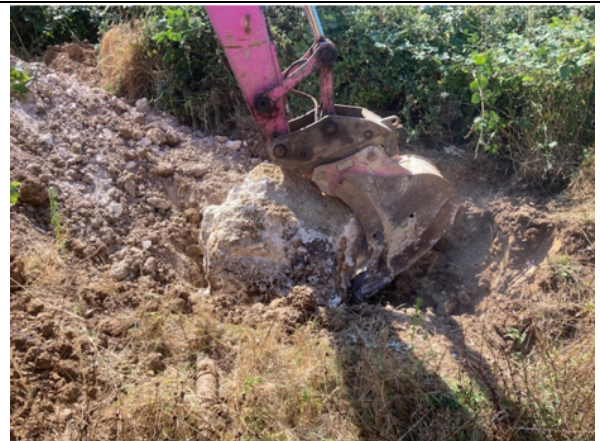
Concrete obstruction being removed from location  
of WS2

At WS02 a hydrocarbon odour was observed within the orange/brown grey clay fill material between 1.0m and 2.75m bgl. The fill material contained boulders of concrete and kerbstones that prevent percussive drilling but there were no visible indicators of contamination including asbestos with the made ground.

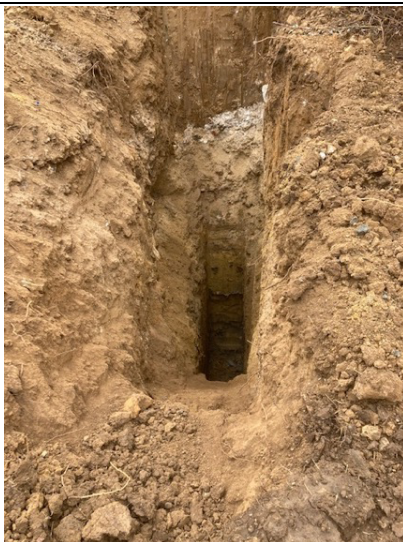
Location of CP3 following excavation of concrete  
obstruction

Made Ground was observed at all exploratory locations as firm to stiff orange/brown grey slightly gravelly clay to a maximum depth of 5.0m in CP1 and CP2 beneath the store footprint. At CP3A and CP3B the fill material contained concrete boulders and concrete kerbstones that were removed by excavator and the exploratory hole was advanced as a trial pit.

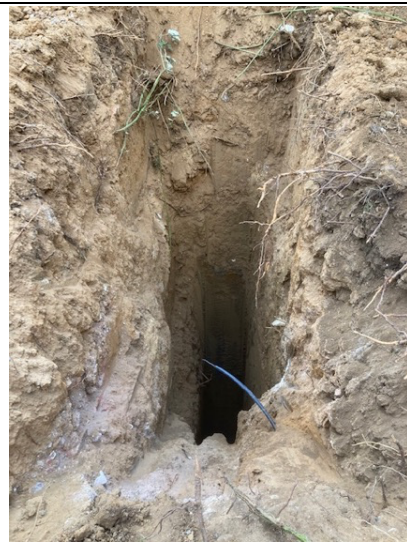
Location of WS3 following excavation of concrete  
obstruction
