# Havant Thicket Reservoir Project

**Environmental Statement Volume 4 - Appendices**  
**Appendix A10 Ground Conditions**  
**A10.2 Havant Thicket Winter Storage Reservoir,**  
**Desk Study Report**

Portsmouth Water Ltd.

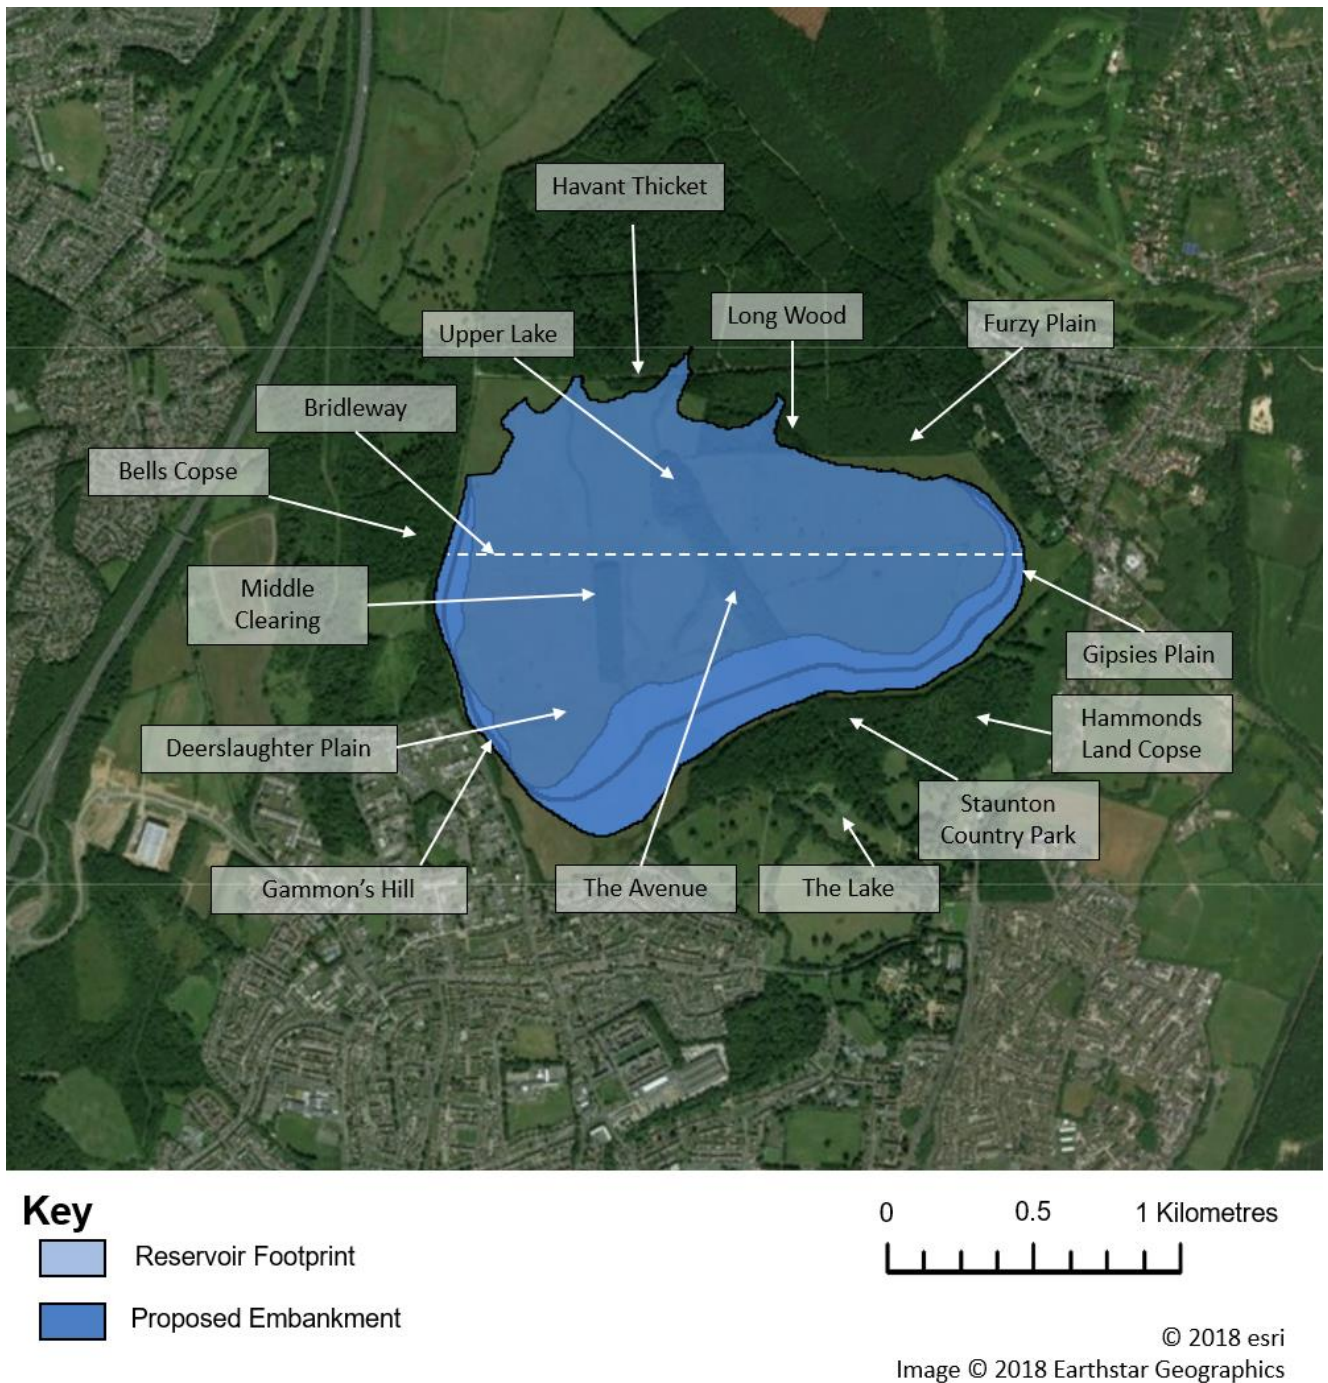
**Figure 2-1** - Proposed reservoir site layout

Figure 2-1 provides an aerial photograph to illustrate the current site layout, the key descriptors used in the Study Area history section and the proposed location of the Havant Thicket Winter Storage Reservoir. In order to evaluate key features within the footprint, the Study Area areas has been separated into four quadrants to assist the reader spatially as shown in the figure.

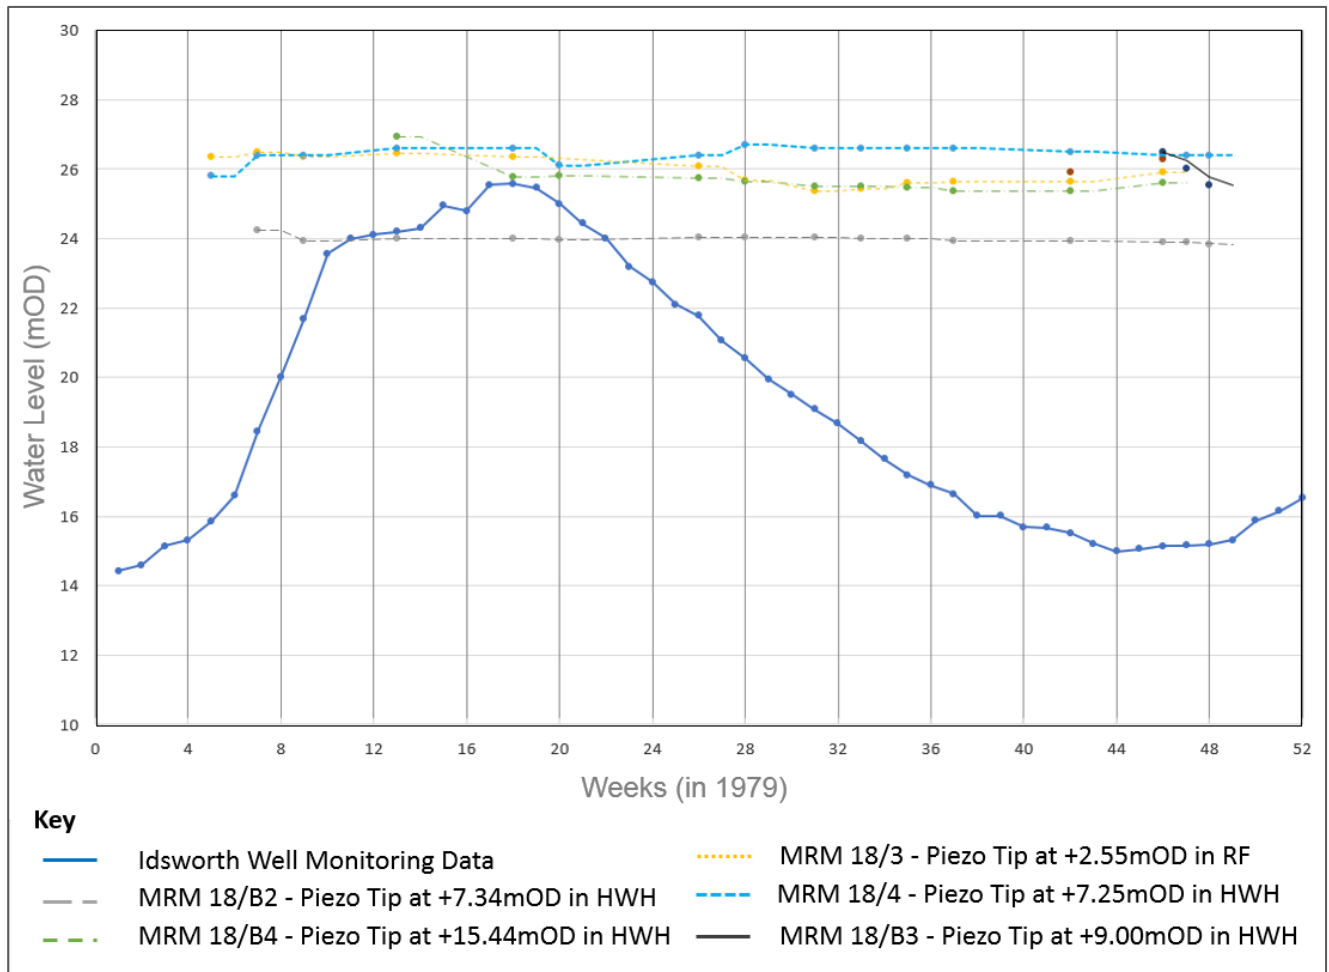
**Figure 7-4 - Selected historical groundwater monitoring from MRM Ground Investigation plotted with Idsworth Well Monitoring Data in 1979**

The Idsworth well monitoring data is plotted with monthly groundwater monitoring data obtained from the MRM ground investigation in Figure 7-4. The readings do not indicate that there is hydraulic continuity between Palaeogene deposits / Harwich Formation and the underlying Chalk. However, groundwater monitoring wells installed in the MRM investigation have not been verified by Atkins and information from near field groundwater monitoring in the Chalk is sparse. Additional groundwater monitoring is required to confirm the groundwater regime underlying the Study Area.

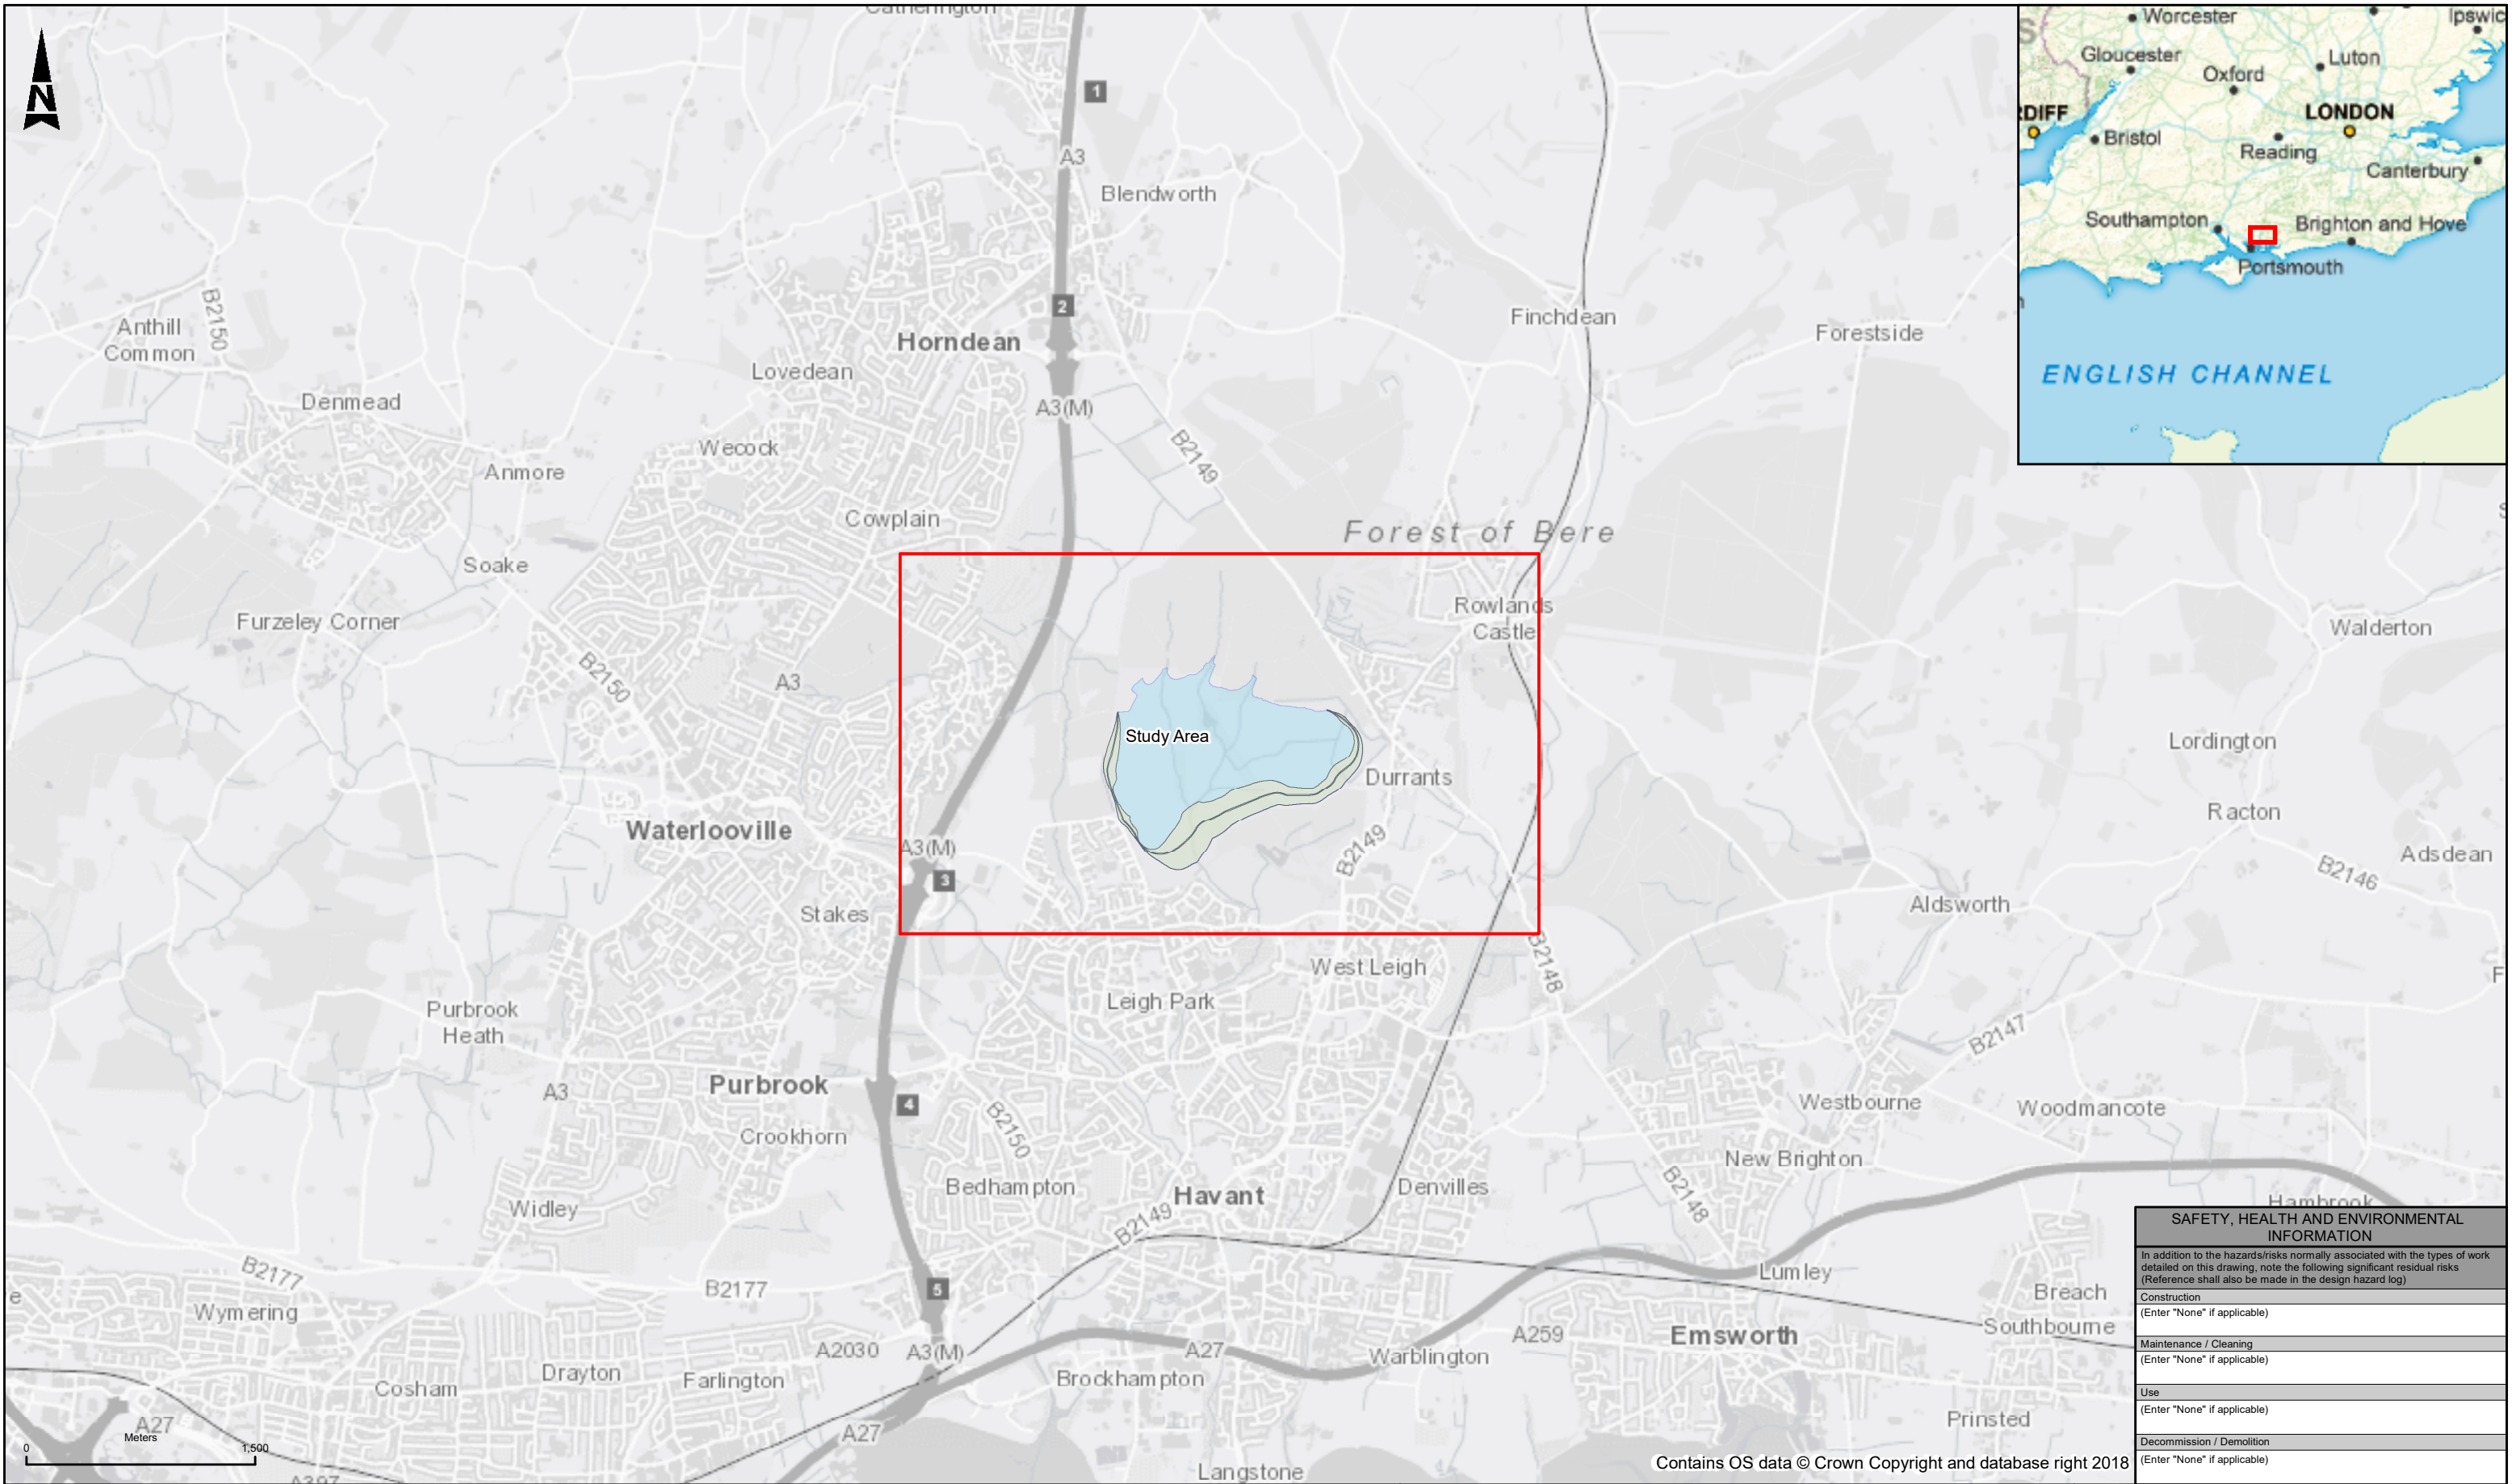
Reservoir Footprint (Arup 2009)

Reservoir Embankment (Arup 2009)

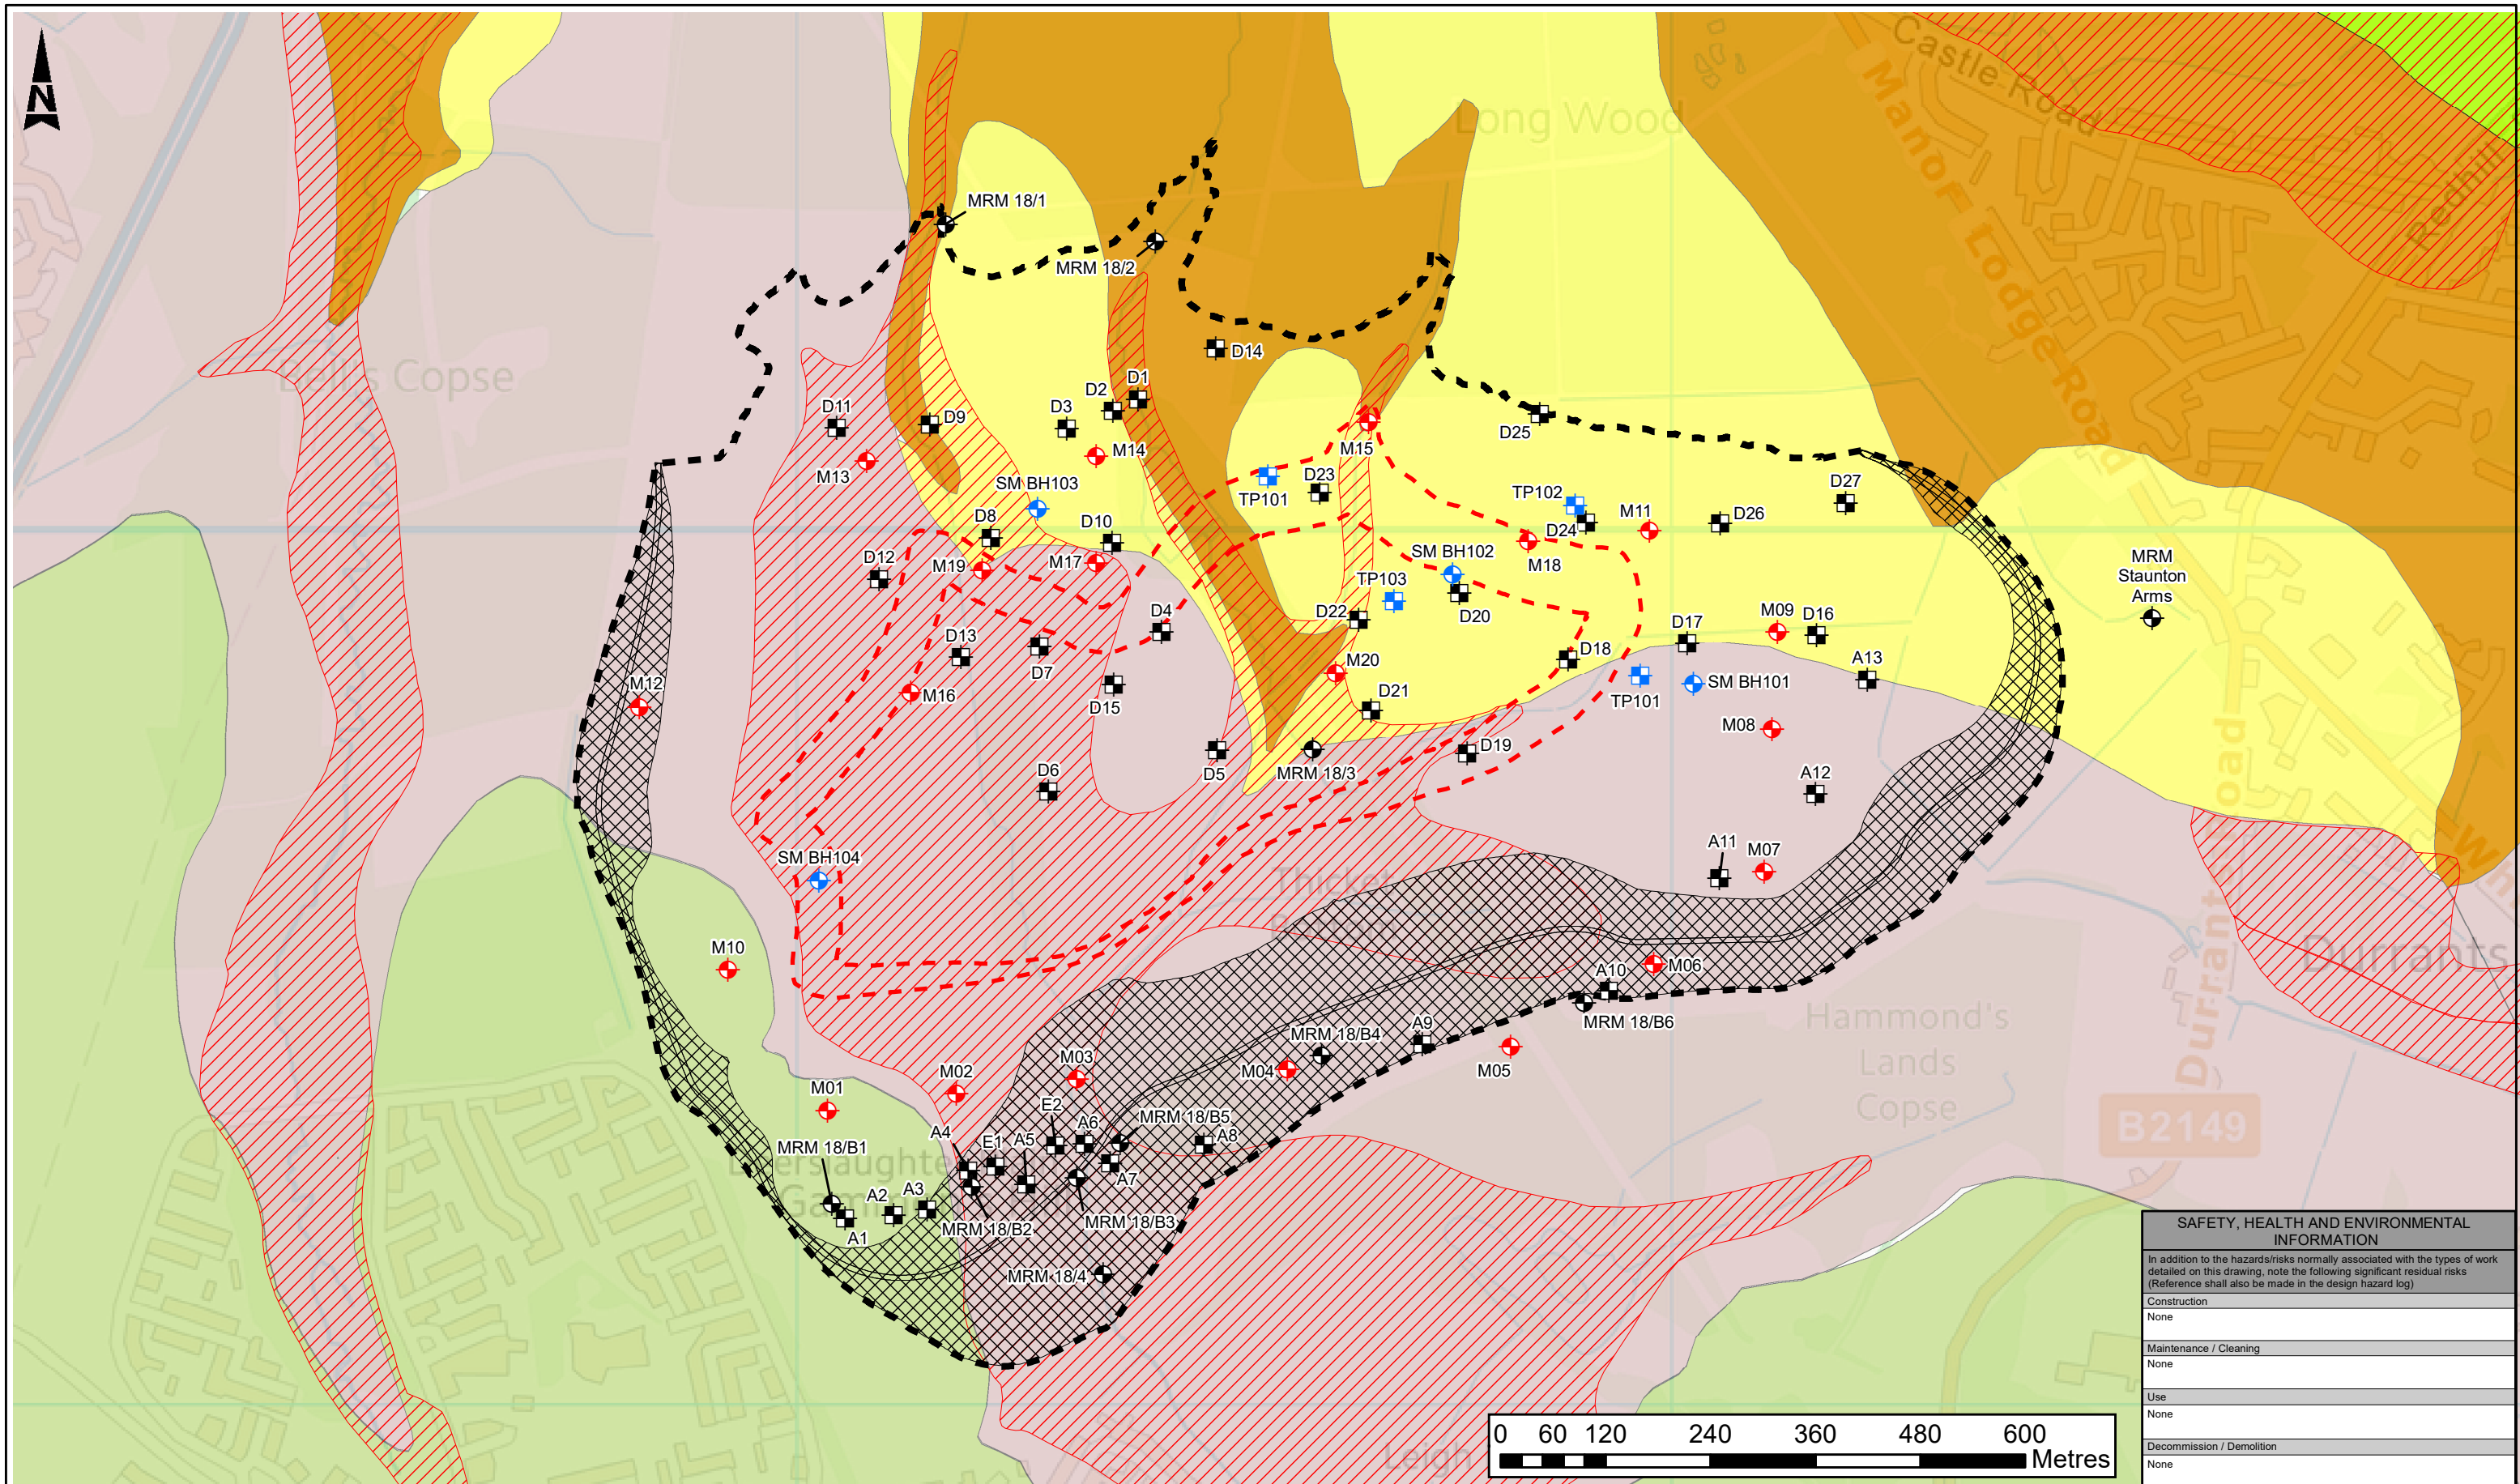
1. Historical boreholes, geology and proposed reservoir layout based on GIS data provided to Atkins by Portsmouth Water on the 1st April 2019.
2. Soil Mechanics 2006 and MRM 1979 trial pit locations digitised by Atkins based on georeferenced plans. Trial pit locations shown are approximate, and accurate to approximately +/- 15m of the positions shown.
3. This drawing contains OS data © Crown copyright and database right (2018). OS data obtained by Atkins using ProMap on the 2nd April 2019.
4. This drawing contains British Geological Survey materials ©NERC 2019

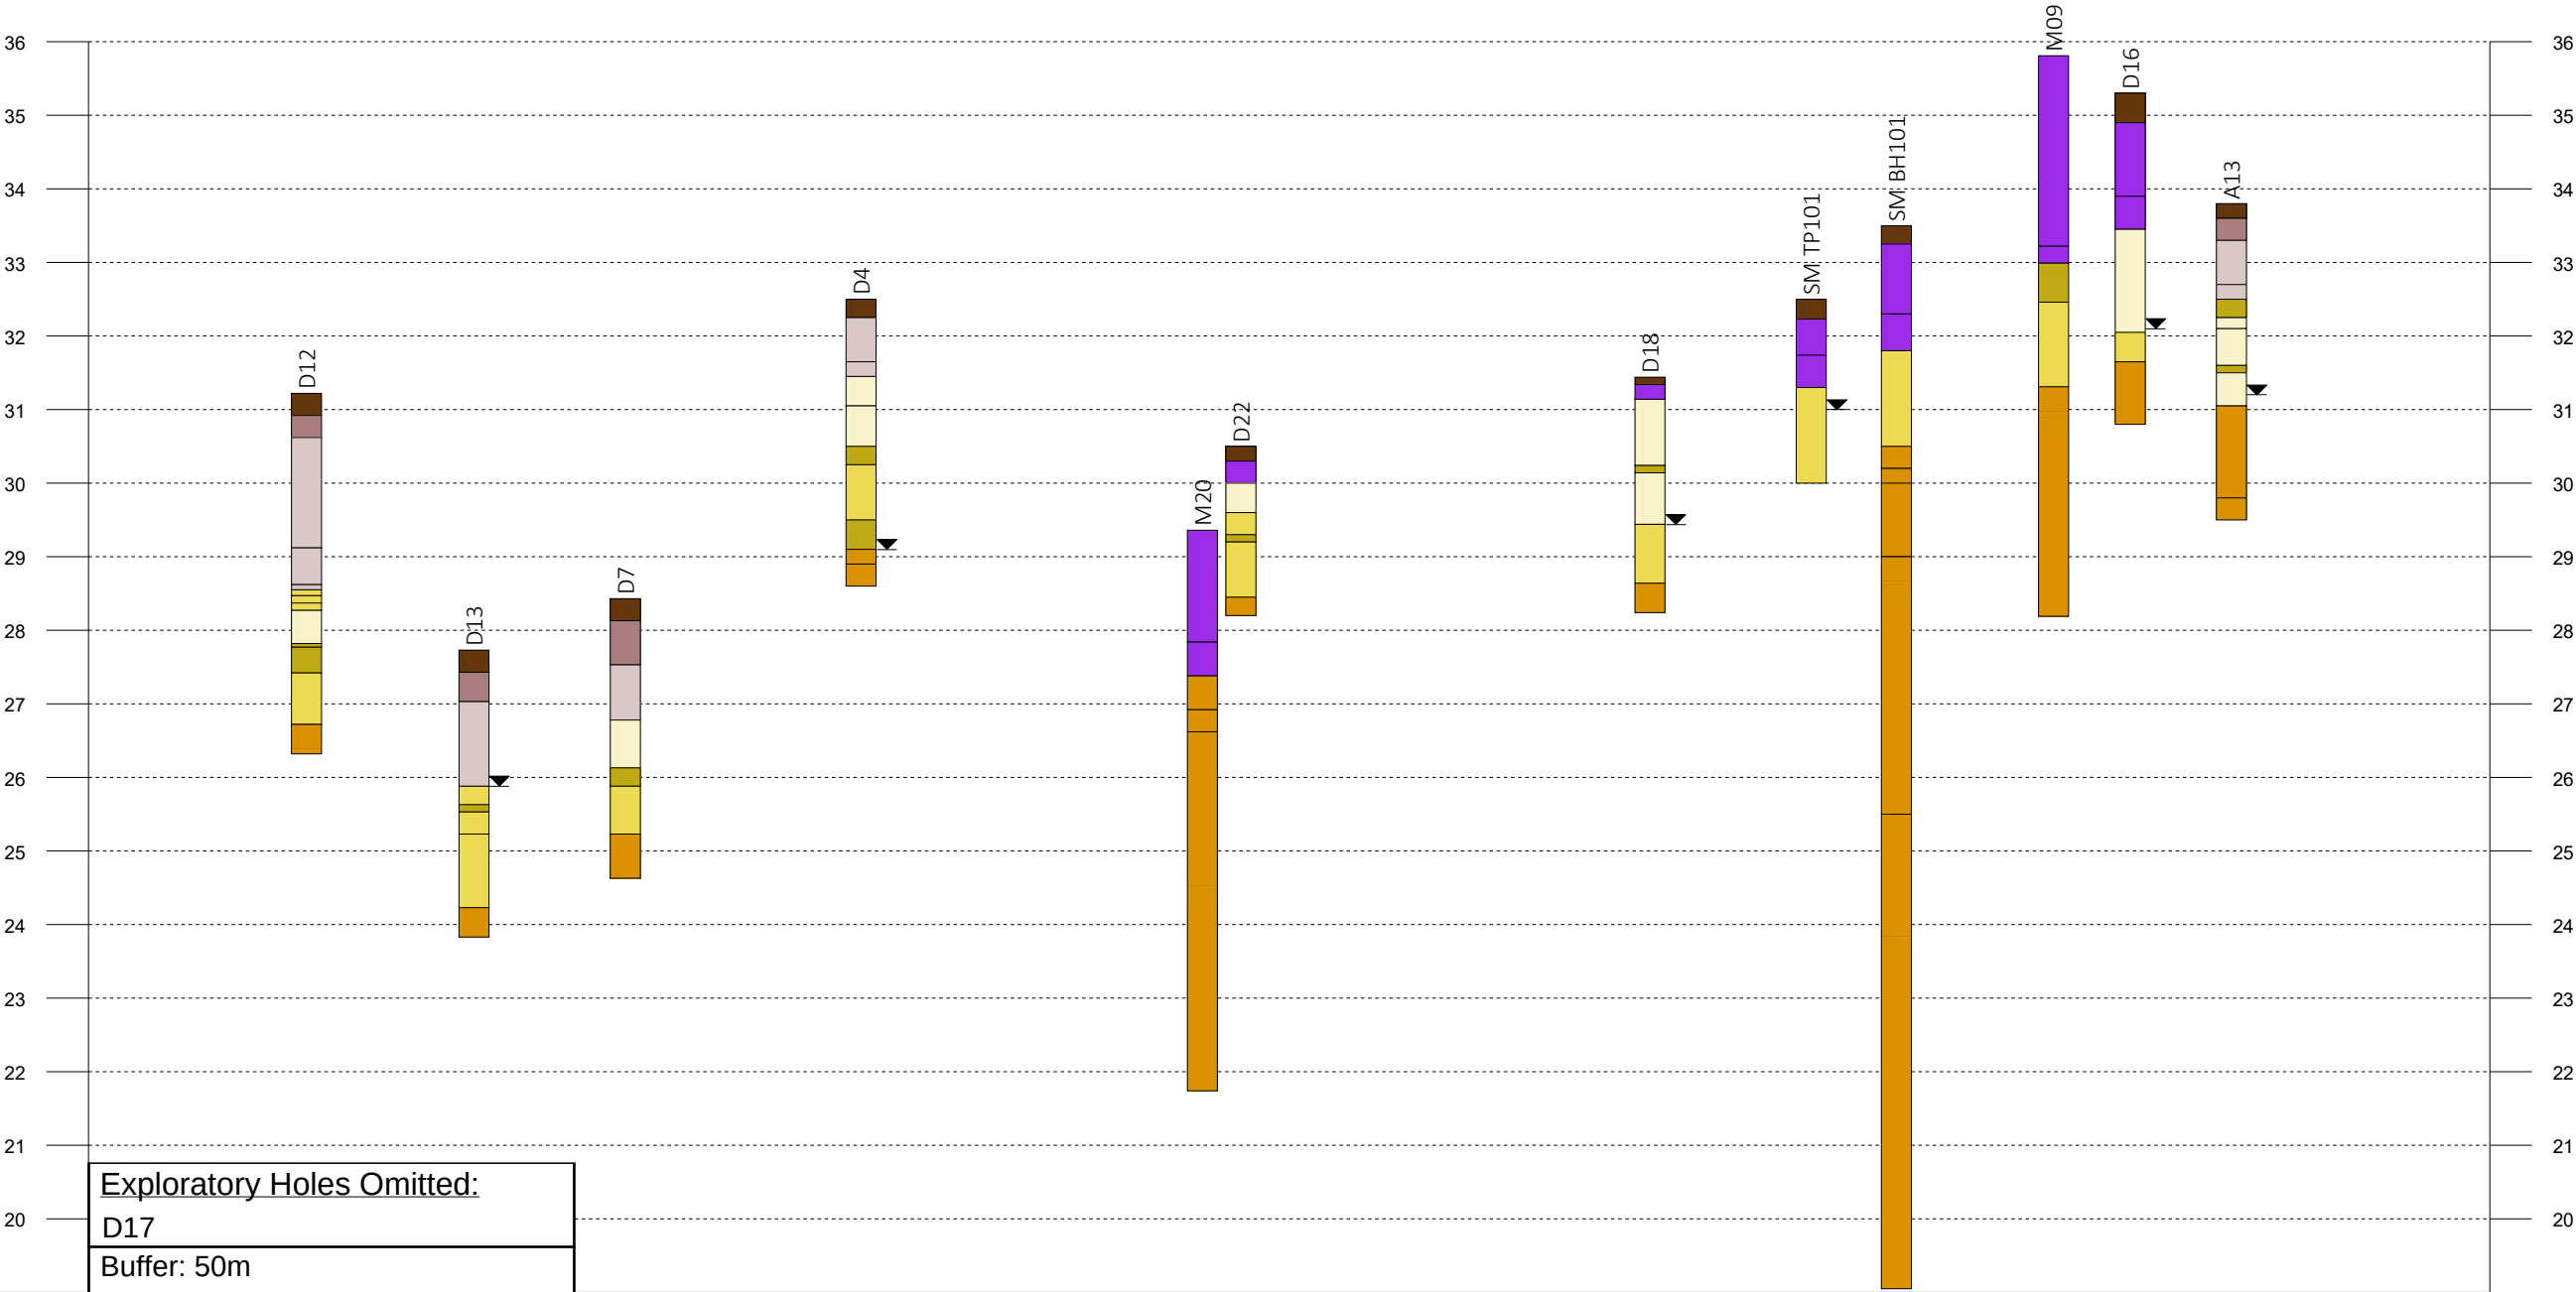
| Chainage (m) | 0.00 | 104.17 | 202.88 | 292.09 | 431.01 | 632.23 | 654.91 | 896.01 | 991.07 | 1041.27 | 1133.91 | 1179.11 | 1238.76 | 1322.45 |
| Offset (m) | | 45.95 | 37.79 | 20.89 | 2.72 | 32.35 | 28.98 | 2.91 | 19.75 | 22.02 | 42.13 | 39.60 | 7.22 | |

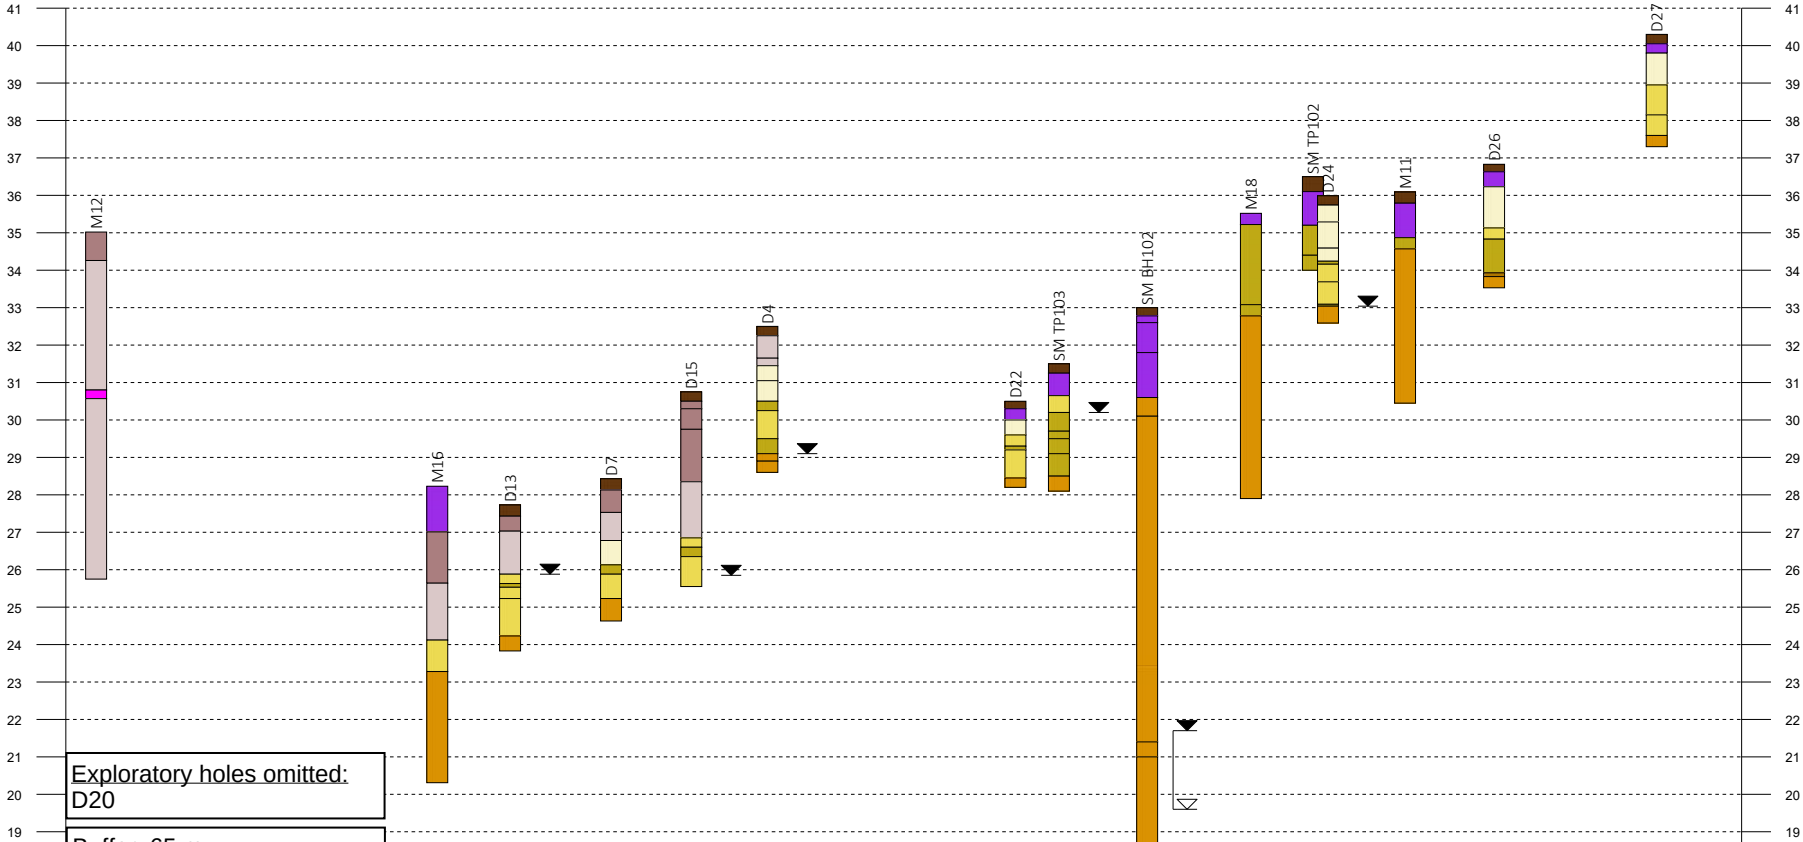
| Chainage (m) | 0.00 | 12.11 | | 156.22 | | 306.11 | | 371.15 | | 461.36 | | 533.04 | | 601.03 | | 756.42 | | 822.64 | | 861.47 | | 940.31 | | 1032.98 | | 1088.3 | | 1101.8 | | 1170.7 | | 1250.2 | | 1350.1 | | 1385.7 |
| Offset (m) | 54.21 | 43.16 | | 48.29 | | 4.98 | | 19.90 | | 9.56 | | 53.85 | | 9.10 | | 48.73 | | 50.44 | | 31.35 | | 26.45 | | 9.56 | | 50.75 | | 6.27 | | 31.85 | | 43.62 | | 10.55 | | 56.47 |

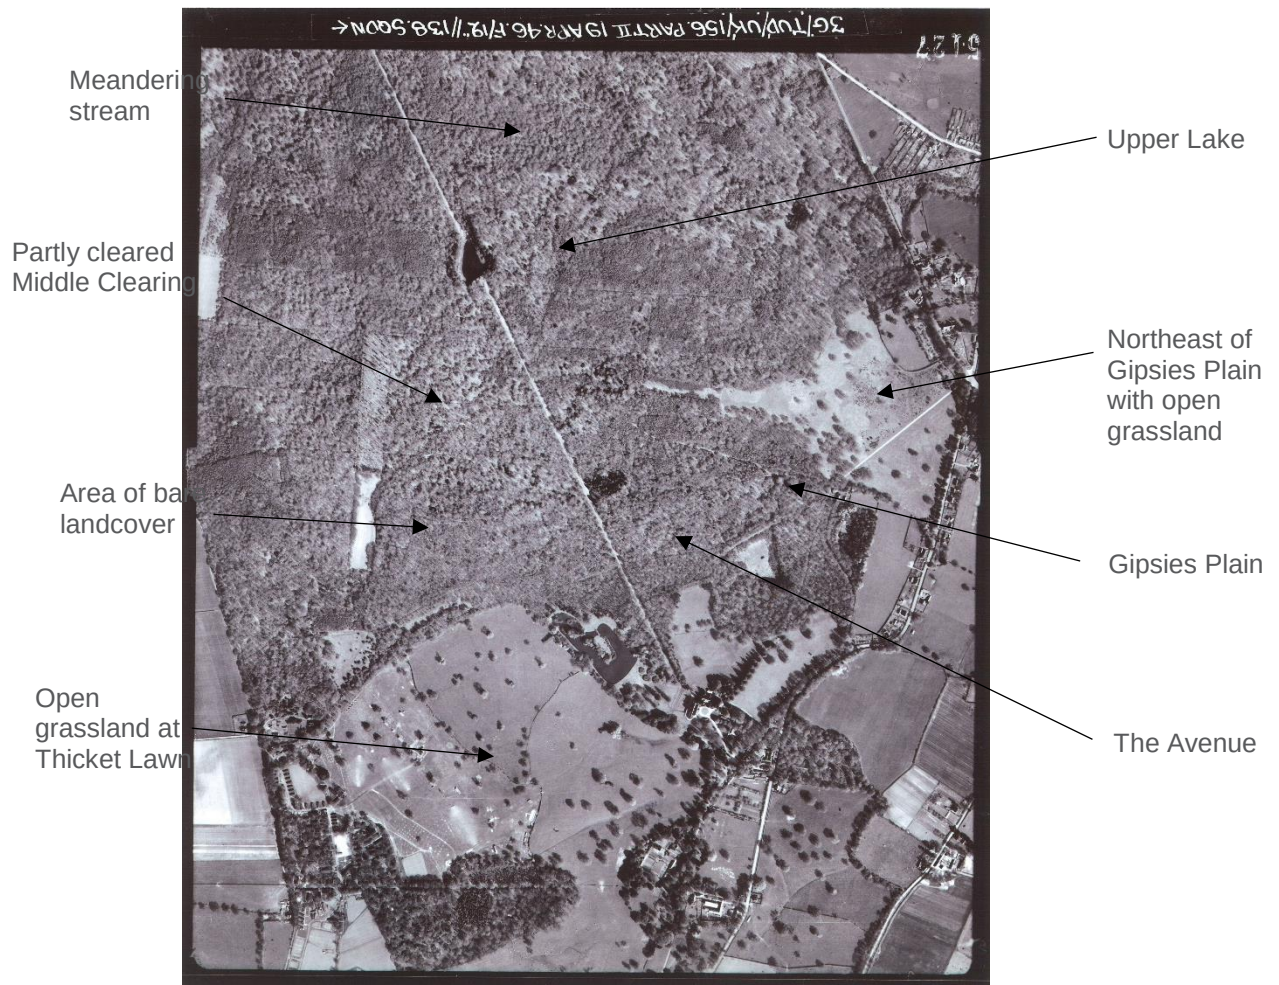
Figure C-1 - Aerial photograph taken on 19 Apr 1946 (Photo ID: RAF/3G/TUD/UK/156 - 5127)

- Vegetation appears to be relatively sparse to the north of the Study Area and becomes gradually denser further into the gentle valley.
- Dense vegetation and the relatively poor quality of the early photos prevent the delineation of geomorphological features.
- No discernible evidence for slope movements could be identified as affecting the Study Area.

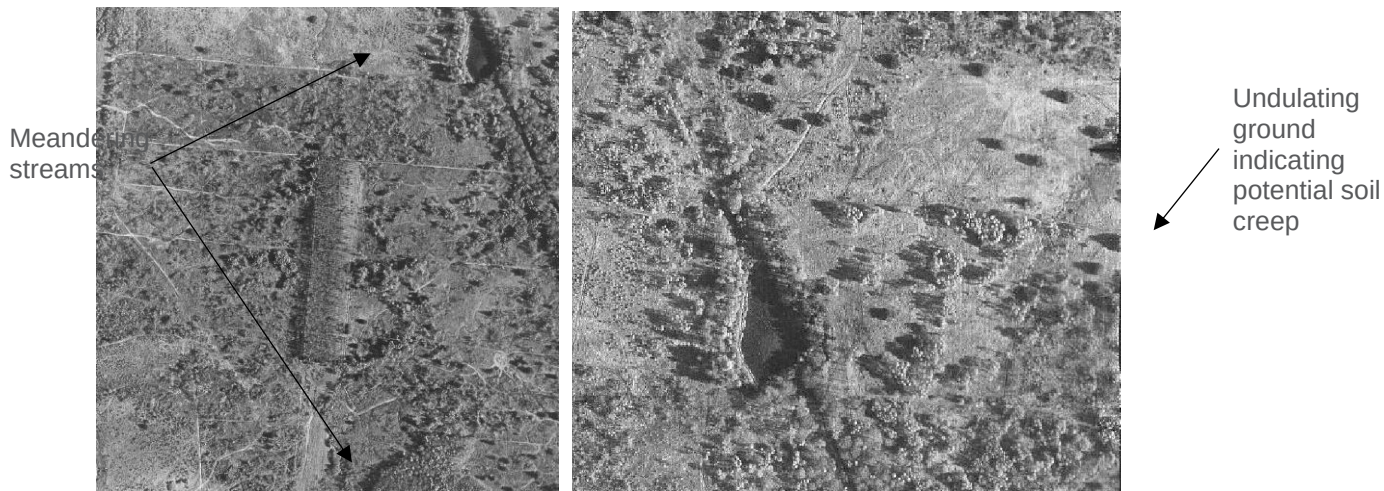
Figure C-2 –Aerial photographs taken on 07 May 1954 (Left - Photo ID: RAF/82/914 – 013. Right - Photo ID: RAF/82/914 – 014)

- No discernible evidence for slope movements could be identified as affecting the relatively gentle slopes elsewhere in the Study Area.

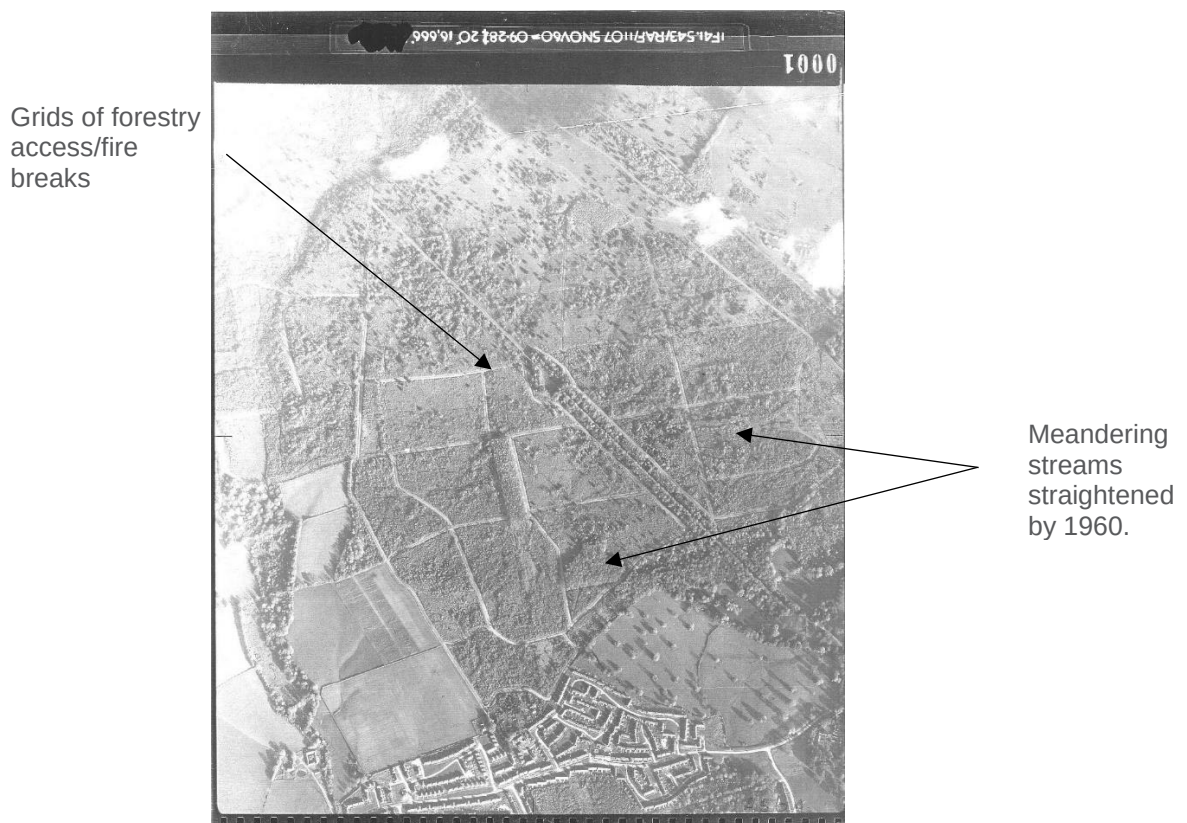
Figure C-3 - Aerial photograph taken on 05 Nov 1960 (Photo ID: RAF/543/1107 - 0001)

- The majority of the woodland across the Study Area has been cleared, with forestry access tracks now also clearly visible in the aerial photographs (Figure C-3).
- The meandering streams visible in earlier aerial photographs across the Study Area (Figure C-3), appears to have been straightened in 1960 (Figure C-3), possibly to improve drainage of the Study Area, which (anecdotally) can become very water-logged.
- No discernible evidence for slope movements could be identified as affecting the Study Area.

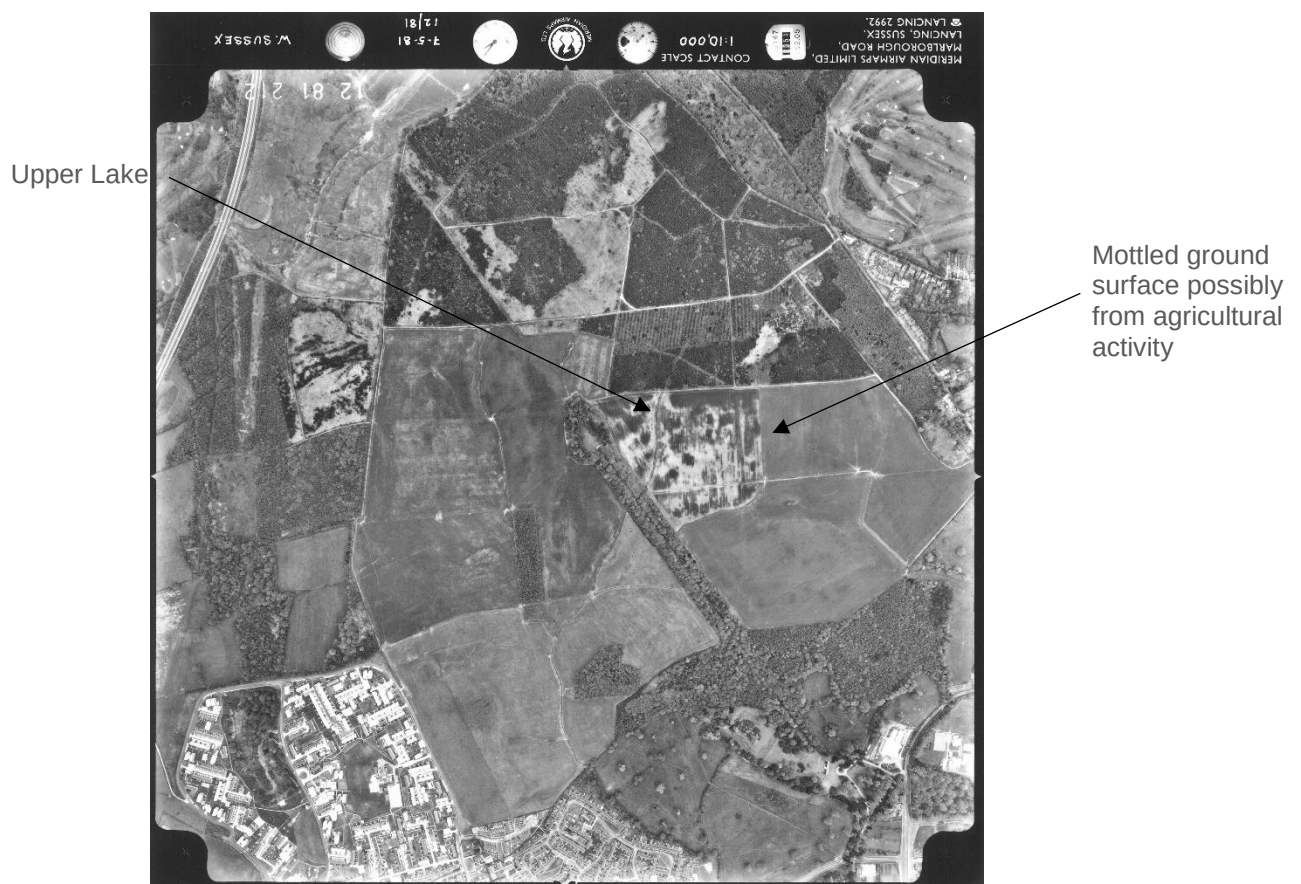
Figure C-4 - Aerial photograph taken on 07 May 1981. (Photo ID: MAL/81012 - 212)

- Trees have been cleared with open grassland observed across the majority of the Study Area
- An area can be observed to the east of the Upper Lake (Figure C-4) that has a mottled ground surface, possibly due to soil disturbance by forestry, deforestation or agricultural activities.
- No discernible evidence for slope movements could be identified as affecting the Study Area.

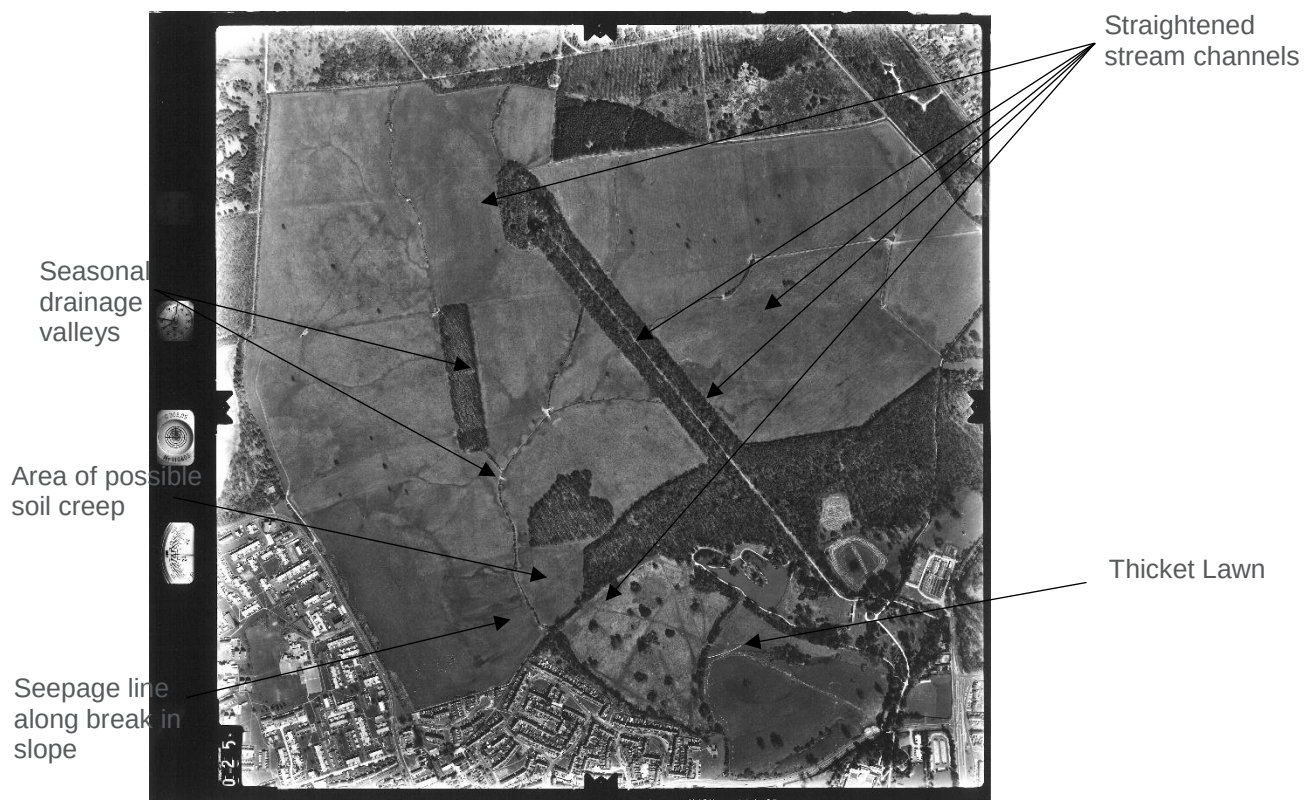
Figure C-5 - Aerial photograph taken on 20 Apr 1996. (Photo ID: OS/96535 - 025)

- The seepage lines appear to be accompanied by areas of soil creep based on aerial photograph interpretation (Figure C-5), however this could not be confirmed during the site walkover.

- Other possible geological boundaries between the London Clay and Harwich Formation in the eastern part of the Study Area have also been inferred based on the presence of relatively distinct changes in slope angle due to breaks of slope.
