# 128 Victoria Road | P008

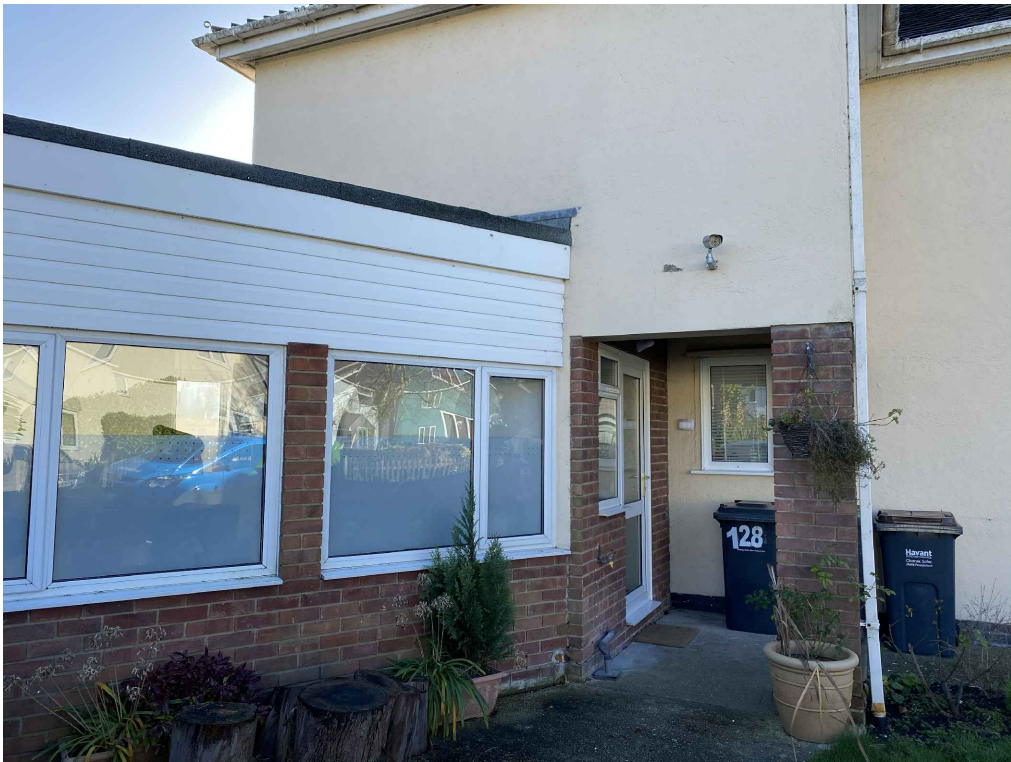
**View upon arrival as existing;** differing scales, materials and lack of clear entrance. Lack of privacy and security through historic space planning and various access points.

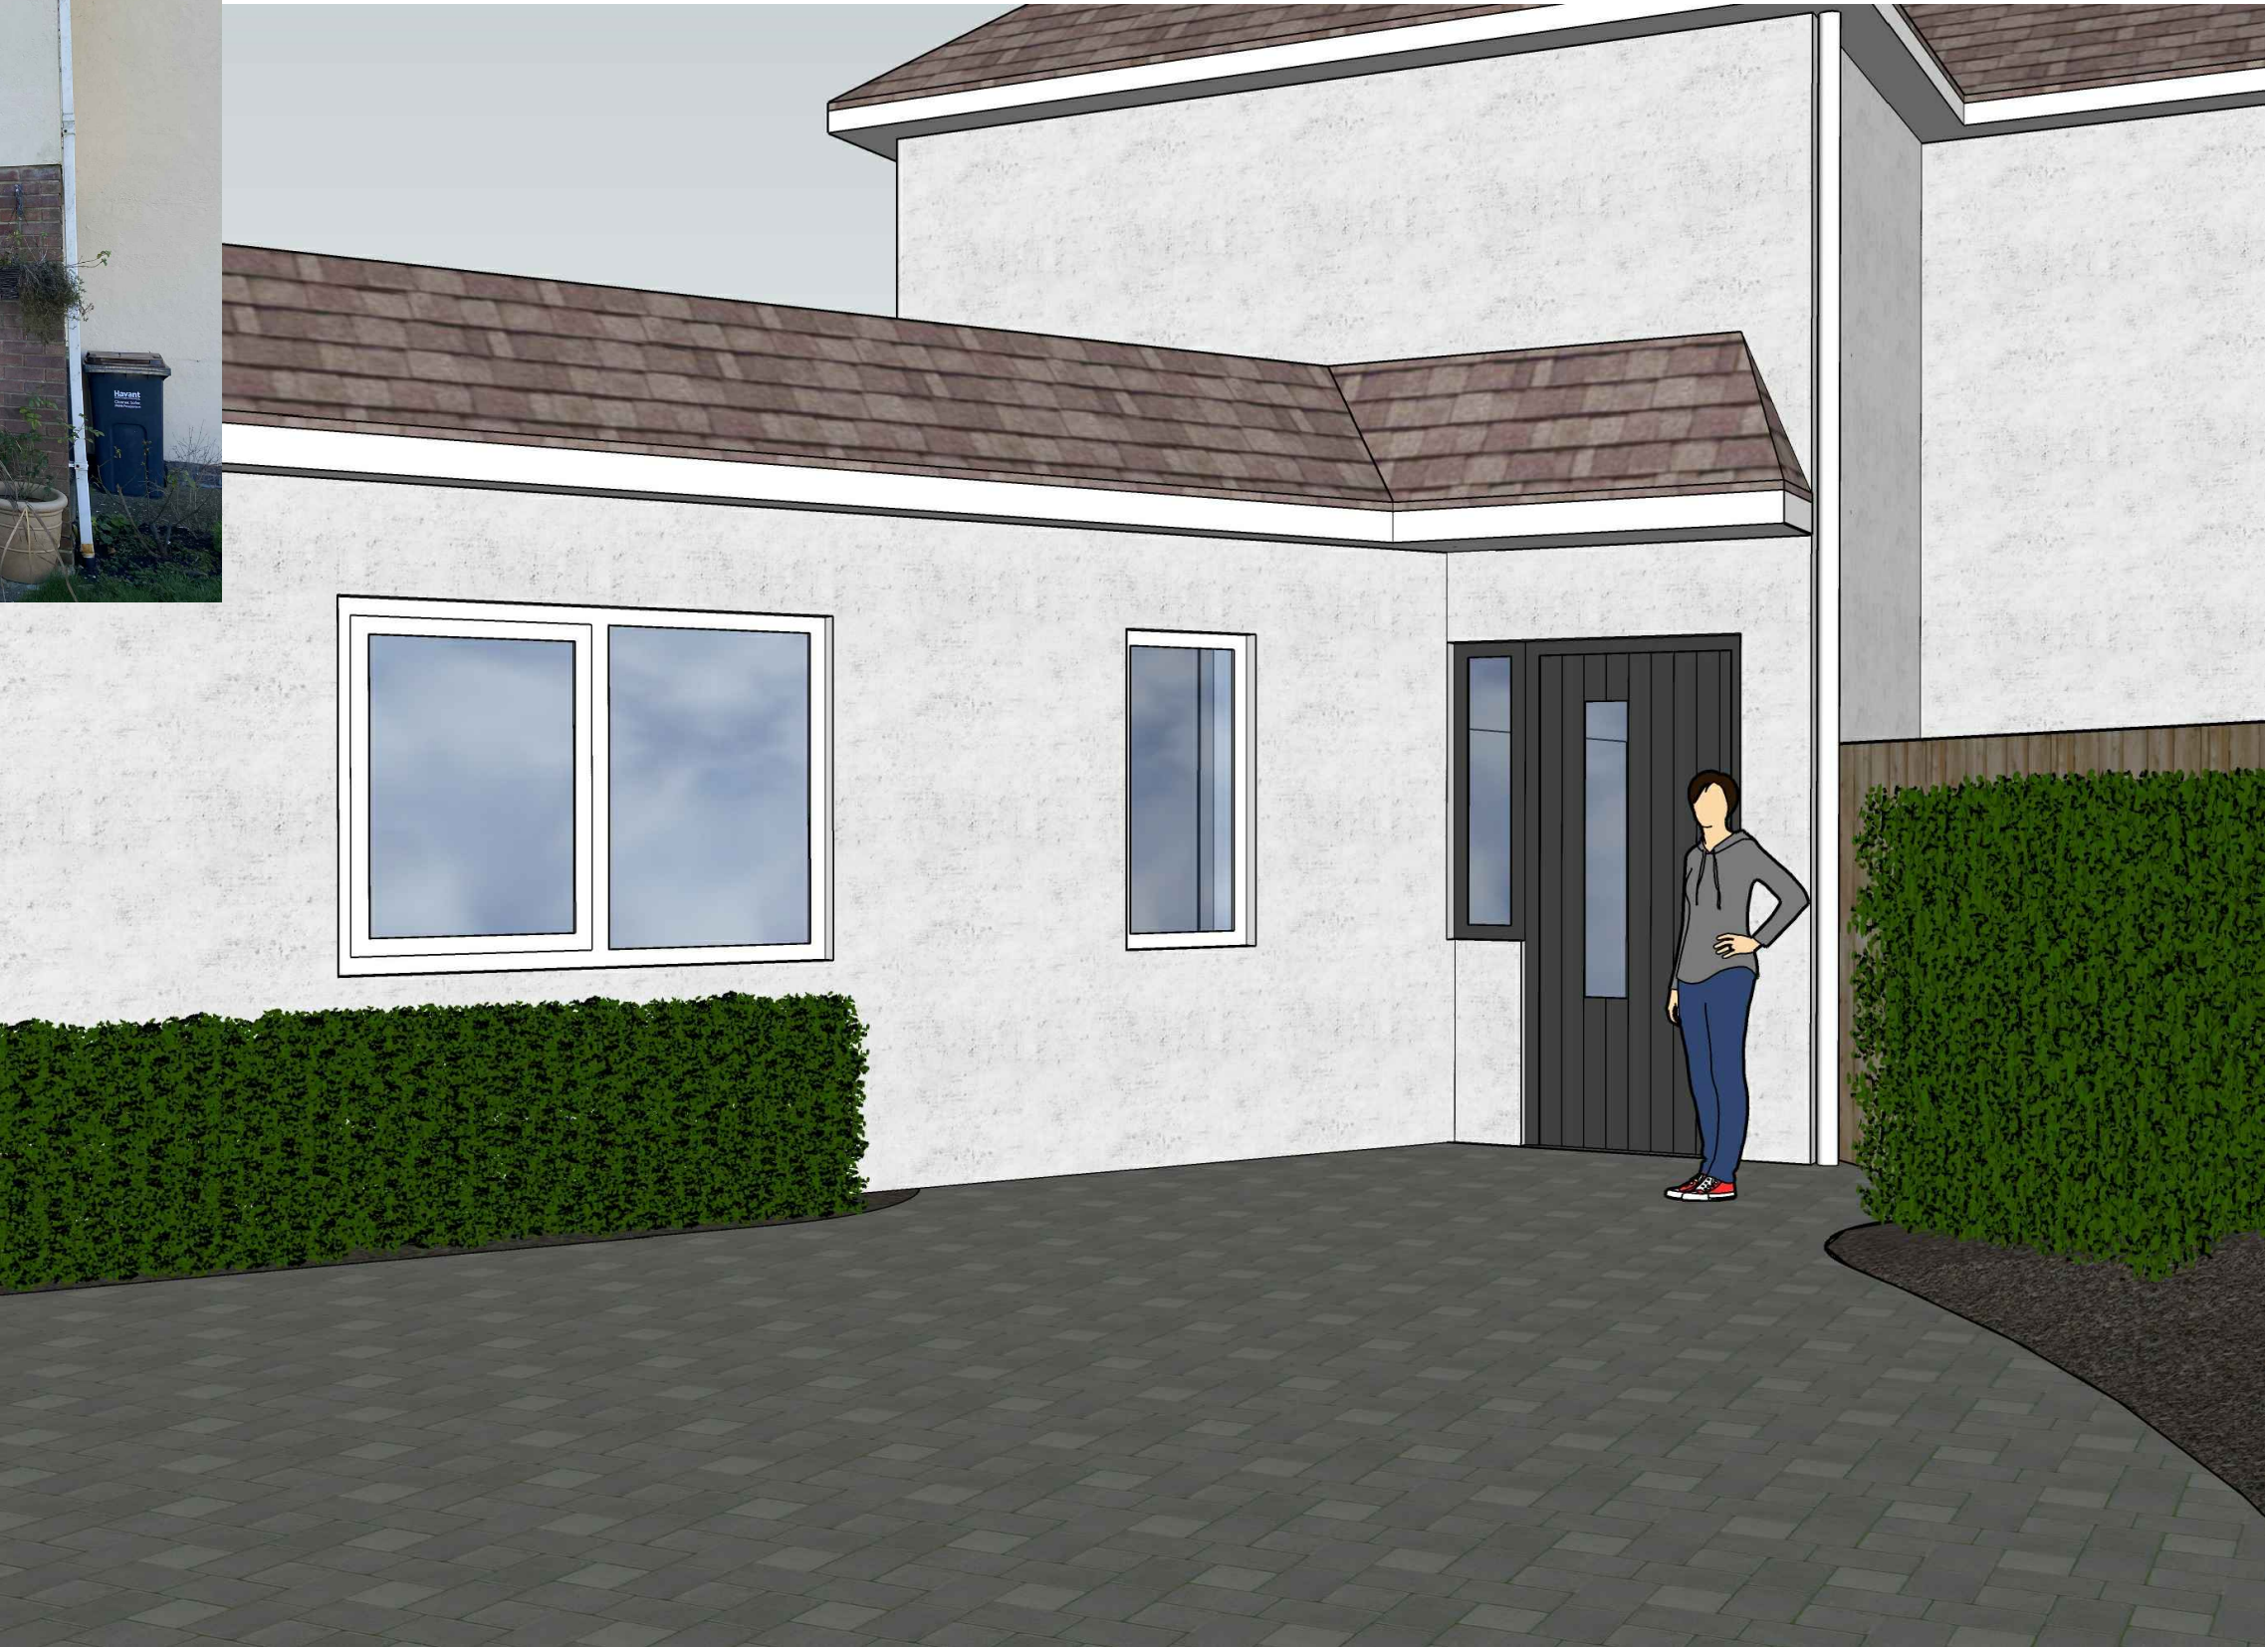
**Illustrative View of proposed;** Defined 'Front Door' and entrance from driveway, scale and consistency in materials and massing.
