## **Campdown, Land off College Road, Purbrook, Waterloooville, PO7 8AA**

Geo-environmental site assessment

28720 R01 (01)

OCTOBER 2016

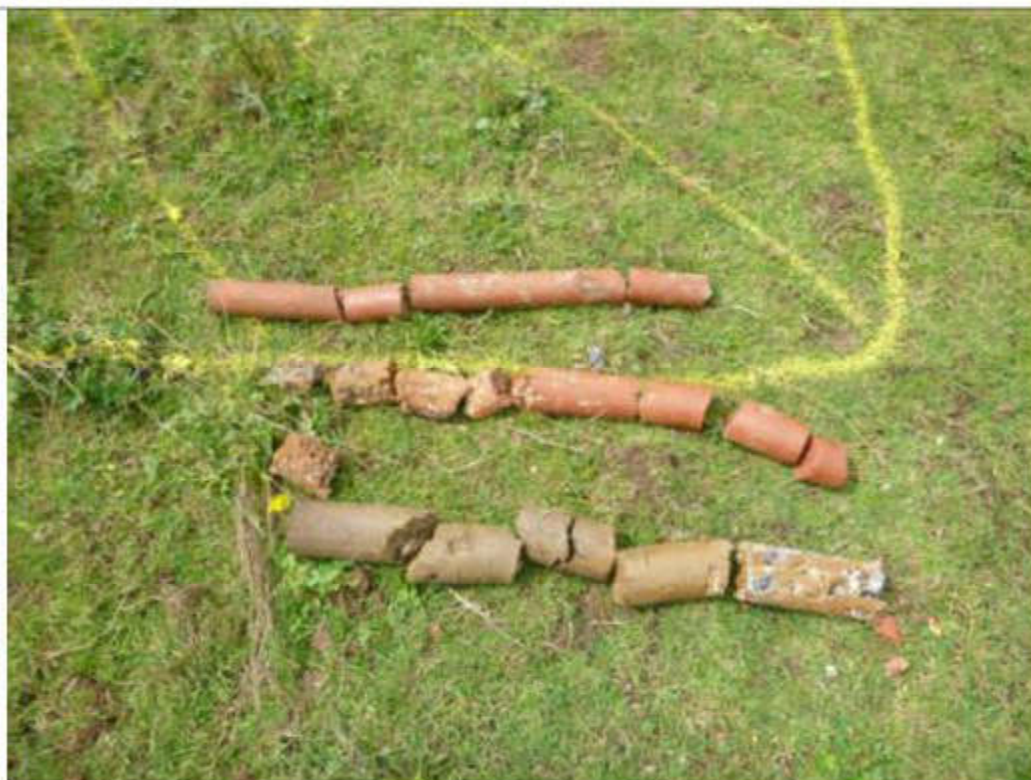
Soils from  
BH14

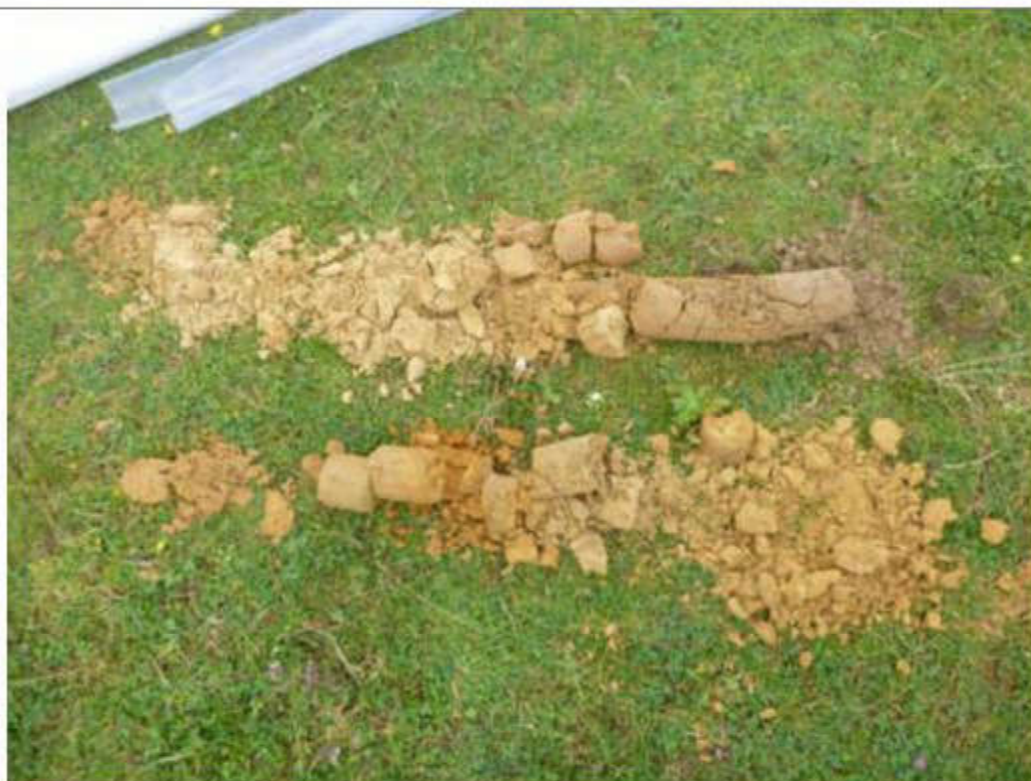
Photo No.  
10

The topsoil generally comprised of brown to orange brown sandy gravelly CLAY with gravel of flint. Brick was noted to be present in some locations. Topsoil comprising of sand was found to be present at BH8.

Soils from  
BH8

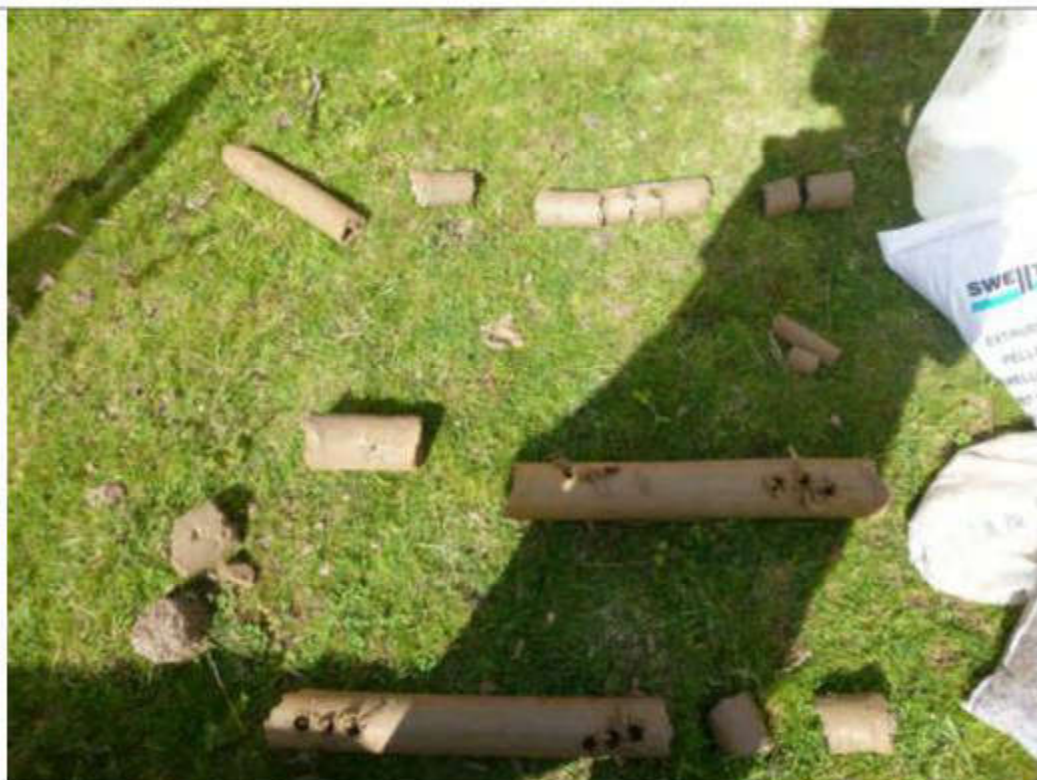
Soils from  
BH18
