# Arboricultural Impact Assessment (AIA)

Ref - J190701 Rev A.

Co-op Havant, Bedhampton Road, PO9 3PT

RPM Consult

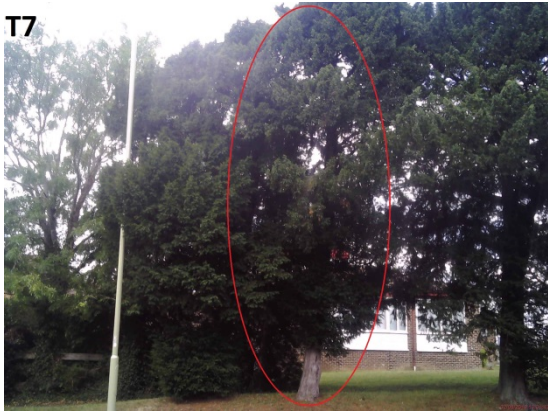
**T7**

| Reference Number | Common Species Name<br>(Scientific name abbreviation) | Height (m) | Stem Diameter (mm) | | | Branch Spread (m) | | | | Existing height above ground level | | Life Stage (Age) | General Observations | | Estimated Remaining Contribution (Yrs) | Category Grading | Root Protection Area (m2) |
|---|---|---|---|---|---|---|---|---|---|---|---|---|---|---|---|---|---|
| T7 | Yew, Taxus baccata | 9 | | | 360 | 2 | 2 | 2.5 | 1.5 | 2.5m n | 2.5m | SM | Fair | Unclear ownership, potentially highways/council/third party tree. Minor exposed heartwood in 2 small pockets on North side of main stem, no decay observed. Nesting material in canopy with one egg shell observed on the ground at base of tree, although nesting activity not confirmed. If this tree is within the boundary of the proposed construction site, an RPZ is to be installed to the North and the main stem of the tree, to prevent any root damage during excavations and to discourage materials/machinery being stored on exposed surface roots. | 10+ | c2 | 59 |

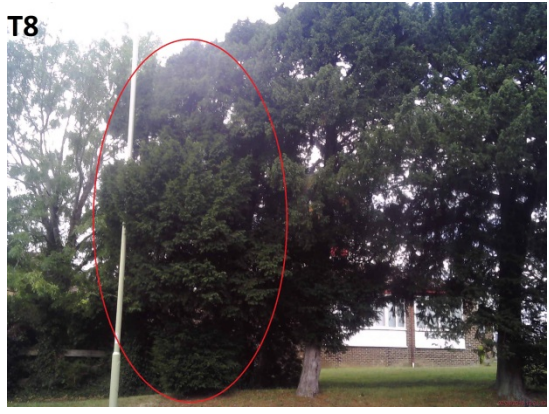
**T8**

| Reference Number | Common Species Name<br>(Scientific name abbreviation) | Height (m) | Stem Diameter (mm) | | | Branch Spread (m) | | | | Existing height above ground level | | Life Stage (Age) | General Observations | | Estimated Remaining Contribution (Yrs) | Category Grading | Root Protection Area (m2) |
|---|---|---|---|---|---|---|---|---|---|---|---|---|---|---|---|---|---|
| T8 | Yew, Taxus baccata | 9 | | | 360 | 2 | 1 | 2.5 | 2.5 | 2.5mS | 2.5m | SM | Fair | Unclear ownership, potentially highways/council/third party tree. Epicormic growth at base. If this tree is within the boundary of the proposed construction site, an RPZ is to be installed to the North and the main stem of the tree, to prevent any root damage during excavations and to discourage materials/machinery being stored on exposed surface roots. | 10+ | c2 | 59 |

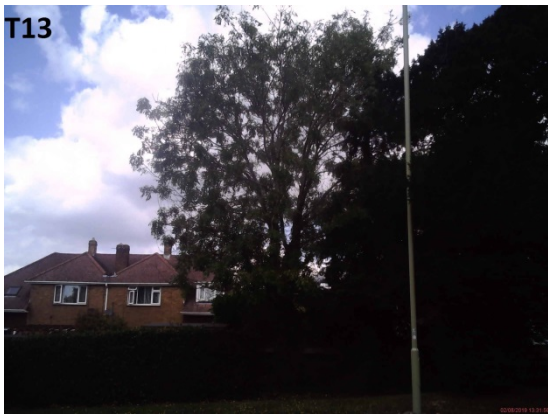
**T13**

- 3.5.1 T13 has been surveyed as a Cat 'U' and is recommended for removal.
