ENVIRONMENTAL DESK STUDY  
AND  
PRELIMINARY  
RISK ASSESSMENT

Deer View Lodge  
Cope Lane  
Hayling Island  
Hampshire  
PO11 0QB

July 2019

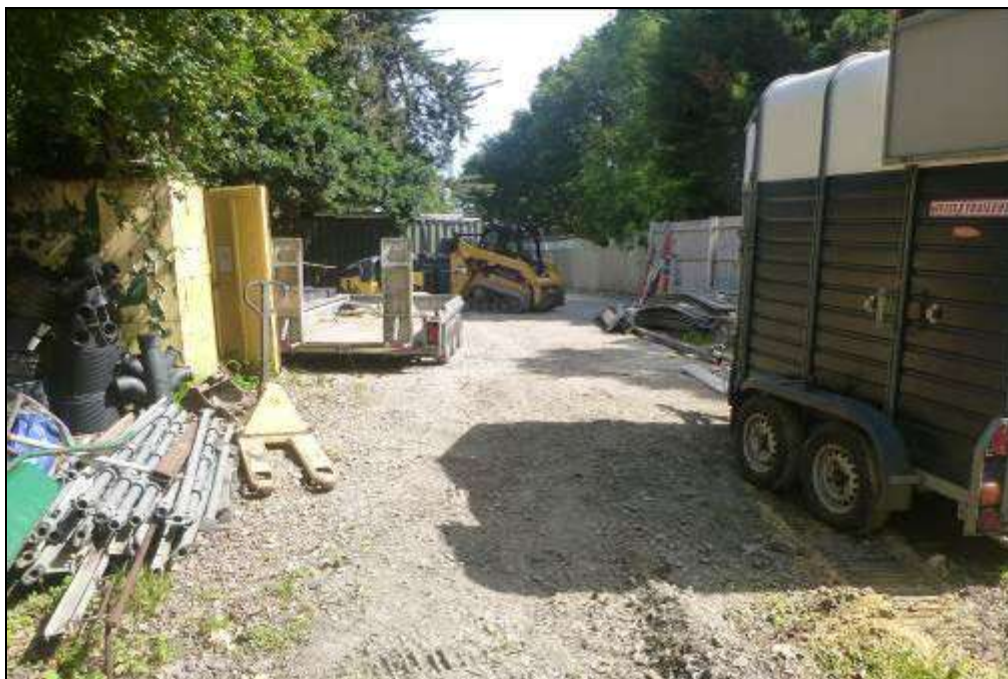
**Photograph 3** Showing the area to the immediate north of the building

To the immediate north of the subject building there is an area of compressed soil and scalping. During the site walkover it was noted that heavy machinery, construction waste and an oil tank were located upon this area; all of which have the potential to result in ground contamination.

In view of the above conclusion, and through reference to Havant Borough Council memorandum, further assessment of risk is recommended, in the form of an intrusive site investigation. This should concentrate on areas where there is believed to be some potential for unacceptable risk. Hence, this should include proposed gardens areas, or where there could be made-ground deposits or other contamination hotspots.

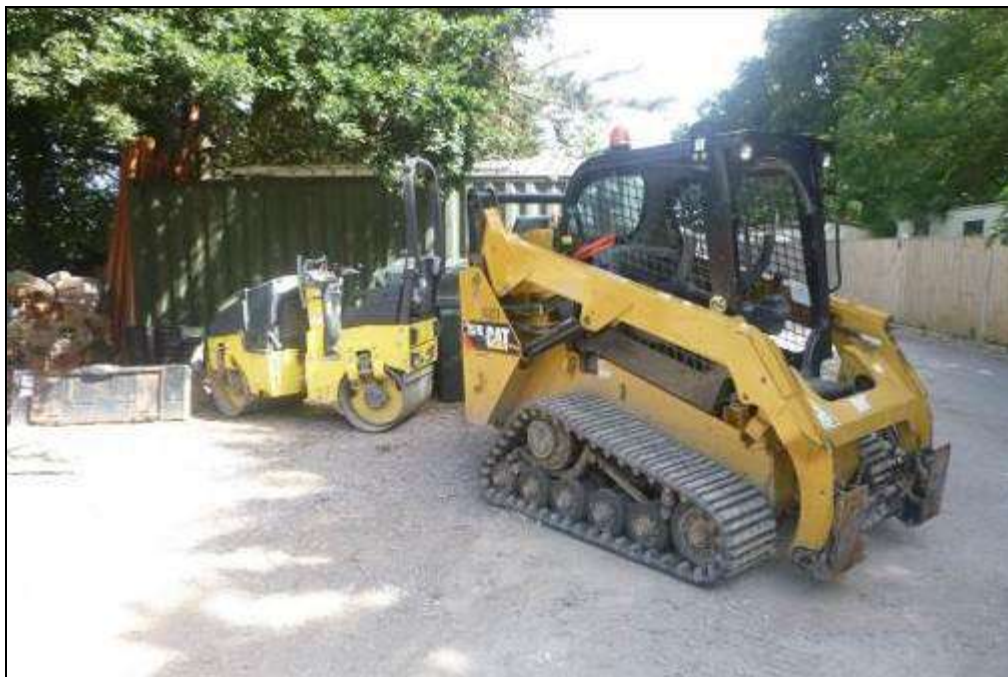
**Photograph 5** Showing plant machinery to the north of the building

- heavy metals and other inorganics from general activities (on and off-site) and made-ground or hardcore deposits;
- hydrocarbon residue from the use or storage/use of vehicles, or possible small-scale oil and/or fuel leaks (on and off-site); and
- ground gases from any made-ground deposits on-site and infill off-site.

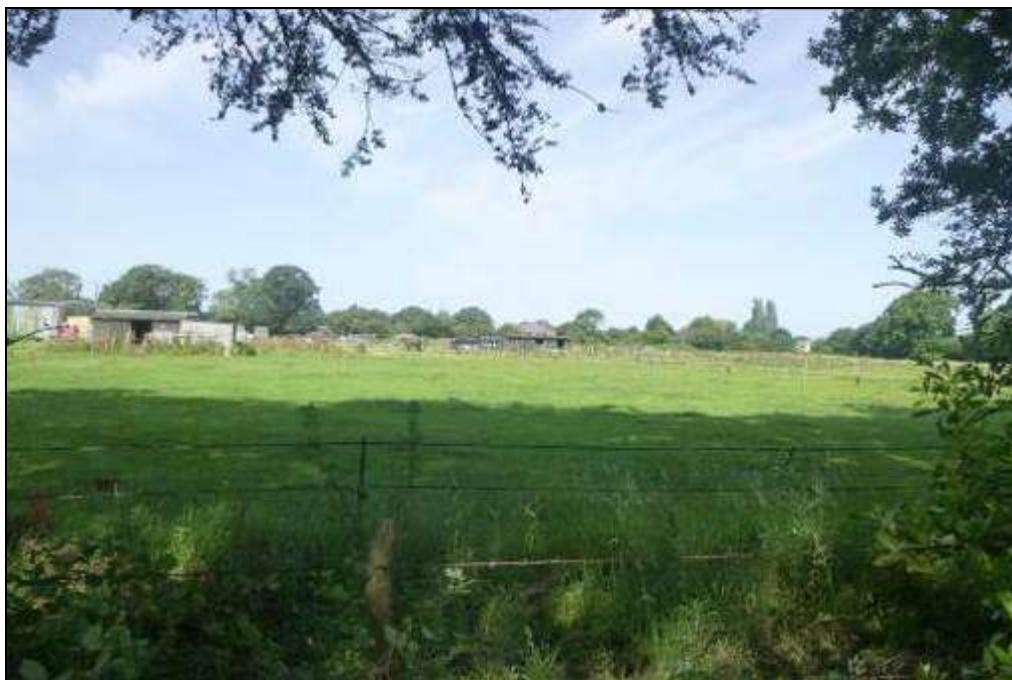
**Photograph 9** Showing the area of the former brickworks site

With regards to off-site sources, it has been noted that brickworks had been present on land to the immediate west of the site and around 60m to the west, between the late 1900s and the early 1940s; in view of which it is presumed that some degree of excavation along with possible infilling could have occurred. It is also possible that processes associated with the brickworks could have occurred on the subject site itself during this early period when the works appeared to be immediately adjacent to the site.

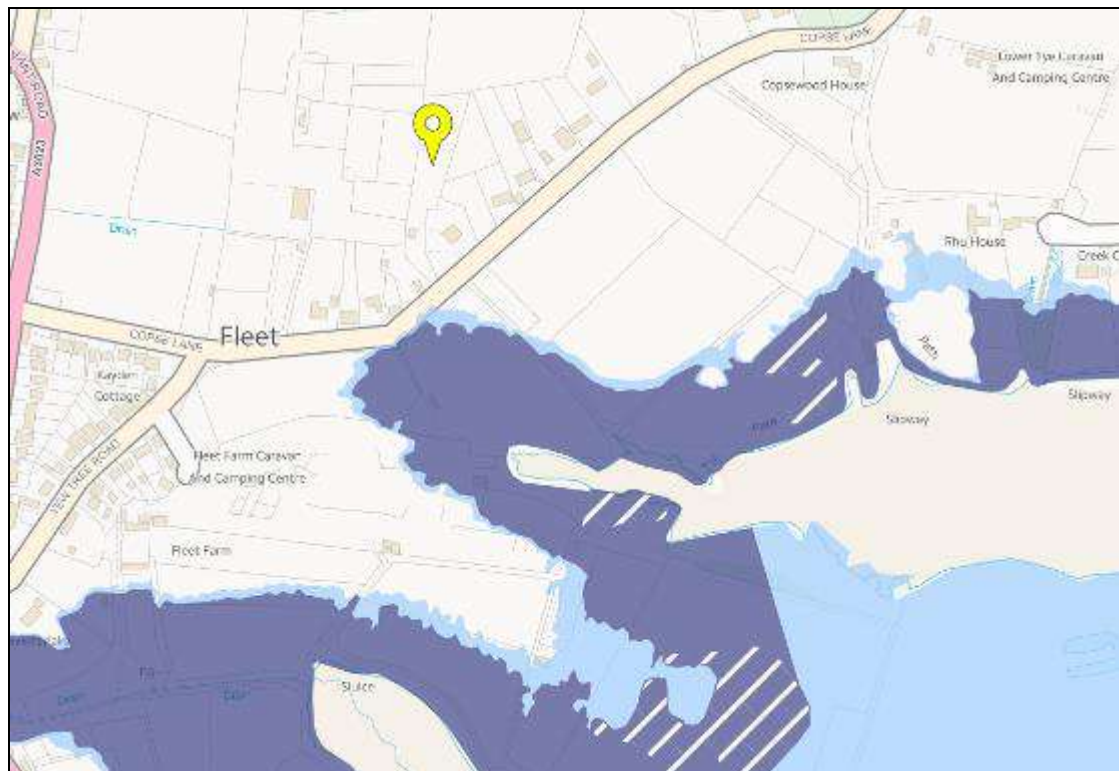
**Figure 2** Showing the flood risk at the site

These have been designated due to possible flooding of the Sweare Deep.

— Flood Zone 2

— Flood Zone 3
