ENVIRONMENTAL DESK STUDY  
AND  
PRELIMINARY  
RISK ASSESSMENT

Northney Farm  
St. Peter's Road  
Hayling Island  
Hampshire  
PO11 0RX

May 2019

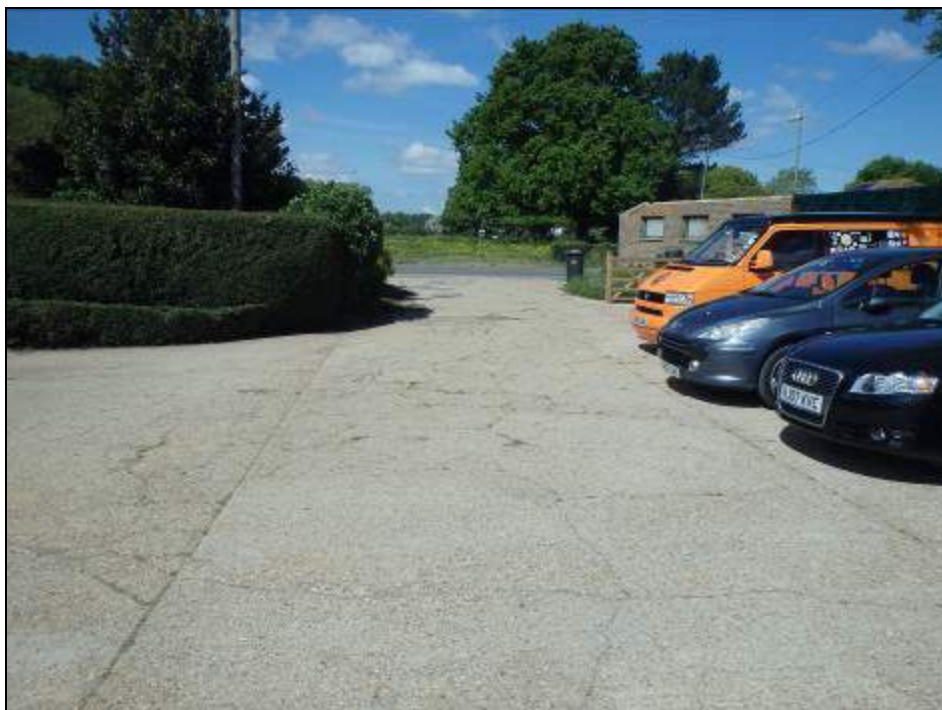
**Photograph 1** Showing the entrance onto the site

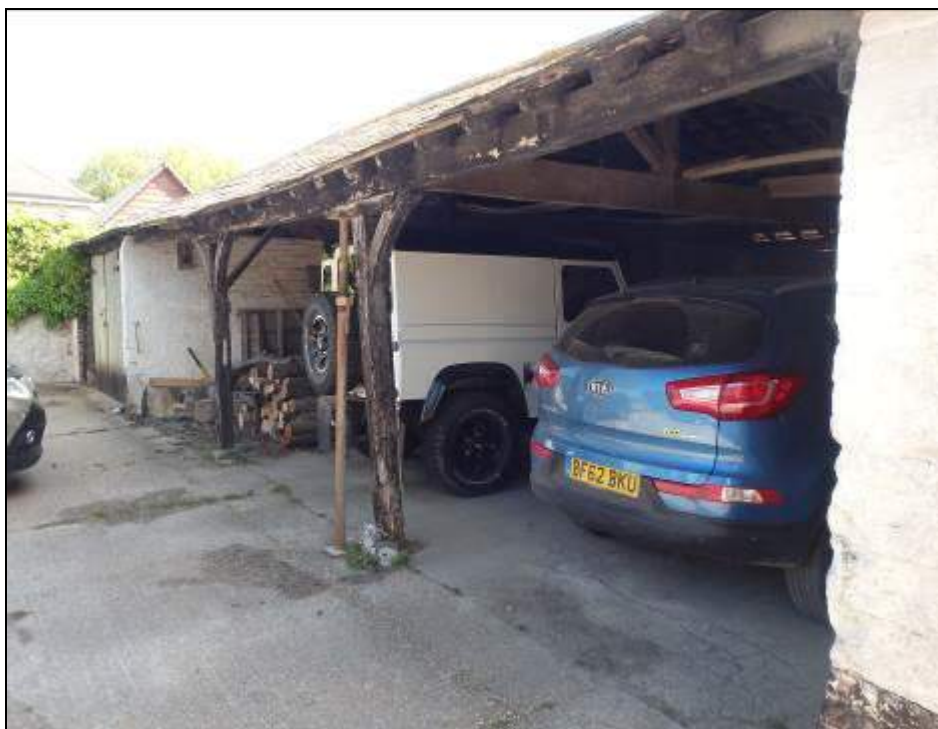
The buildings form an 'L' shaped arrangement, of which the western-most section is a single-storey brick structure with a slate roof. This was the former cart-shed constructed around the turn of the 20<sup>th</sup> Century. The front part of this building exists as two separate sections, of which the right-hand side has concrete ground cover, and is in use for the storage of wood and vehicles. The ground surface is in a reasonable state of repair and shows only light localised staining.

**Photograph 2** Showing the former cart-shed on the western section of the site

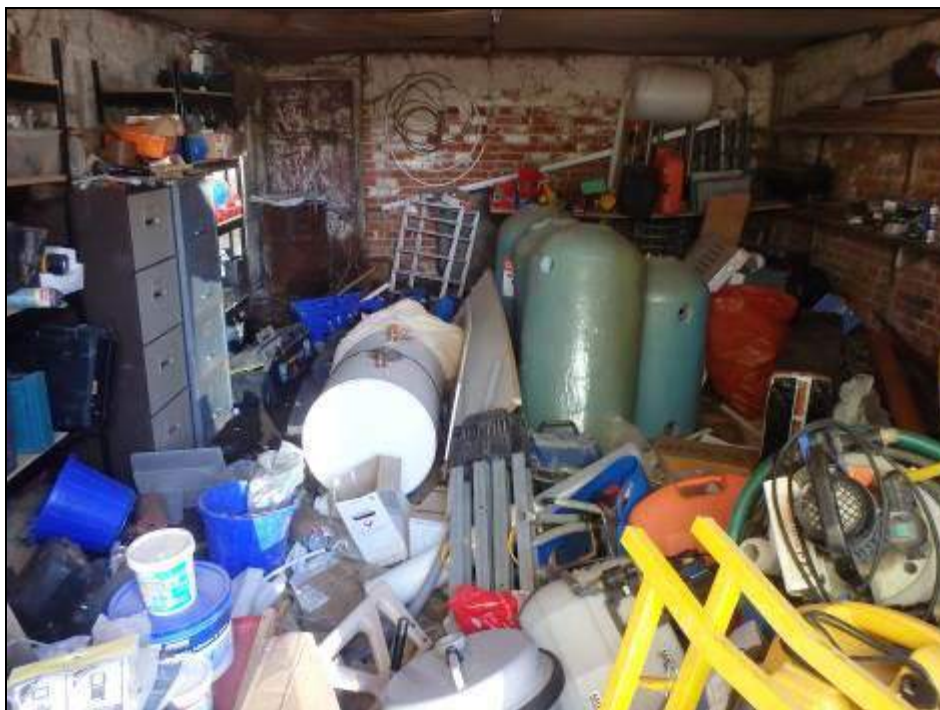
The left-hand side of the former cart-shed is being used for general storage, much of which appears to be plumbing/heating related. Storage within this area is extensive, and the ground surface is compacted soil. This was notably stained in some areas.

**Photograph 3** Showing the storage inside the former cart-shed

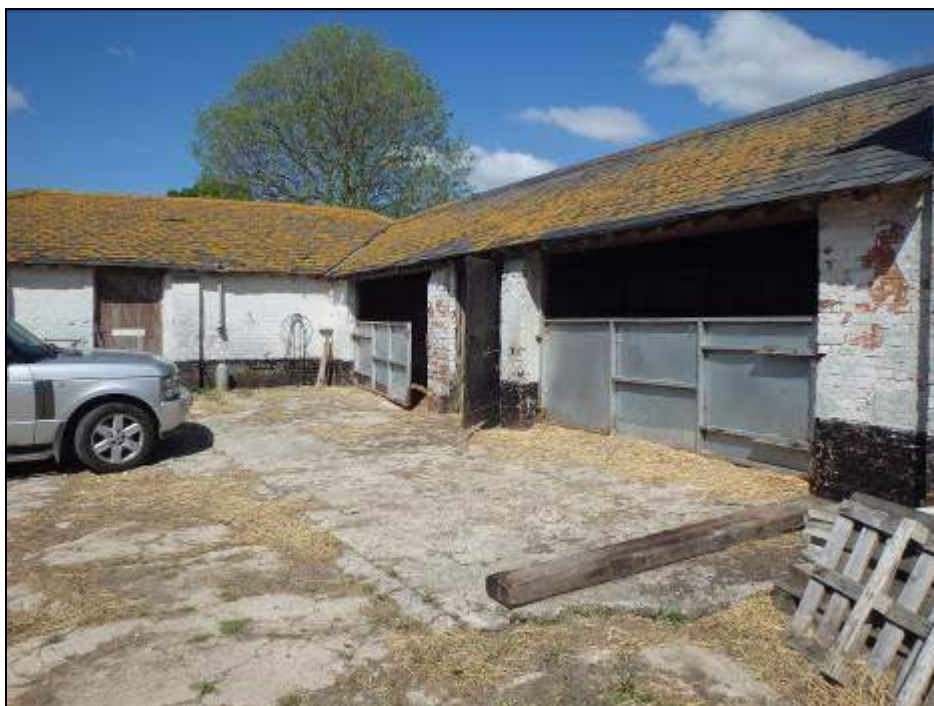
The section of building that extends eastwards from the cart-shed is being used as calf pens. The ground surface here has concrete cover overlain by straw. This section of the building adjoins a two-storey extended brick-built, slate-roofed building, within which the flooring is part stone blocks and part concrete. The flooring is in a good state of repair, and only shows minor staining. This building was also originally designed for the keeping of livestock; as indicated by a central drainage gulley and feeding trough, but is now used for general storage.

**Photograph 4** Showing the calf pens at the rear of the cart-shed

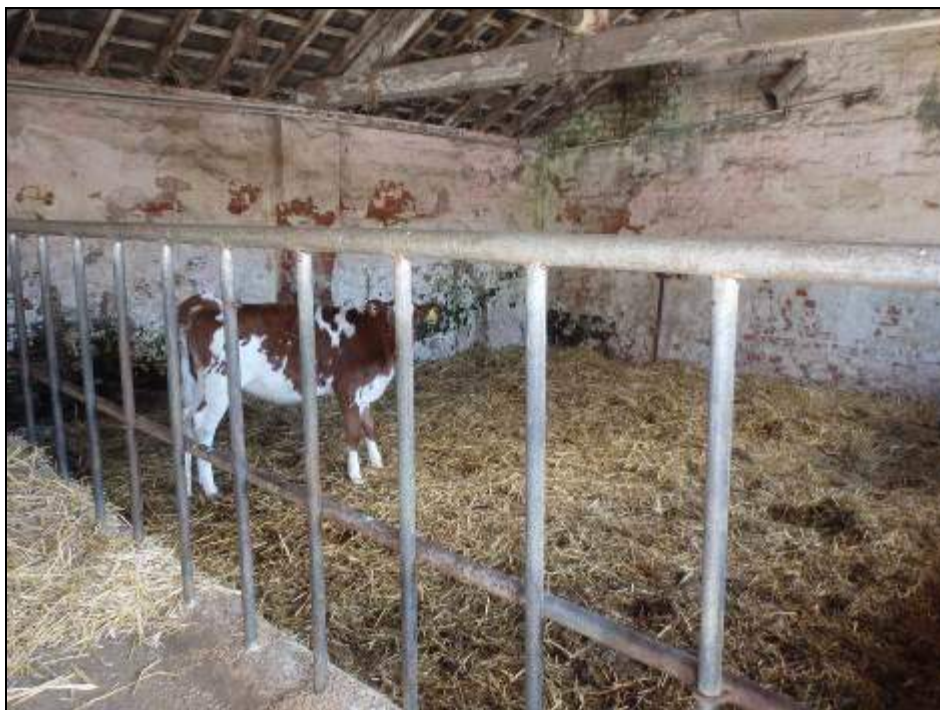
**Photograph 5** Showing inside the calf pens

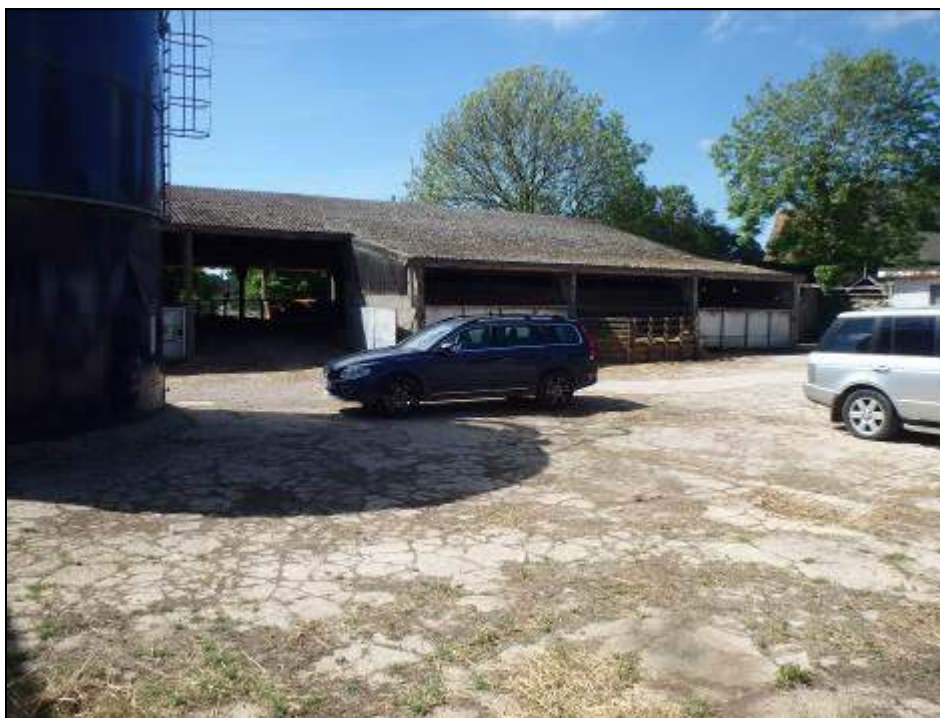
At the rear of the cart-shed section of the building there is a concrete courtyard. The surface here shows extensive cracking and repairs. This area slopes southwards towards the main cow-shed, at the front of which there is a yard drain or soakaway. The cow-shed is constructed from 'presumed' asbestos cladding to the roof and upper walls. There is also a large silo in the corner of the yard, which is understood to have only ever been used for grain.

**Photograph 6** Showing the courtyard at the rear of the cart-shed

The courtyard area is concrete covered, although in a poor state of repair. It is not expected for this to have seen any specific use, other than possibly for the temporary parking of agricultural vehicles. It is expected for this concrete cover to be underlain by made-ground and/or hardcore, although it is not expected to extend to any significant depth.

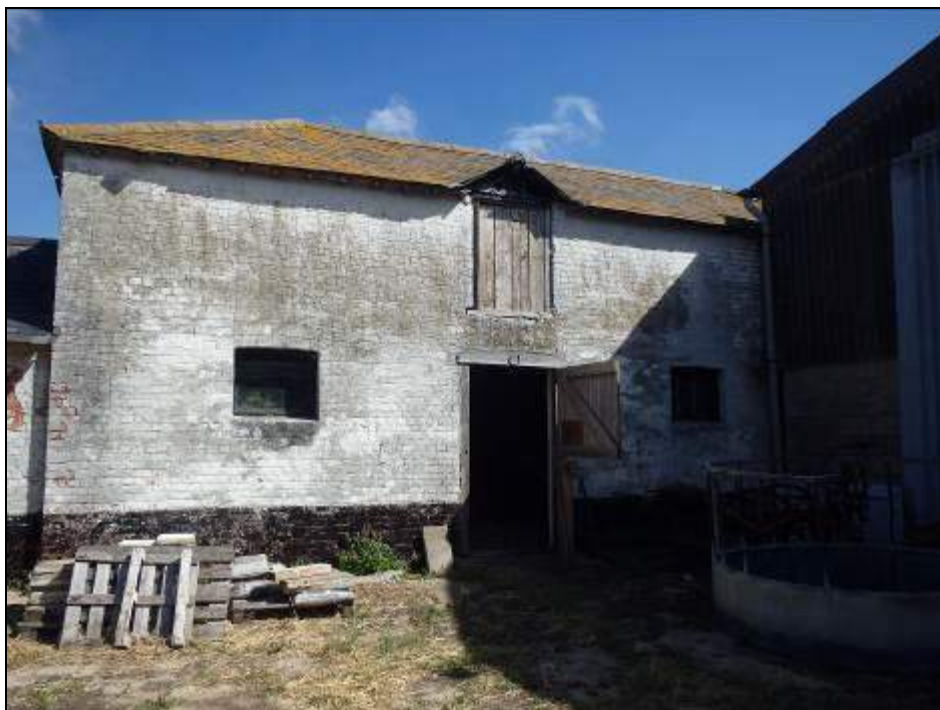
**Photograph 7** Showing the eastern-most section of the subject building

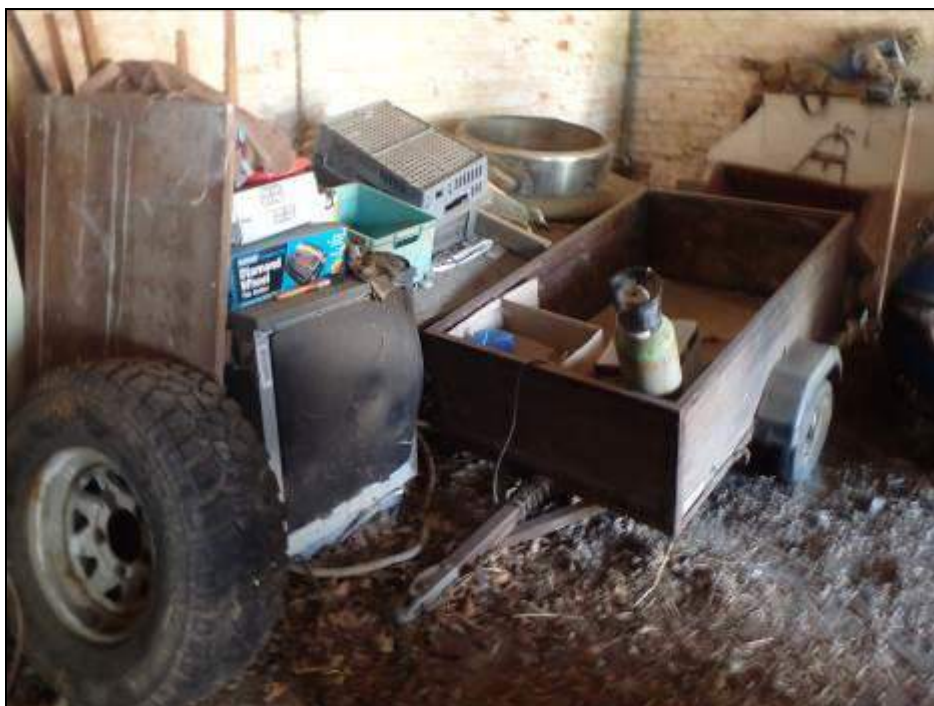
**Photograph 8** Showing inside the eastern-most section

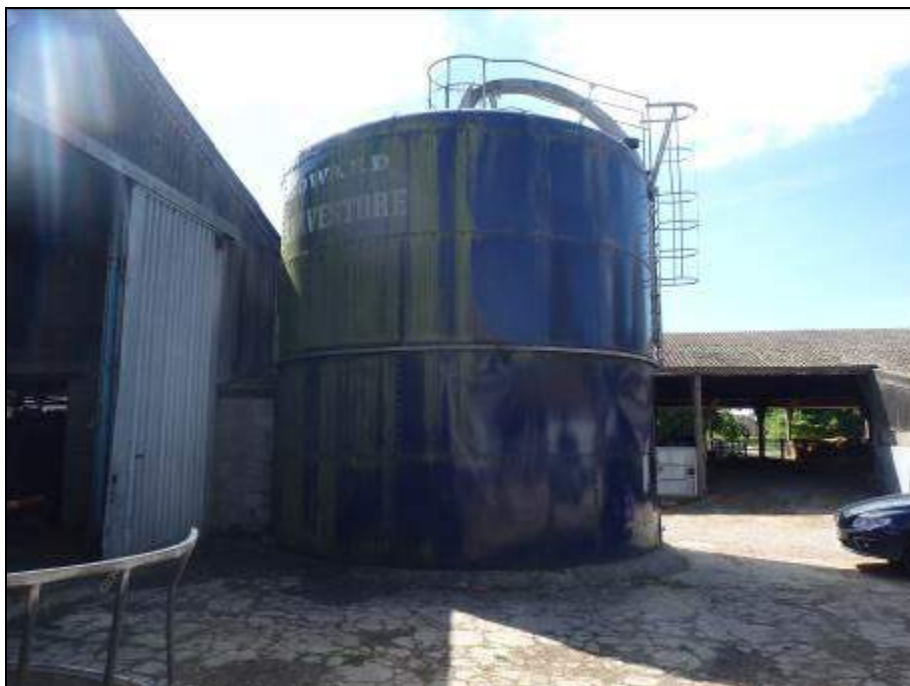
**Photograph 9**      Showing the adjacent silo and hay barn

It is not expected for any of the subject building to have asbestos materials present, nor to have had asbestos materials present previously. It is however noted that the hay barn that abuts the southeastern corner of the eastern section of the building has been clad with presumed cement-bonded asbestos panelling.

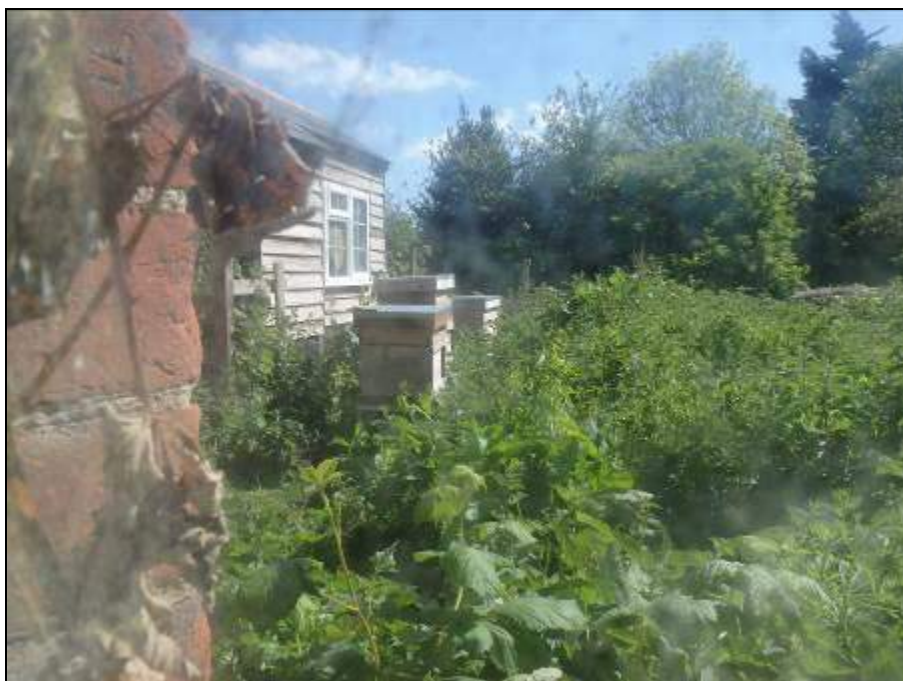
**Photograph 10**      Showing the proposed garden area
