## **Staunton Country Park**

### **Removal of derelict structure**

### **Building recording and analysis**

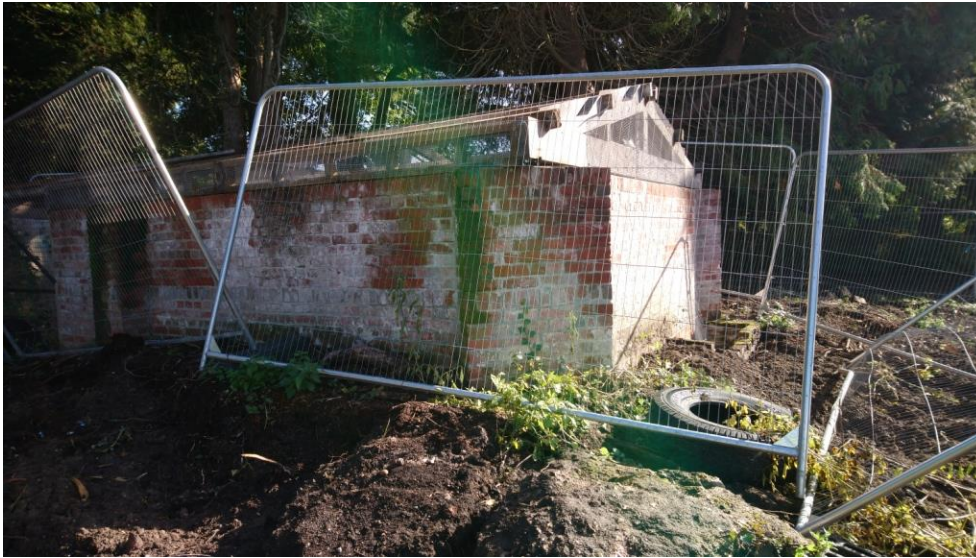
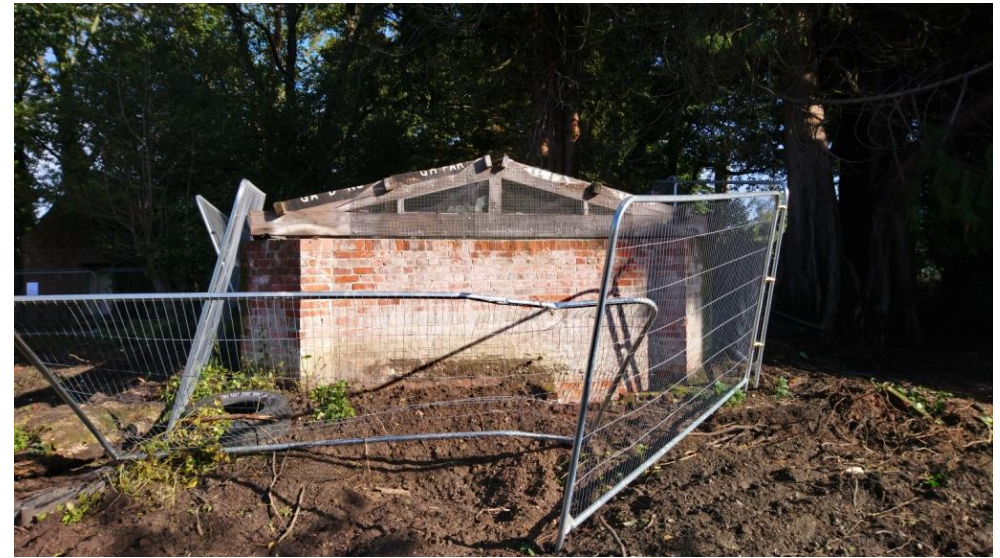
Recent works to remove vegetation has exposed a building thought to have been used as a water storage structure as part of the mansion, built in the 1860's following the purchase of the estate by W.H. Stone.

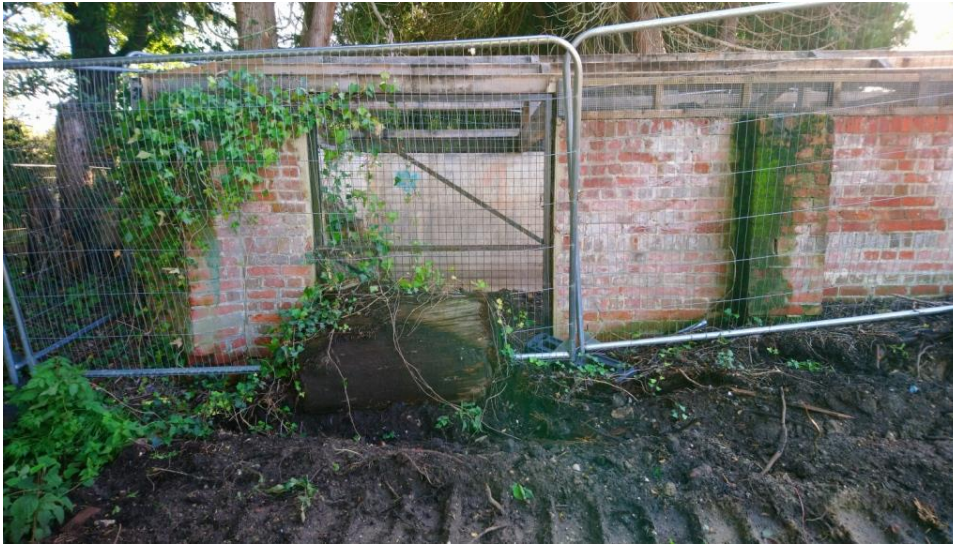
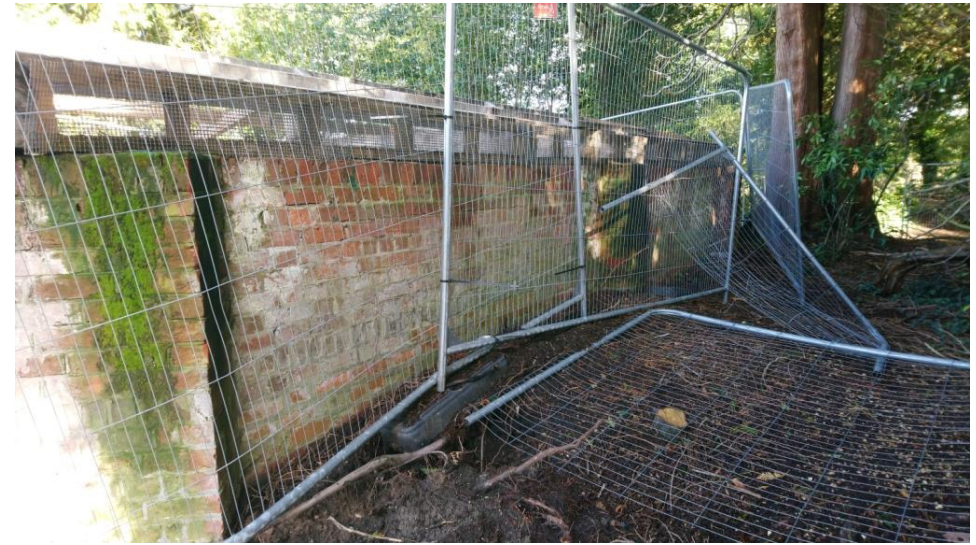
The external wall is constructed in a 1 ½ brick masonry English bond, and finished internally with a render, to create a water storage tank. The external walls are strengthened by brickwork piers on each corner and a mid span pier on the long elevations. There is a large opening in one wall. The jambs have been faced up with mortar which would suggest that it was not part of the original structure.

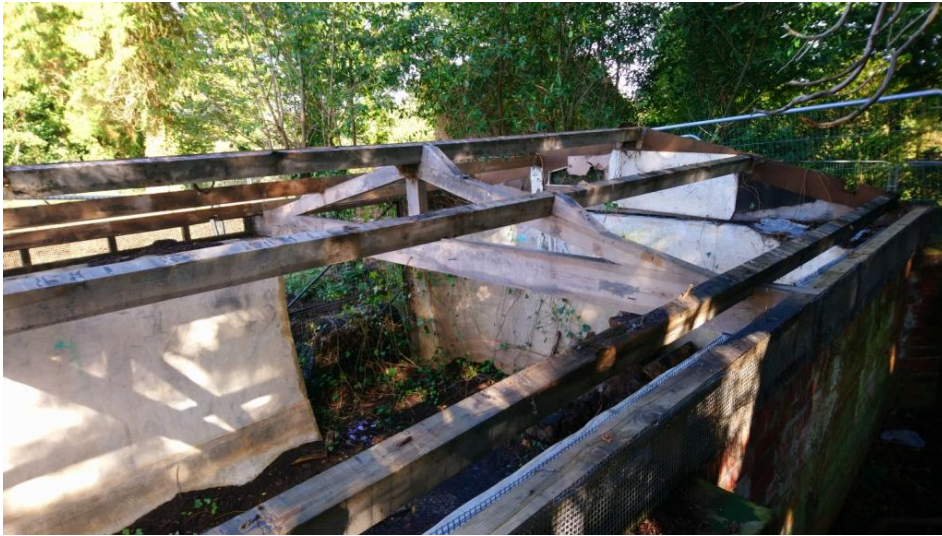
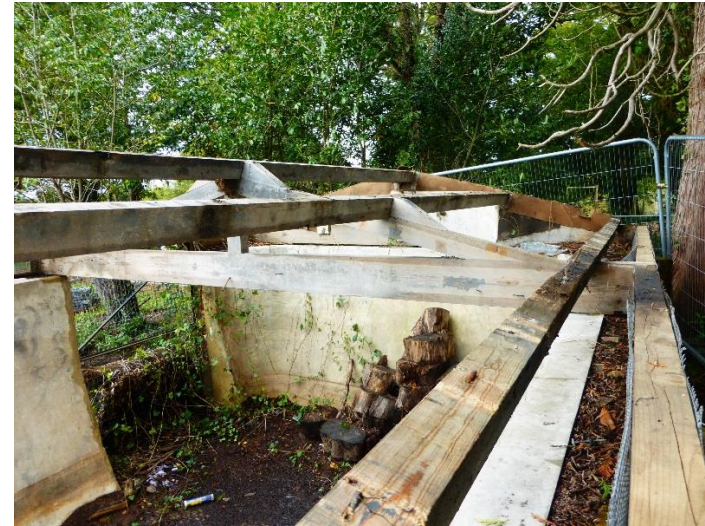
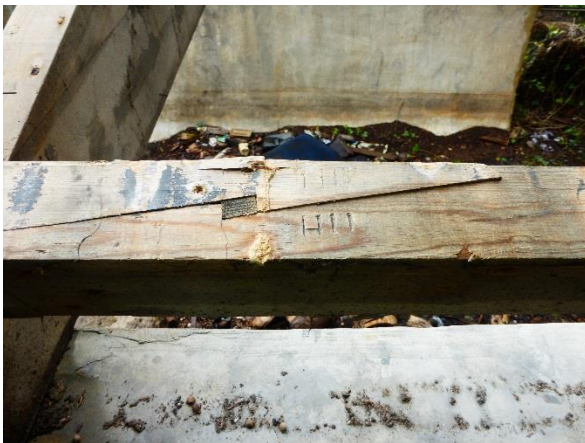
The roof covering has been removed. Until recently it did have a corrugated metal sheet covering, which was stripped over a weekend. The structure consists of several low pitch timber trusses and purlins. There are some interesting carpenters marks where spliced joints were made.

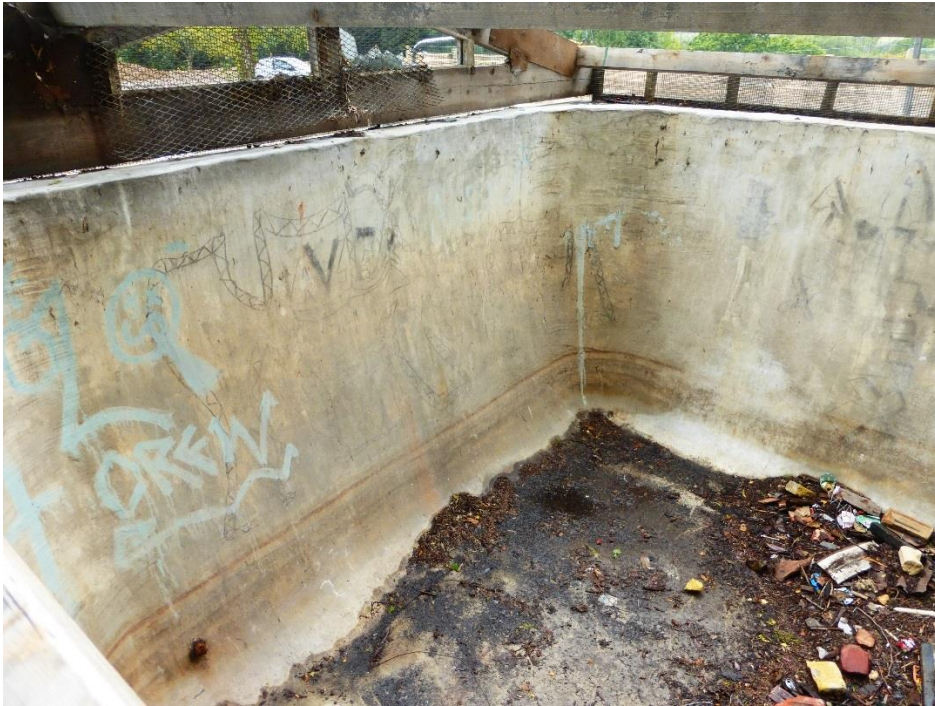
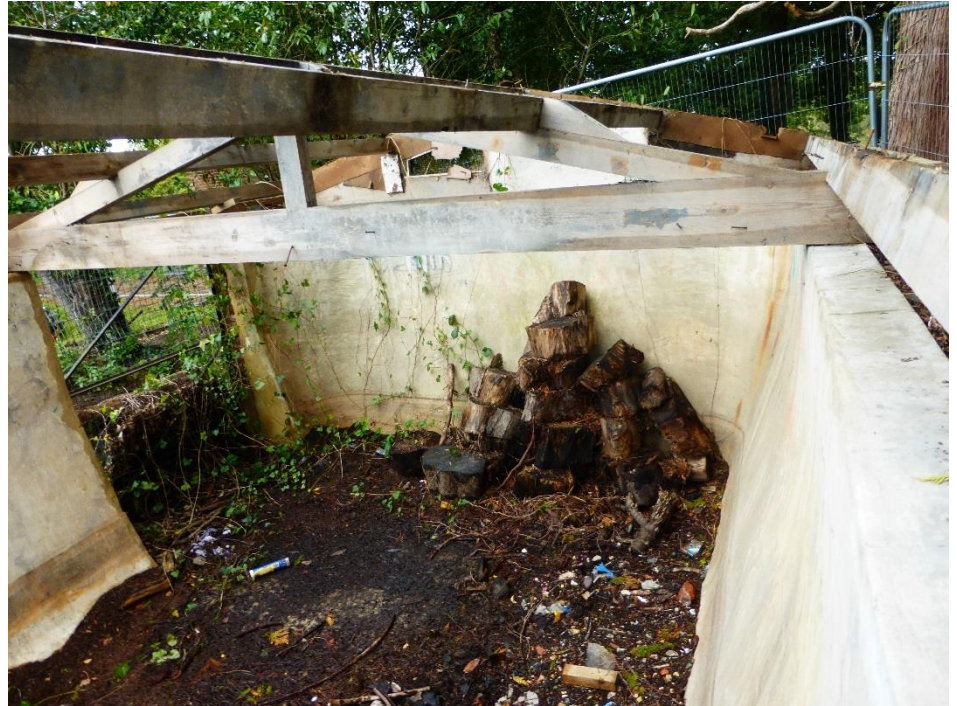
Internally the walls have a render finish with exaggerated formed coved corner details typical for a water storage structure.
