Site: The Manor, Edward Gardens, Bedhampton  
 Date Visited: 27 November 2018  
 Date Prepared: 04 12 2018  
 Area of Work: Rear S/S Bay

#### Bay to East Elevation

#### Schedule of Emergency Works:

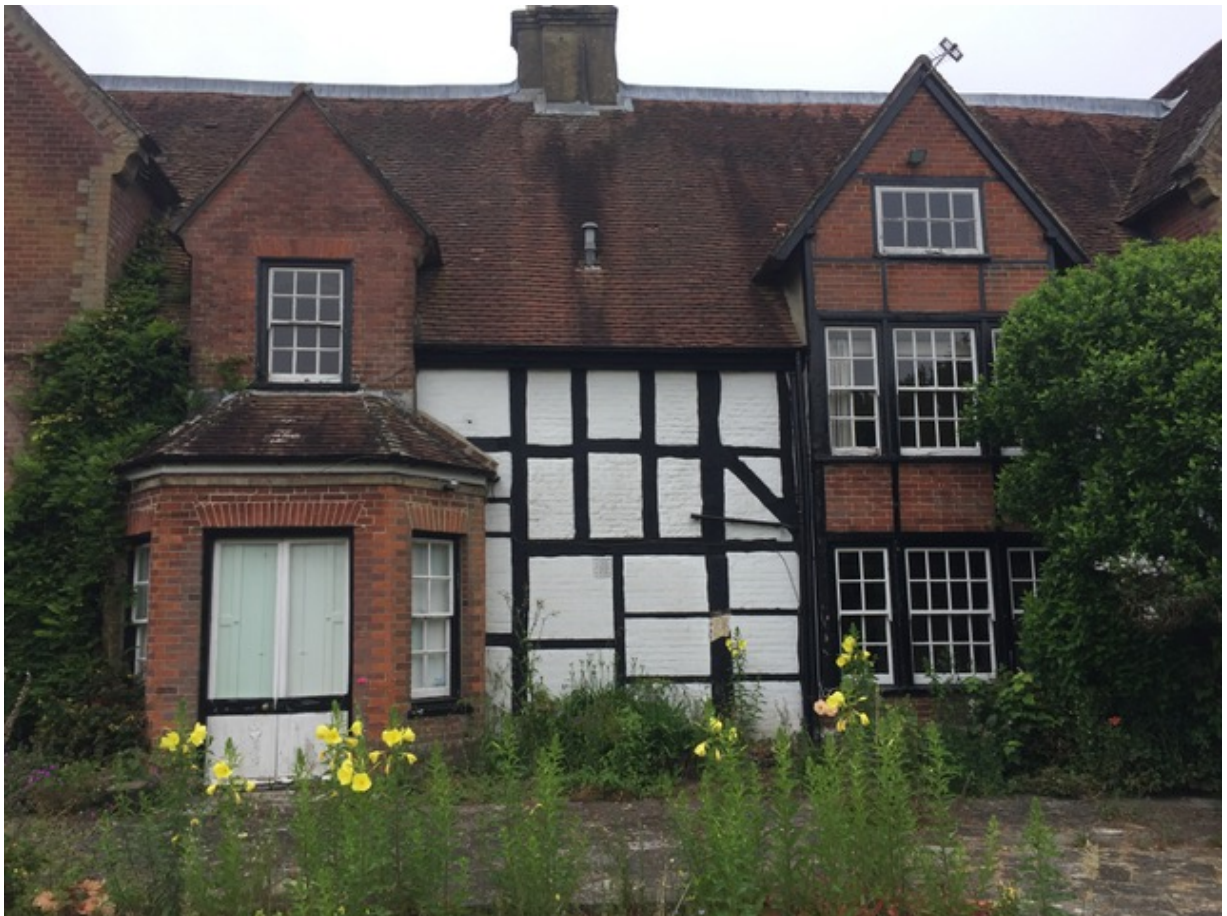
*Before with roof on showing signs of failure of flashing, bonnets and delamination of tiles*

| A1. | Introduce new rafters |
| | <ul style="list-style-type: none"> <li>Inspect removed timber rafters to ascertain type and size.</li> <li>Obtain new rafters to match existing in terms of type, grain and moisture content.</li> <li>Replicate existing joining detail – notched and nailed to wall plate of bay. Reinforce as necessary with forged steel straps connecting plate and rafter as necessary.</li> <li>Form hipped ends with jack rafter to replicate former detail.</li> </ul> |
| A2. | Reinstatement of Roof Covering |
| | <ul style="list-style-type: none"> <li>Lay TLX Gold Insulating Breather membrane single layer loosely draped over rafters, no increase in ridge height</li> <li>New 25 x 38mm (or similar and approved) softwood battens applied over top of membrane spaced to suit gauging of tiled covering</li> <li>Relay salvaged existing plain roof tiles</li> <li>Where required, additional plain tiles shall match the existing in terms of colour, tone, texture and size.</li> <li>New tiles to be randomly mixed in with the existing tiles.</li> <li>Finish dry verge in lime mortar comprising 1:3 NHL3.5 : Evenly grade washed sharp sand (not marine)</li> <li>Bed ridge tiles in lime mortar NHL3.5 : Evenly grade washed sharp sand (not marine)</li> <li>Reinstate finial to match existing, bed in lime mortar NHL3.5 : Evenly grade washed sharp sand (not marine)</li> <li>Provide Code 4 / 5 Flashing at junction with main elevation, laid in accordance with the recommendations of the Lead Sheet Association</li> <li>Prior to laying lead coat the underside with patination oil to prevent underside lead corrosion.</li> <li>Where the roof slope are situated on exposed elevations, fix</li> </ul> |

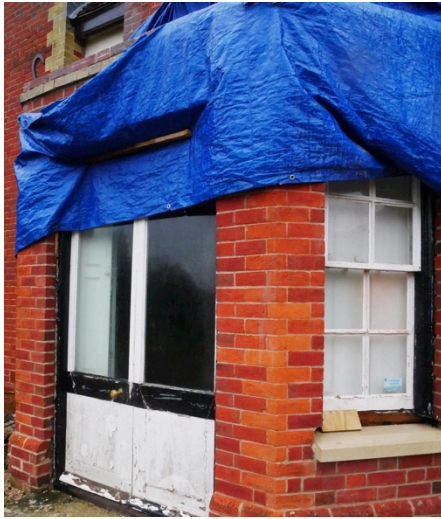
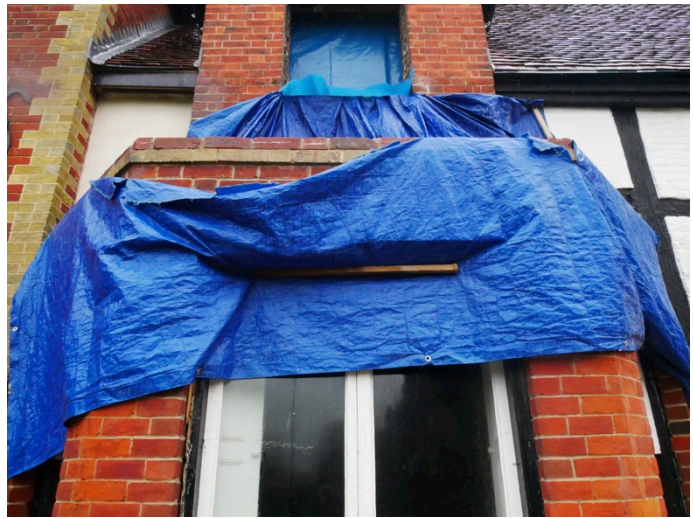
*As seen on 27th November 2018.*
