### South Internal Elevation: Post Fire Damage

The Old Brewery, 15E South Street, Havant, PO9 1BU

19008-615<sup>0</sup>

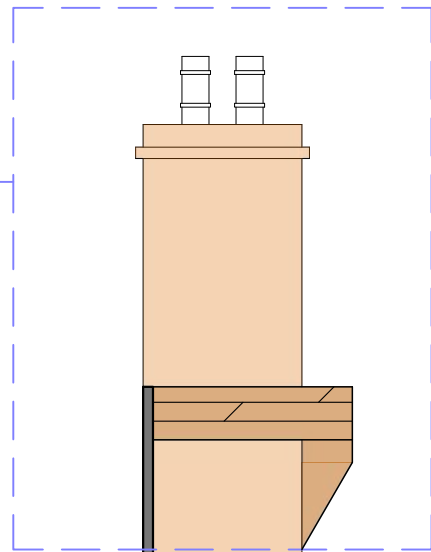
- ① 75mm brickwork
- ② Concrete dwarf wall remnants.
- ③ Rat Trap boundary wall
- ④ Single skin brickwork
- ⑤ Chimney remnants
- ⑥ All timbers approximately 50% charred.
