Site: The Manor, Edward Gardens, Bedhampton  
 Date Visited: 27 November 2018  
 Date Prepared: 04 12 2018  
 Area of Work: Later Extension to NW

#### Later Extension

#### Schedule of Emergency Works:

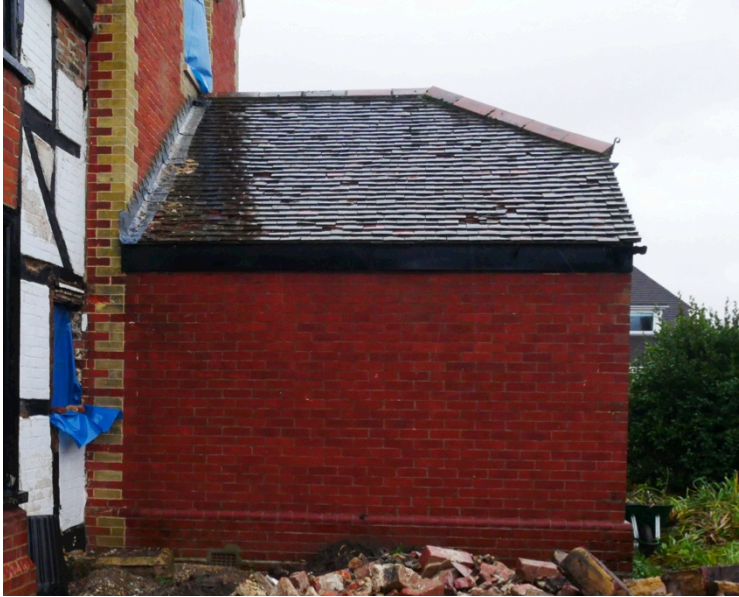
*Extension to rear – southern roof slope with broken , missing and delaminated tiles.*

| A1 | Stripping of Roof |
| | <ul style="list-style-type: none"> <li>All roof tile, ridge and hip tiles of sound condition to be set aside and stored securely on site off of the ground and protected from the natural elements.</li> <li>Any defective tiles to be removed from site.</li> <li>Strip off all existing battens and remove from site.</li> <li>Strip off any existing felt / breather membrane and remove from site</li> </ul> |
| A2. | Renew Roof Covering |
| | <ul style="list-style-type: none"> <li>Lay TLX Gold Insulating Breather membrane single layer loosely draped over rafters, no increase in ridge height</li> </ul> |

| | <ul style="list-style-type: none"> <li>• New 25 x 38mm (or similar and approved) softwood battens applied over top of membrane spaced to suit gauging of tiled covering</li> <li>• Relay salvaged existing plain roof, ridge and hip tiles</li> <li>• Where required, additional roof, ridge and hip tiles shall match the existing in terms of colour, tone, texture and size.</li> <li>• New roof tiles to be randomly mixed in with the existing tiles.</li> <li>• Bed ridge and hip tiles in mortar to match the existing. Use evenly grade washed sharp sand (not marine)</li> <li>• Provide Code 4 / 5 Flashing at junction with main elevation on tile joint, laid in accordance with the recommendations of the Lead Sheet Association</li> <li>• Prior to laying lead coat the underside with patination oil to prevent underside lead corrosion.</li> <li>• Where the roof slope is situated on exposed elevations, fix undercloak onto battens prior to laying of tiles and place end in gutter to prevent splashback.</li> <li>• Renew fascia boards and paint back as existing</li> </ul> |

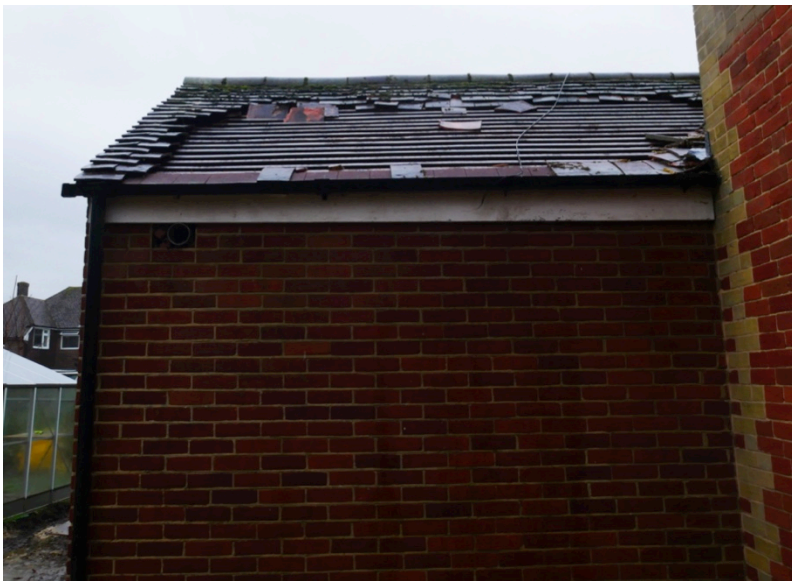
*Extension to rear – southern roof slope with broken , missing and delaminated tiles. Exposed NW side with partially stripped roof slope.*
