## Heritage Statement include DAS

The Manor House,  
Edward Gardens,  
Bedhampton  
Havant

April 2019

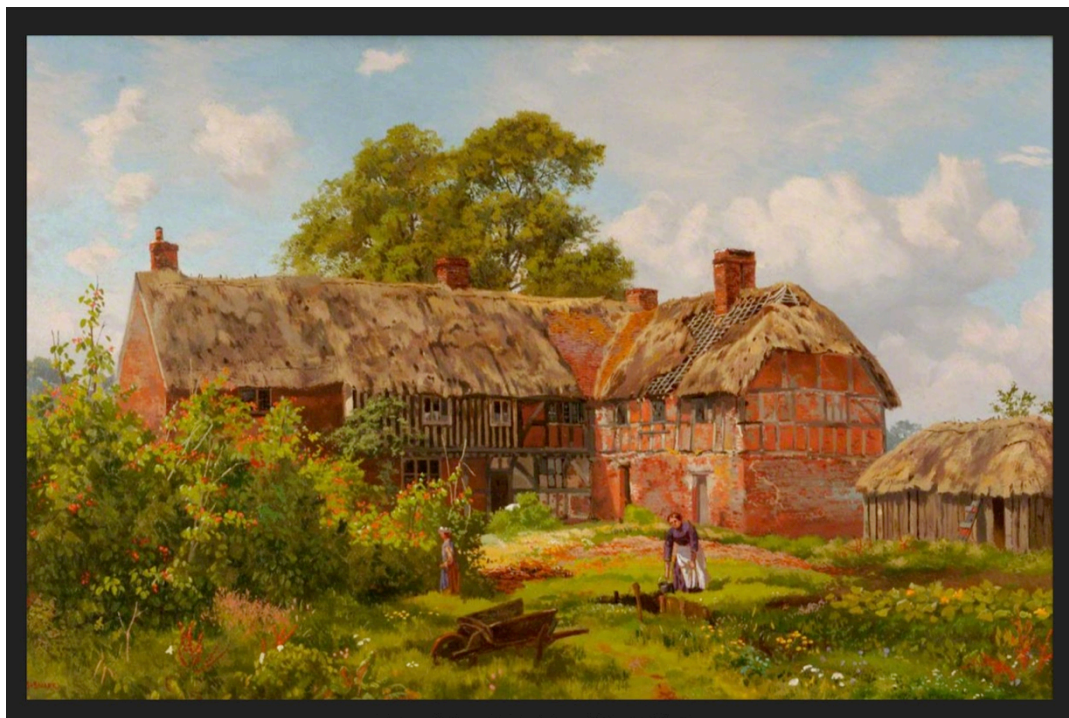
Figure 1 - Incorrectly referred as 'The Old Manor House' by M Snape (1853 - 1930) engraving after sketch by M. Snape (*Papers and proceedings of the Hampshire Field Club*, vol. II (1892), opposite page 253)

- 2.4 The Manor House is a large details house with an historic core, indicated as dating from 16<sup>th</sup> century. It has been altered and extended over time, particularly in the mid 19<sup>th</sup> century and during the 20<sup>th</sup> century when it was converted to a nursing home. The history of the building is also difficult to research for 19<sup>th</sup> century. It is understood that the building painted by M. Snape (after a sketch of 1876) called 'Old Manor House' relates to the old L-shaped timber framed building that was located to the south of Bidbury Mead and Bidbury Lane, which later became the Old Poorhouse on the first edition OS Map. The name of the 'Old Manor House' does not appear in any other sources, and it likely to be an error.

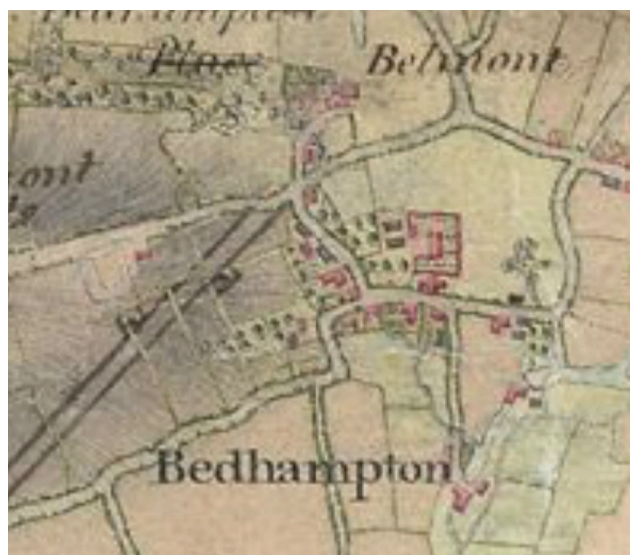
Figure 2 - 1797 Pen and Ink map showing The Manor House (Source: NLS)

- 2.8 The 1797 'pen and ink' map does not assist in the regression exercise. It shows a strong rectangular form, with a north-south orientation and a contained planted garden which appears to separate it from the surrounding lands. There are buildings to the west of the main house and the church is clearly notable to the south.

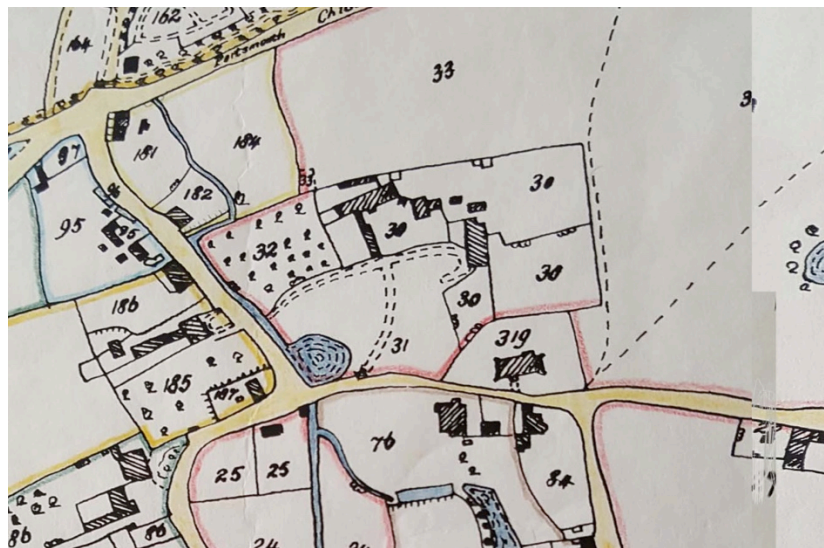
Figure 3 - 1825 mapping (Source: BHT)

- 2.9 The 1825 mapping clearly shows the house with a number of buildings that resemble a farmyard grouping. There appears to be a distinction between parcels of land associated with the house and that associated with the farm and orchard. At this time, the west elevation of the house is clearly flush with no suggestion of a porch being present. However scarring to the concealed face of the building suggests that the current porch is the third and larger than the previous two. It is therefore considered that for a building of status, the main entrance door would have had a porch of sorts, be that a simple flat projecting canopy or as seen in the scar marks, a narrower span of a pitched roof. The northern side of the building is stepped in its footprint suggesting the possibility of an extension to this side. There is no evidence of the buildings to the north and northwest today and this area has been redeveloped to accommodate 20<sup>th</sup> century housing. From this map it is assumed that the main entrance to the house was to the west side where the two tracks converge before continuing up to and continuing past the west elevation of the house.

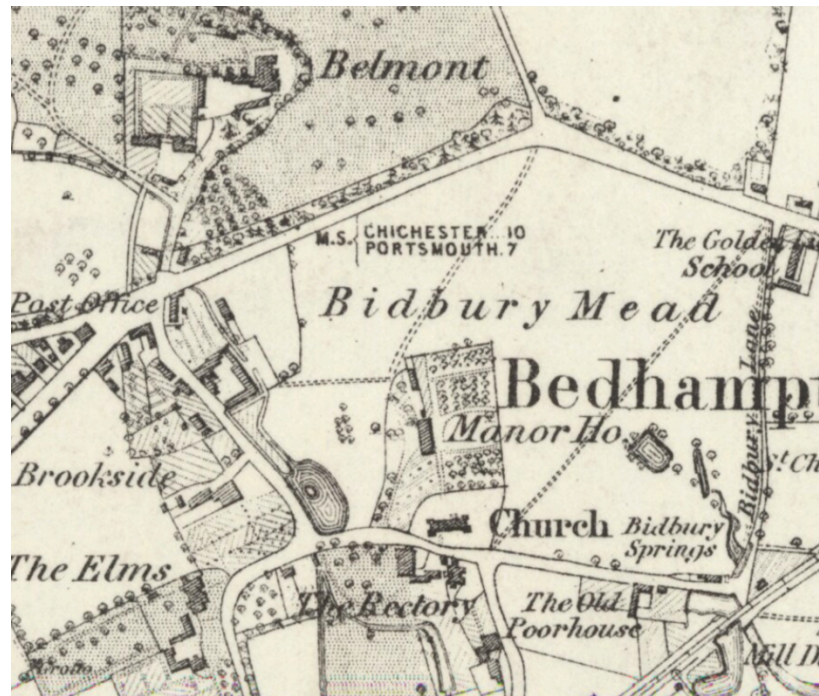
Figure 5 - 1870 OS mapping, surveyed 1859-69 (Source: NLS)

- 2.14 Mapping dating from surveys carried out during 1859 to 1866, published in 1870 reveals a more regular form than the 1825 mapping but this is likely to reflect further alteration and/or extension to the plan form to the north side. Fig. 5 shows the planted gardens to the rear of the Manor House. The main drive now leads off Bidbury Lane, with a more formal 'swell' in front of the west elevation to the Manor House. Two detached buildings sit to the north, one further away. The

formal arrangement of the gardens is clearly noted. As Bidbury Meads encircles the Manor House, it is considered that these lands were used for agriculture. This is not to say that lands elsewhere were part of the agricultural holding.
