**THE LODGE, OLD BEDHAMPTON,  
HAMPSHIRE**

**PRELIMINARY BAT ROOST  
ASSESSMENT**

Report No: RT-MME-128692-02

Date: August 2018

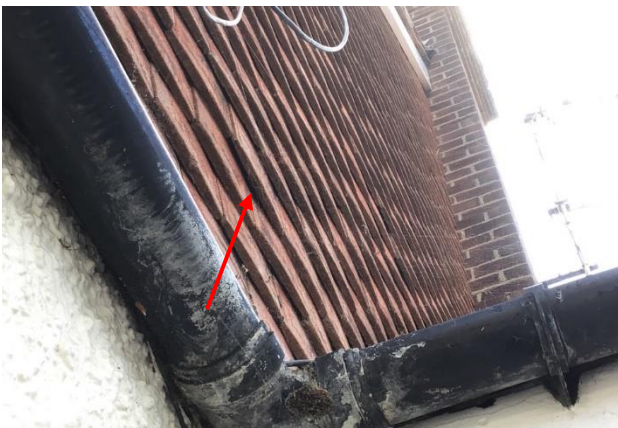
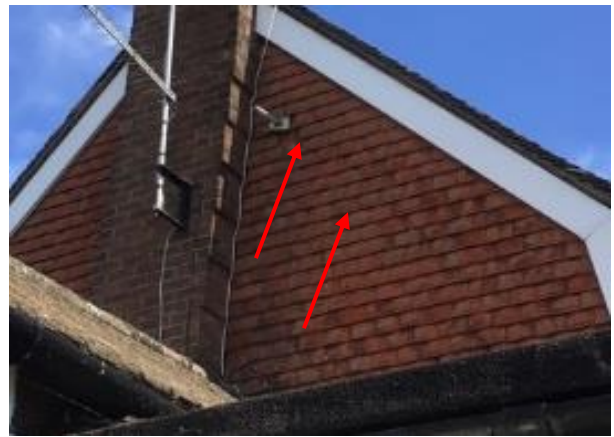
Plate 4.3: Gaps under hanging tiles

- Gaps under hanging tiles (Plates 4.3 and 4.4);
- Missing, lifted or warped roof tiles (Plates 4.5 and 4.6);
- Lifted lead flashing on the roof (Plates 4.7 and 4.8);
- Gaps between the wall and soffit box (Plates 4.9 and 4.10);
- Gaps at the eaves (Plate 4.11);
- Gaps between the plastic fascia and hanging tiles (Plate 4.12);
- Gaps between the wooden fascia and wall.
- Gaps in the wall where part of the building was demolished, appearing to lead into a cavity wall (Plate 4.13);
- Gap between wall and wooden fascia (Plate 4.14); and,
- Gaps between weatherboarding and roof (Plate 4.15).

Plate 4.4: Gaps under hanging tiles

It was not possible to inspect the above features due to the height at which they were located and as such it was not possible to establish if bats had used these features to enter a roost location at the time of surveying. No evidence of roosting bats, e.g. droppings, urine staining, feeding remains or scratch marks, was recorded within the features that could be fully inspected during the survey.

Both the main building and the separate garage building have been identified as having high potential to support roosting bats. Bat Surveys: Good Practice Guidelines published by the Bat Conservation Trust (Collins, 2016) recommends that for structures with high bat roosting potential at least three dusk emergence and/or dawn re-entry surveys be undertaken during the bat emergence/re-entry survey season to determine the presence/absence of roosting bats within the structures. The bat emergence/re-entry survey season extends from May to September. At least two of the surveys should be undertaken during the peak season for emergence/re-entry surveys between May and August and one of the three surveys should be a dawn re-entry survey. If a roost is discovered during these surveys, a Natural England licence application may be required.

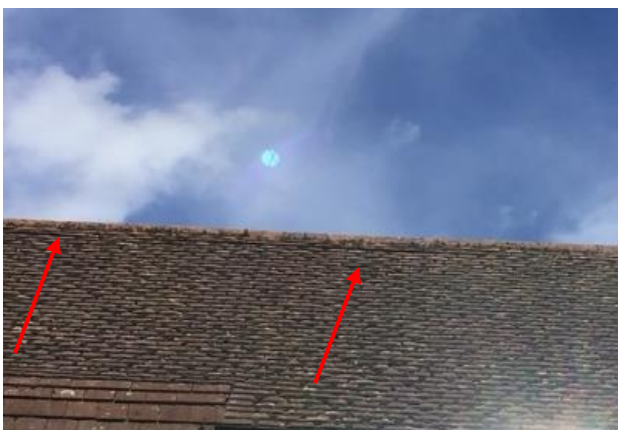
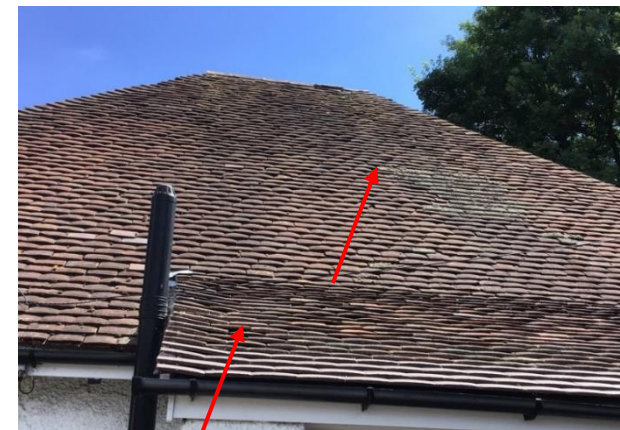
Plate 4.5: Gaps under roof tiles

Plate 4.6: Gaps under roof tiles

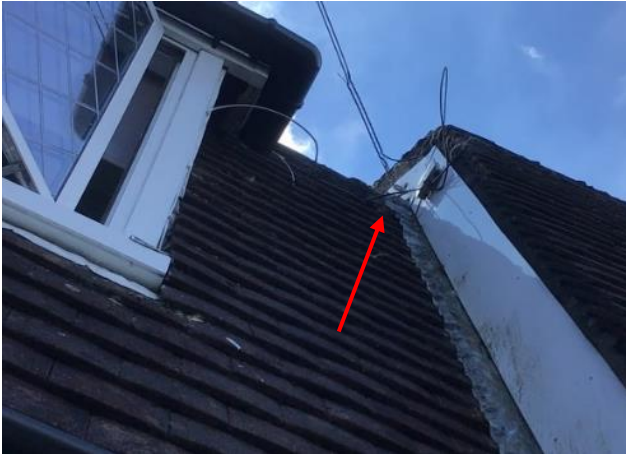
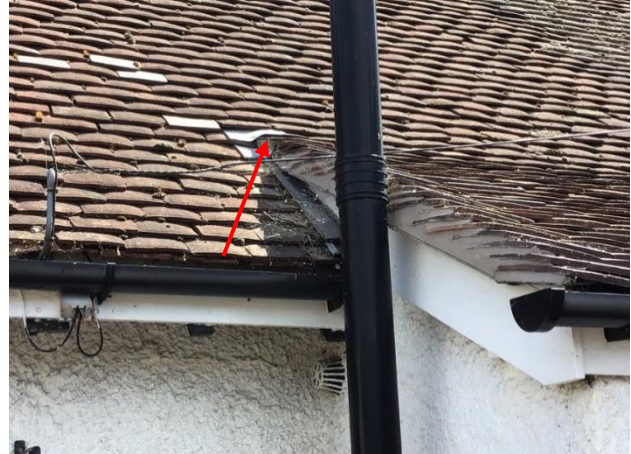
**Plate 4.7: Lifted lead flashing**

**Plate 4.8: Lifted lead flashing**

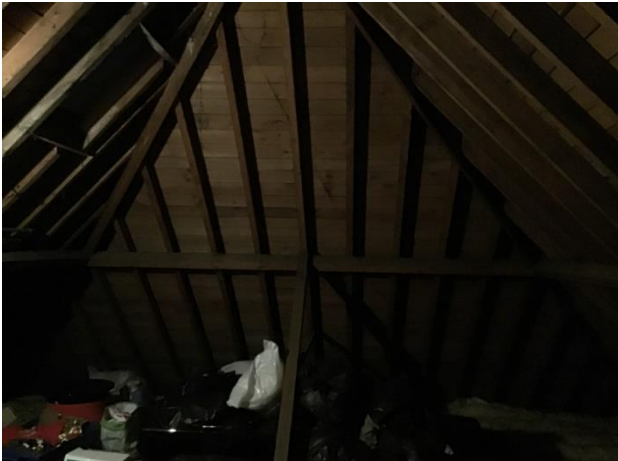
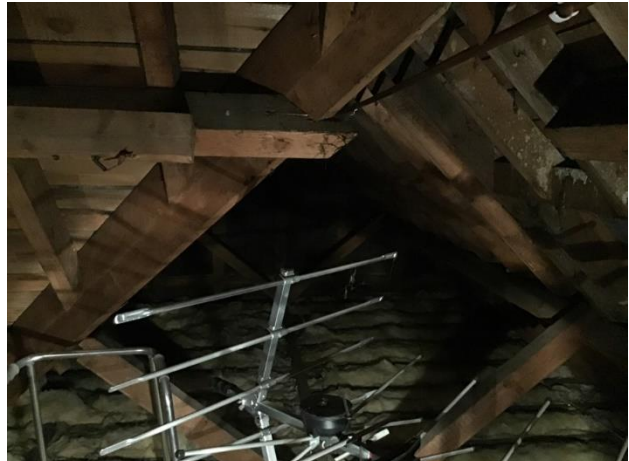
**Plate 4.16: Loft 1**

Loft 1 was approximately 3 m at the apex, 6 m wide and 19 m long (Plate 4.16). It was L-shaped, with the second section approximately 10 m long, 3 m wide and 1.7 m at the apex (Plate 4.17). The loft space was pitched and had a ridge beam (Plate 4.18), although the ridge beam was cobwebbed indicating it was currently not in use by bats. At the gable end of the loft space there was a tightly fitted asbestos board with no gaps (Plate 4.19). The loft space also had fibre glass insulation (Plate 4.20). Wooden boarding was present between the roof and rafters, and missing in places, exposing breathable membrane sarking (Plate 4.21).

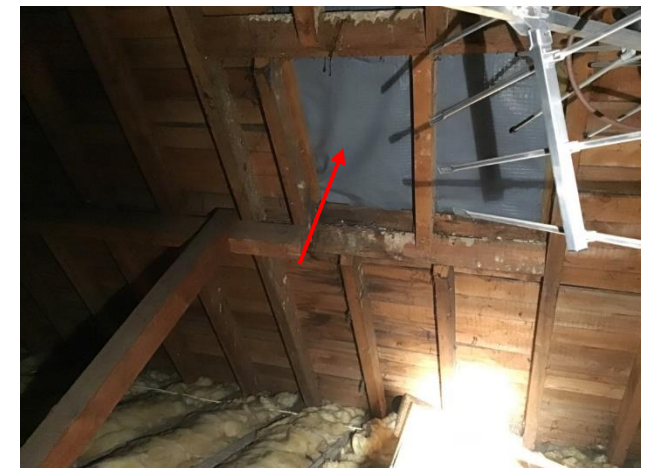
**Plate 4.21: Exposed breathable membrane**

It was not possible to fully inspect all features within the loft space - the area between the breathable membrane sarking and roof tiles, and behind the wooden boarding - and as such the bat roosting potential of this area could not be determined. Whilst no evidence of bats, e.g. droppings, urine staining, feeding remains or scratch marks, was recorded during the internal inspection of the building, not all areas could be fully assessed.

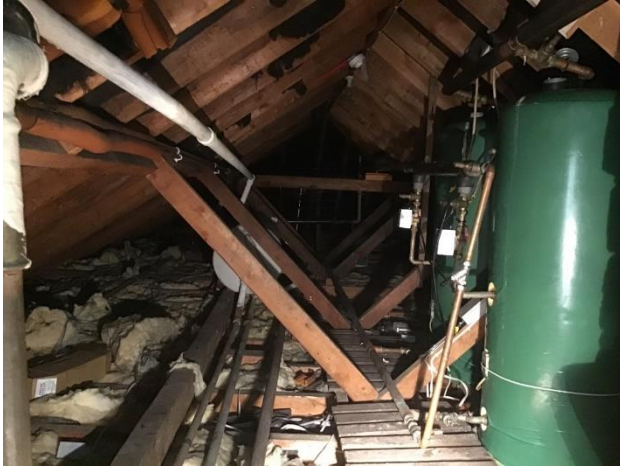
**Plate 4.22: Loft 2**

Loft 2 was situated above the single storey section of the building to the west of the bay conservatory. It was approximately 1.5 m high at the apex, 5 m wide and 10 m long (Plate 4.22). Breathable membrane sarking was ripped in places, exposing roof tiles (Plate 4.23). There was also damaged flint at the gable end (Plate 4.24).

Due to the presence of boilers and hot pipes in the loft, it was not possible to fully inspect this roof space. Furthermore, due to the extent of the crevice between the roof tiles and the breathable membrane, it was not possible to fully inspect this feature. As such, the bat roosting potential of this area could not be determined. Whilst no evidence of bats, e.g. droppings, urine staining, feeding remains or scratch marks, was recorded during the internal inspection of the building, not all areas could be fully assessed.

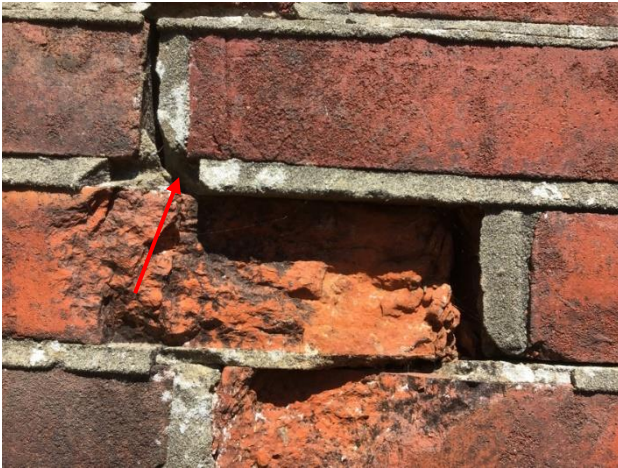
Plate 4.25: Damaged brickwork

- Damaged brickwork (Plate 4.25);
- Gaps between the ceiling and wall at the back of the garage (Plate 4.26);
- Gaps around the doorway (Plate 4.27); and
- Gaps around wooden window frames (Plate 4.29).

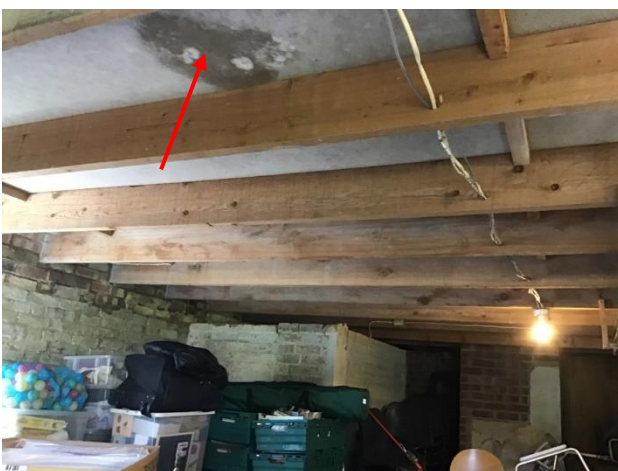
Plate 4.29: False ceiling

Internal assessment revealed what appeared to be a false ceiling (Plate 4.29). There were also gaps between the wall and the ceiling (Plate 4.30). no access was possible into the false ceiling and the gaps between the ceiling and the wall were heavily cobwebbed, indicating no recent use by bats or other fauna.

Due to potential presence of the false ceiling, full internal inspection was not possible. As such, the bat roosting potential of this area could not be determined. Whilst no evidence of bats, e.g. droppings, urine staining, feeding remains or scratch marks, was recorded during the internal inspection of the building, not all areas could be fully assessed.

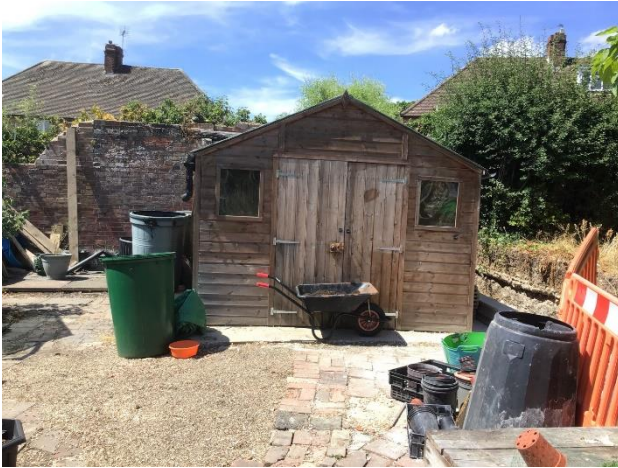
Plate 4.31: Shed

The site also had a single storey wooden shed with a pitched bitumen roof (Plate 4.31). The building was fully inspected internally and externally, and no features were identified that would be suitable for roosting bats, nor was any evidence of bat activity recorded.

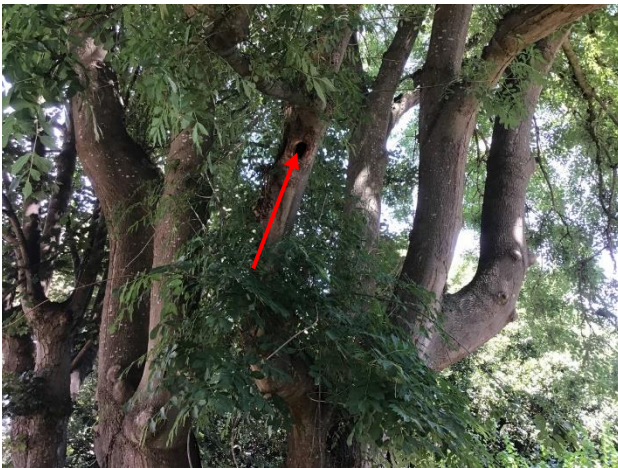
Plate 4.32: Rot hole

Numerous scattered trees were present on site. An ash *Fraxinus excelsior* tree (T1) located along the eastern boundary of the site had multiple knot holes that did not appear to extend into a crevice and a rot hole on one of the south facing limbs that extended into a crevice (Plate 4.32). Due to location of this rot hole it was not possible to fully inspect it.

An ash tree (T1) was identified as having high roosting potential for bats due to a rot hole extending into a crevice. Due to its location, this feature could not be fully inspected during the preliminary assessment and as such further survey work have been recommended in Chapter 6.

Due to the extent of the rot hole leading to a cavity, the tree cannot be fully assessed using an endoscope, and as such, to determine the presence/absence of roosting bats within the tree/s, further survey work is required in the form of nocturnal emergence and dawn re-entry surveys.

Bat Survey: Good Practice Guidelines published by the Bat Conservation Trust (Collins, 2016) recommends that for trees with high bat roosting potential at least three nocturnal emergence and/or dawn re-entry surveys be undertaken during the bat activity season to determine the presence/absence of roosting bats within the tree. The bat activity season extends from May to September. At least one of the surveys should be a dawn re-entry survey, and at least two of the surveys should be undertaken between May and August. If a roost is discovered during these surveys, a Natural England licence application may be required.

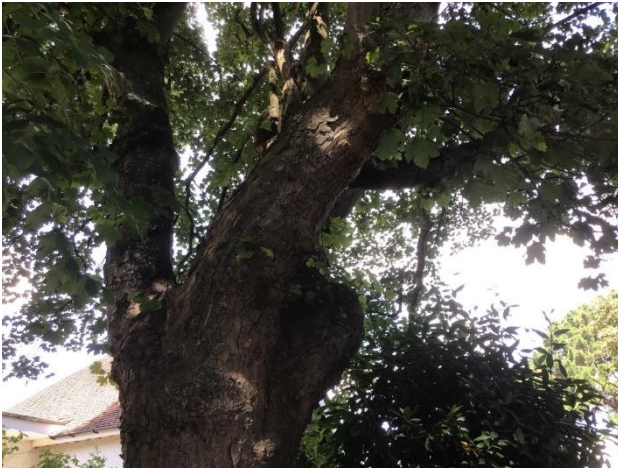
**Plate 4.33: Tree T2**

A sycamore (T2), located along the eastern boundary of the site and magnolia *Magnolia sp.* tree (T3), located within the western section of the site, did not comprise any potential roosting features visible from the ground level, but were of age and size to support potential roosting features.

Trees T2 and T3 were considered to have low potential for roosting bats. The survey data obtained for the site is valid for 12 months from the survey date. If proposed site works have not commenced within this timeframe it will be essential to update the survey effort to establish if the trees have developed features that could be used by roosting bats in the interim. In the unlikely event that a bat is found during works to the trees all works must immediately cease and a suitably qualified ecologist should be contacted.
