**GEOTECHNICAL INTERPRETATIVE REPORT**

**PHASE 2 AREA, WOODCROFT FARM,**

**LOVEDEAN, HAMPSHIRE PO8 9QA**

**GRAINGER PLC**

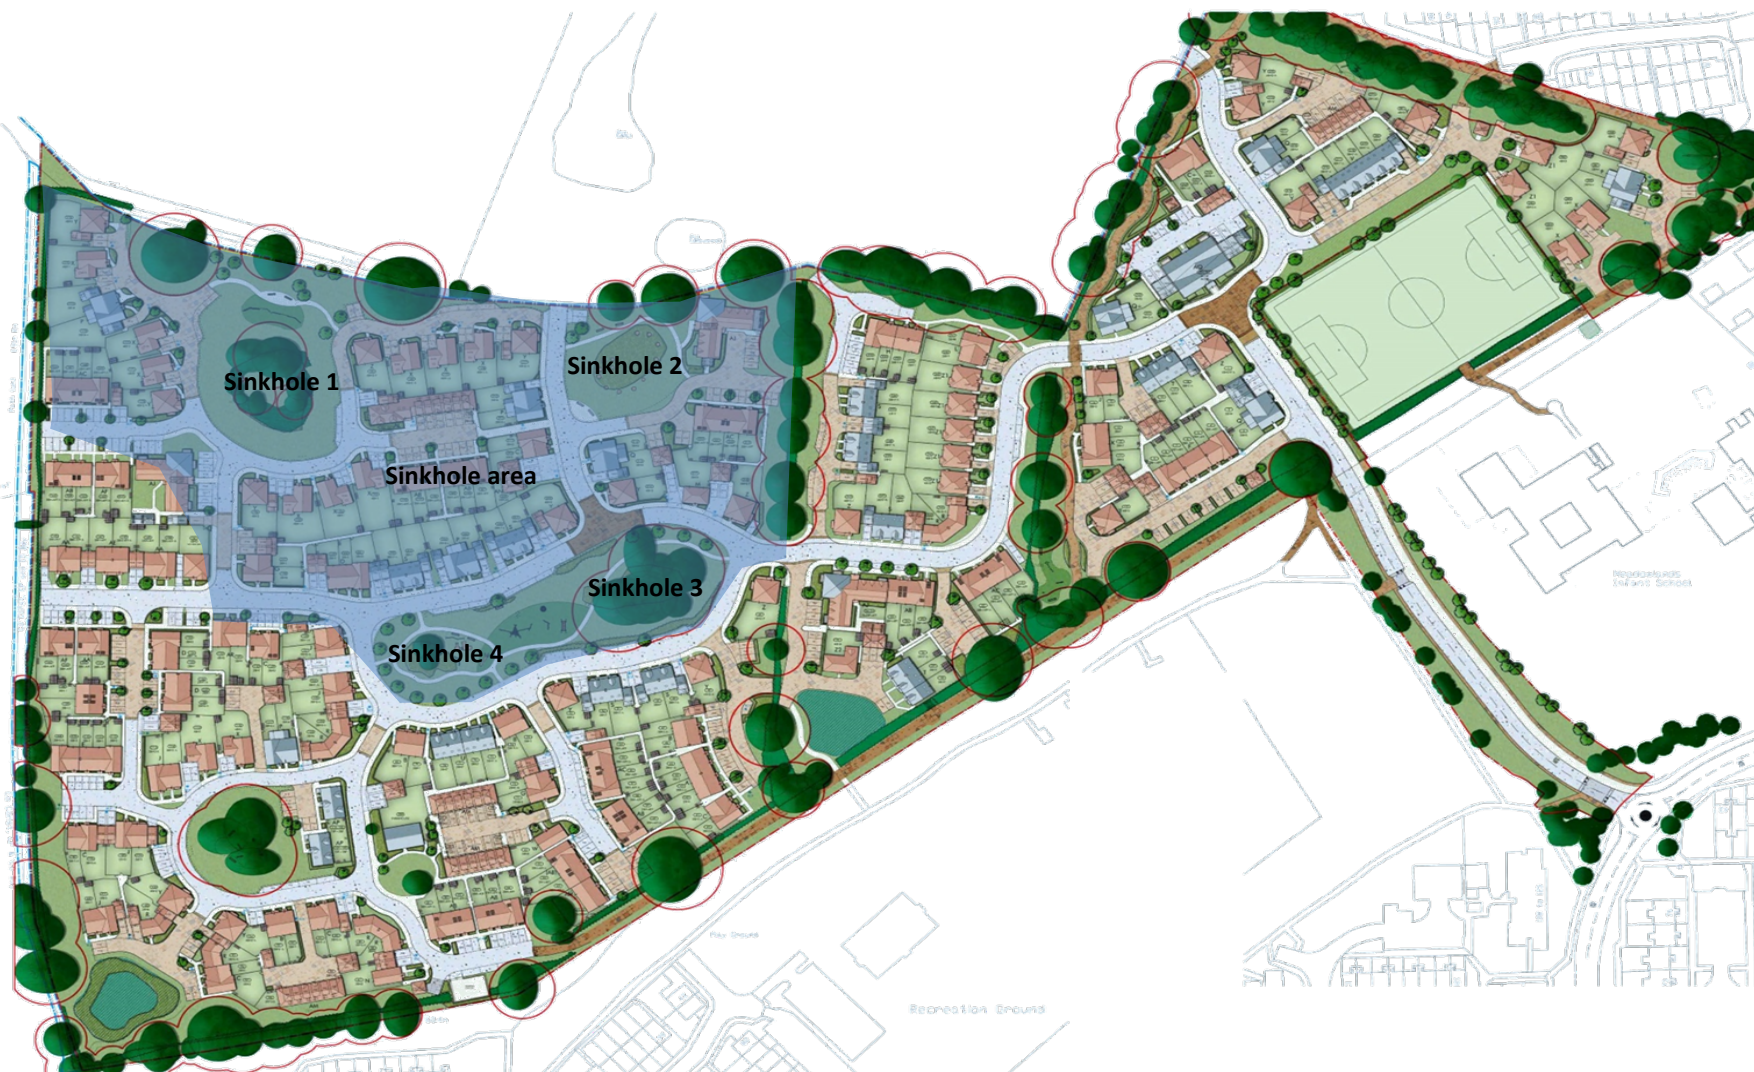
| <b>Project:</b> | Woodcroft Farm, Lovedean, Hampshire | | | <b>Title</b> | Proposed Scheme Layout | |

The development layout incorporates retention of the four main sinkholes, i.e. Sinkholes 1 to 4 as referred to in the PBA reports, but includes development on the land between these features, i.e. on land where further solution features are suspected to be present and where there was limited information on variation in composition and condition of shallow strata, or clarification of the depth to the Chalk beneath the site.

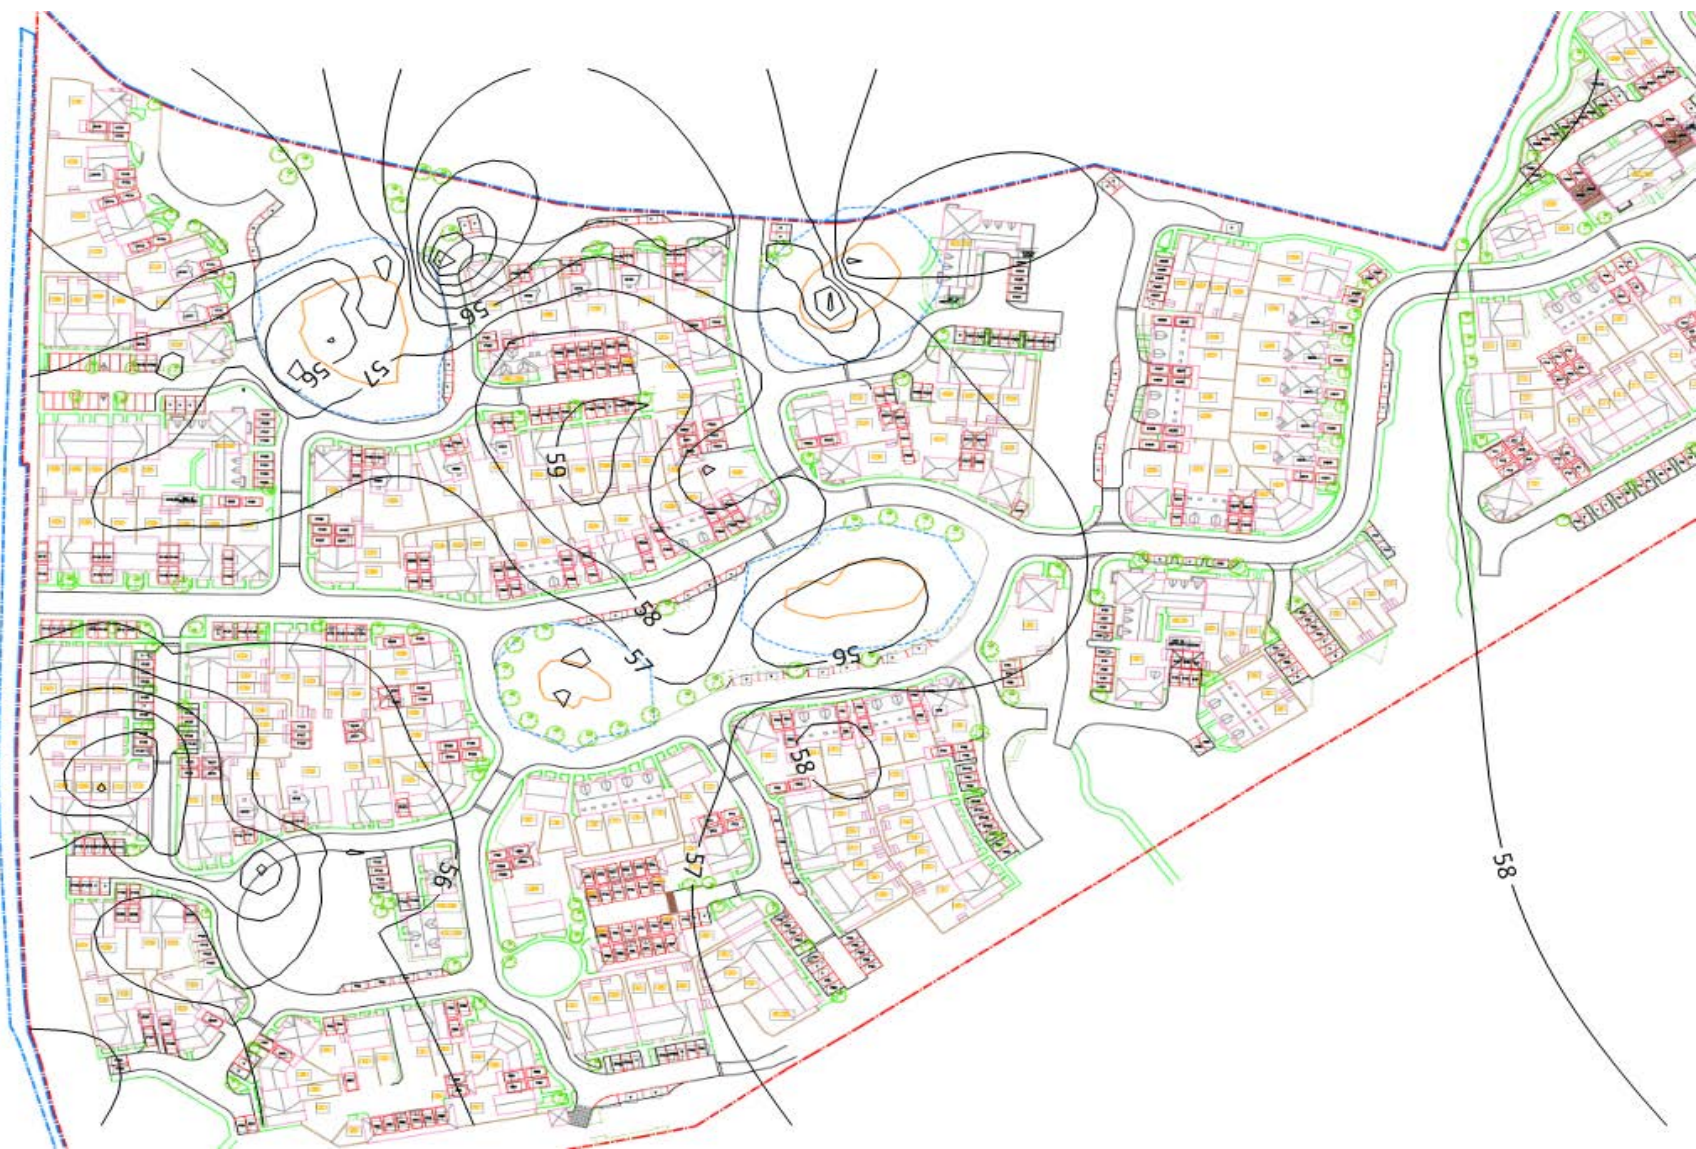
| <b>Figure:</b> 21 | <b>Scale:</b> Not To Scale | | |

| <b>Project:</b> Woodcroft Farm, Lovedean, Hampshire | | <b>Title</b> Chalk level contours on development layout | |

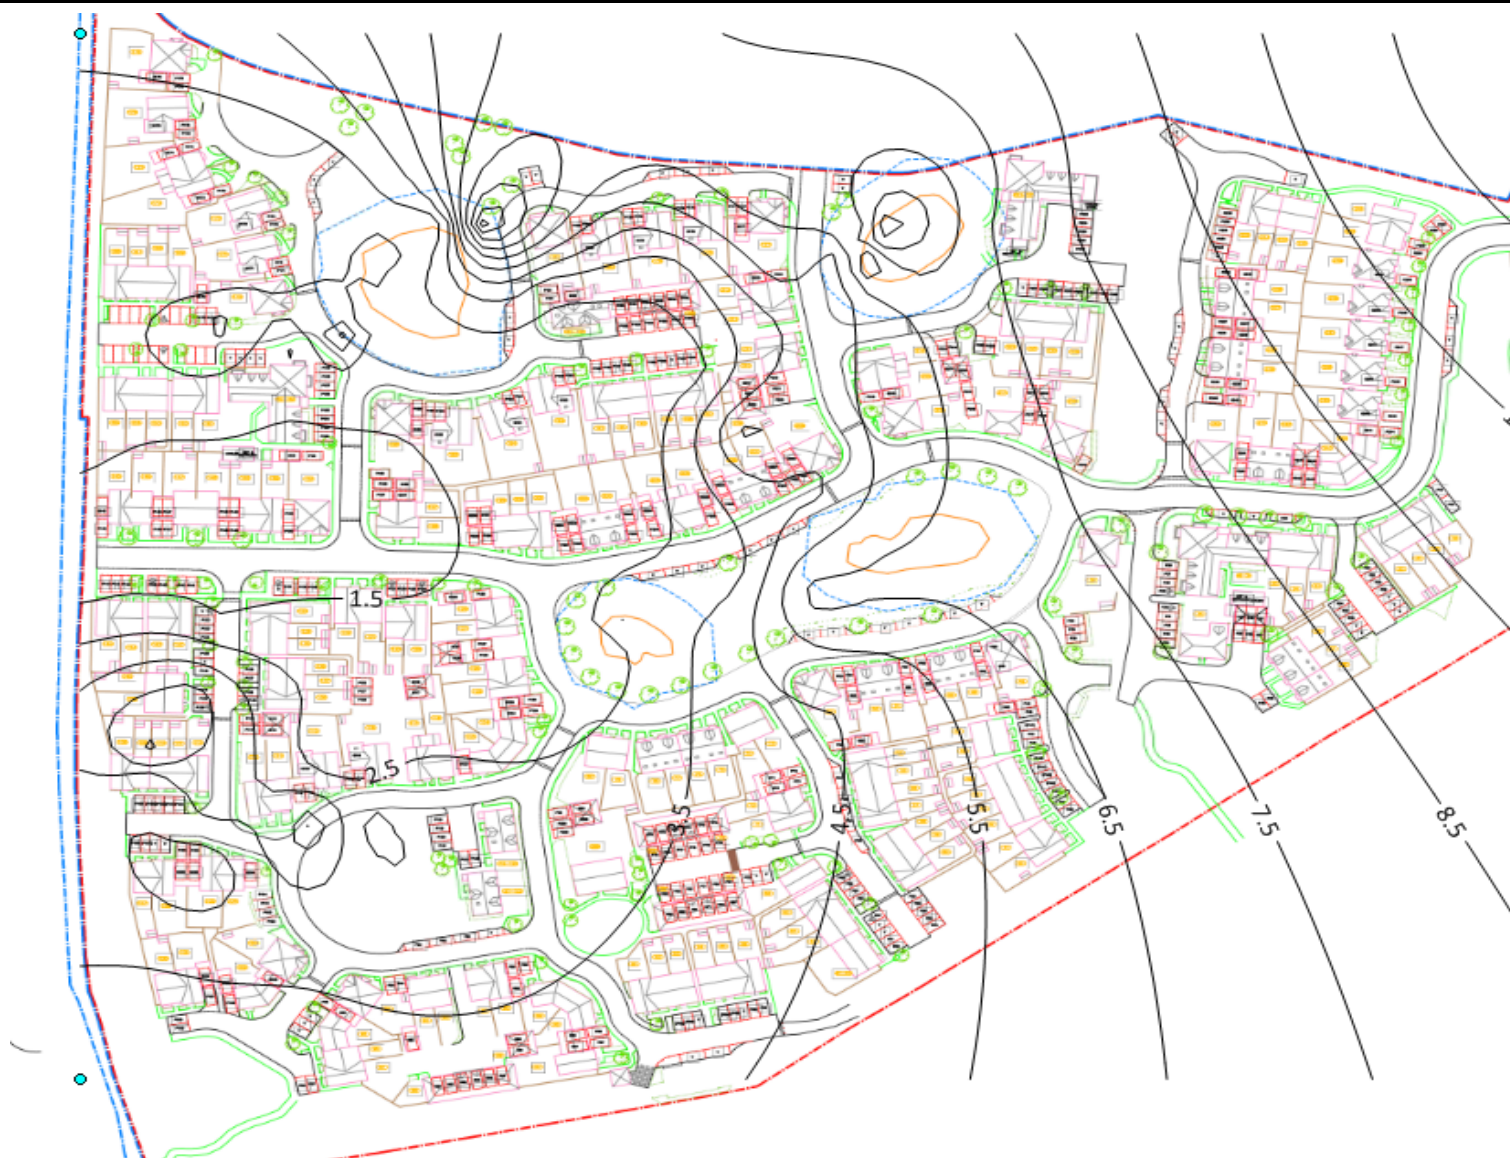
| <b>Project:</b> | Woodcroft Farm, Lovedean, Hampshire | | | <b>Title</b> | Depth to chalk on development layout | |
