**Waterloo Park, Waterlooville,  
Hampshire**

**PHASE ONE ENVIRONMENTAL DESK STUDY REPORT  
(PRELIMINARY RISK ASSESSMENT)**

Client: Hargreaves Properties Ltd

In15371 CL 003a

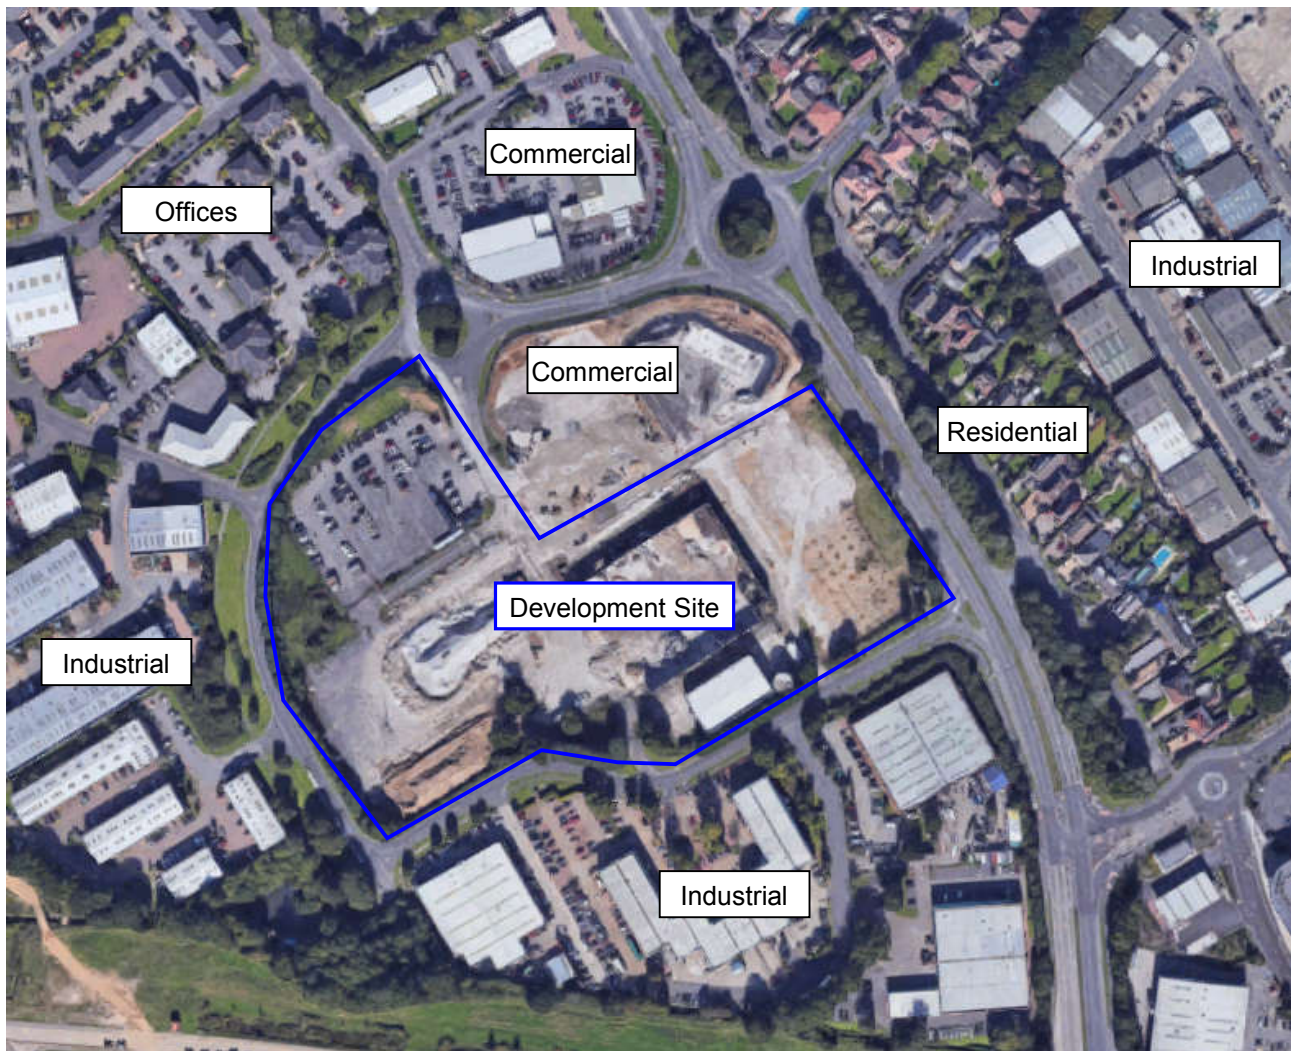
**Figure Two: Aerial; Photograph Showing Site Layout**

| Site Description | The site currently comprises empty plots of development land; forming the majority of the former BAE Systems site at Waterlooville. Former buildings and hardstanding have been demolished and removed. | | |
