**Phase I-II  
Geo-Environmental Site Assessment**

**Residential Development  
Lovedean Lane  
Waterlooville  
Hampshire  
PO8 9RN**

**Omnia ref: A10965/1.0 Draft  
July 2018**

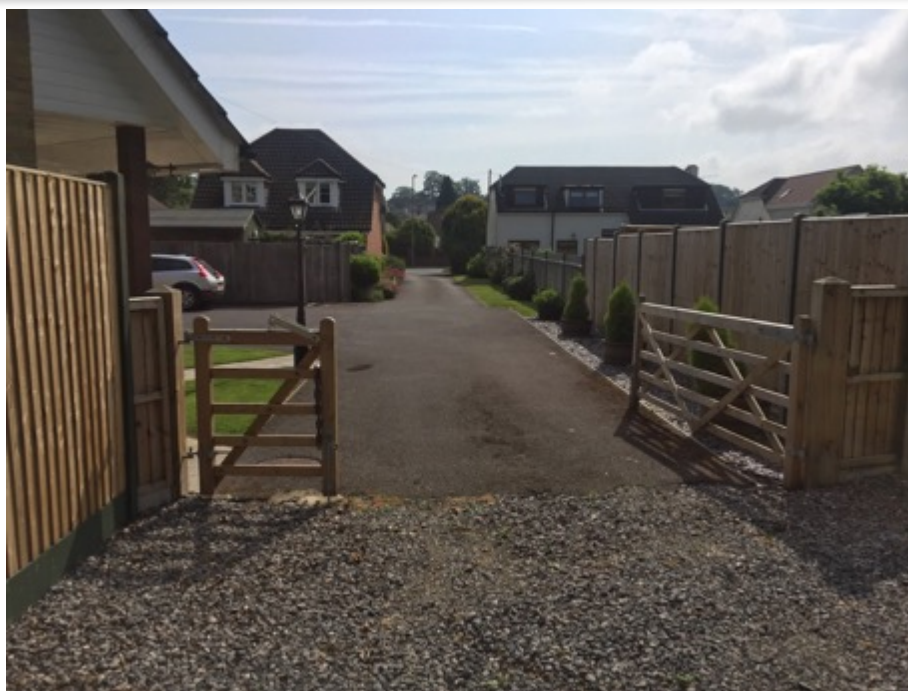
*Photograph 1 Facing east, showing wooden gated entrance to the site, accessed via Lovedean Lane and leading into a residential housing area.*

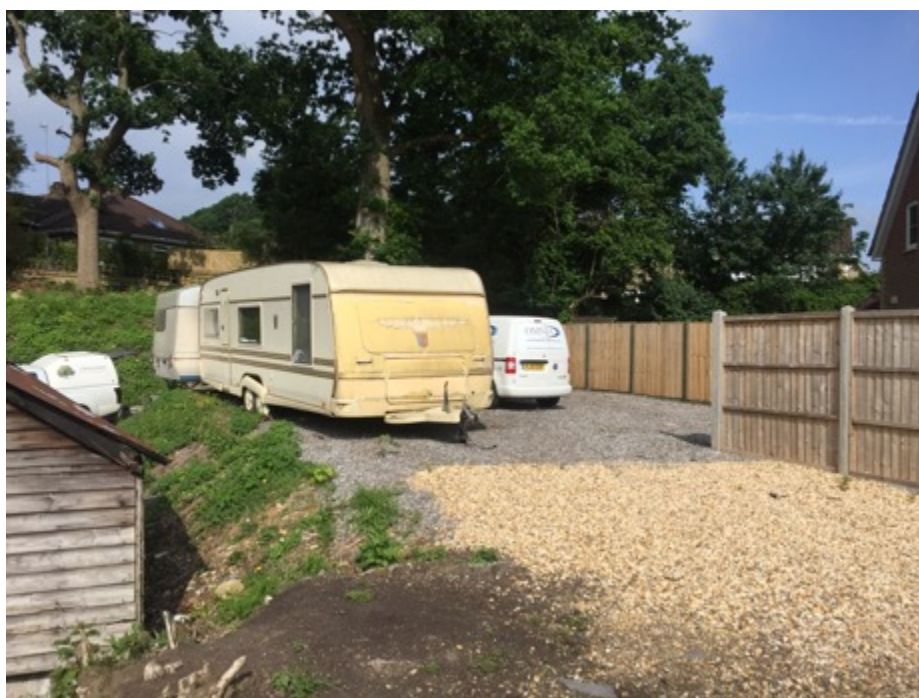
*Photograph 2 Facing north-west, showing two caravans placed near the entrance to the site.*

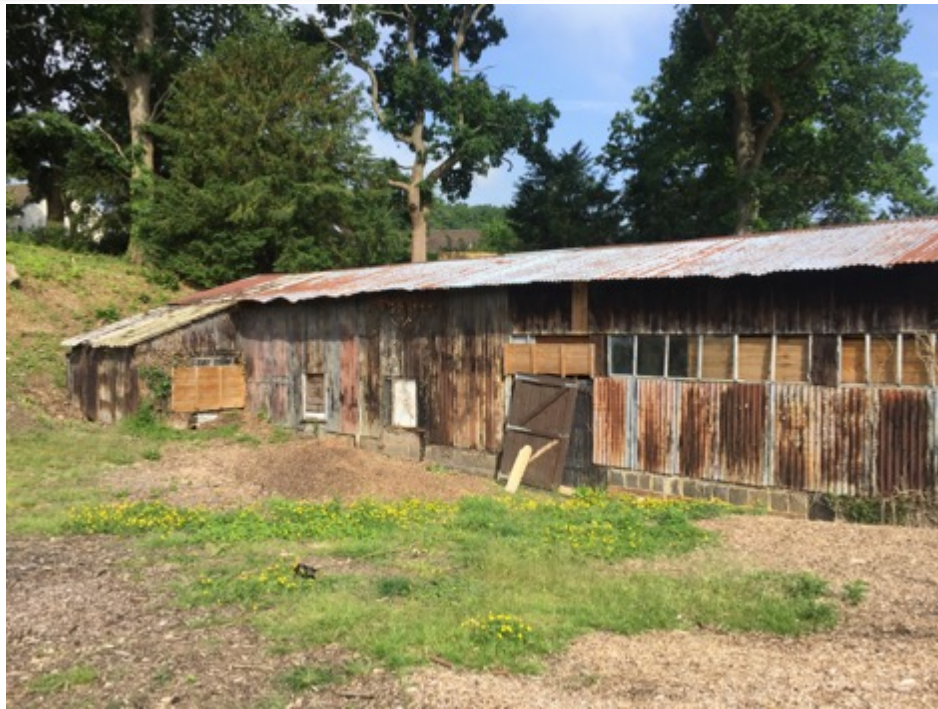
At the time of the walkover, the site comprised of a single rectangular building located in the centre of the site, orientating east to west (*Photograph 3*). The building was constructed of metal corrugated sheeting and was in a poor state of repair. At the time of the site walkover the building was locked and was utilised for the storage of building material including fencing and wooden fence panels (*Photograph 4*). Two (2no.) caravans were located adjacent to the site entrance which were presumed abandoned and in a poor state of repair (*Photograph 2*). Two (2no.) rectangular sheds were also present on site, one located adjacent to the central corrugated building, which was in a very poor state of repair and one in the south of the site comprising a wooden structure with a metal apex corrugated roof, measuring approximately 3.00m (l) x 1.50m (w). The shed in the south of the site was observed to contain mixed building materials and garden equipment (*Photograph 7*) and had a metal green bunded water tanker to the east of the building (*Photograph 6*). Immediately to the north of the shed was a stockpile of large wooden logs.

*Photograph 3 Facing north, showing corrugated building in a poor state of repair located in the centre of the site.*

before the year 2000 and therefore asbestos may be present within the building fabric. It is therefore recommended that an asbestos survey is undertaken prior to the commencement of demolition or renovation works in line with current asbestos legislation.

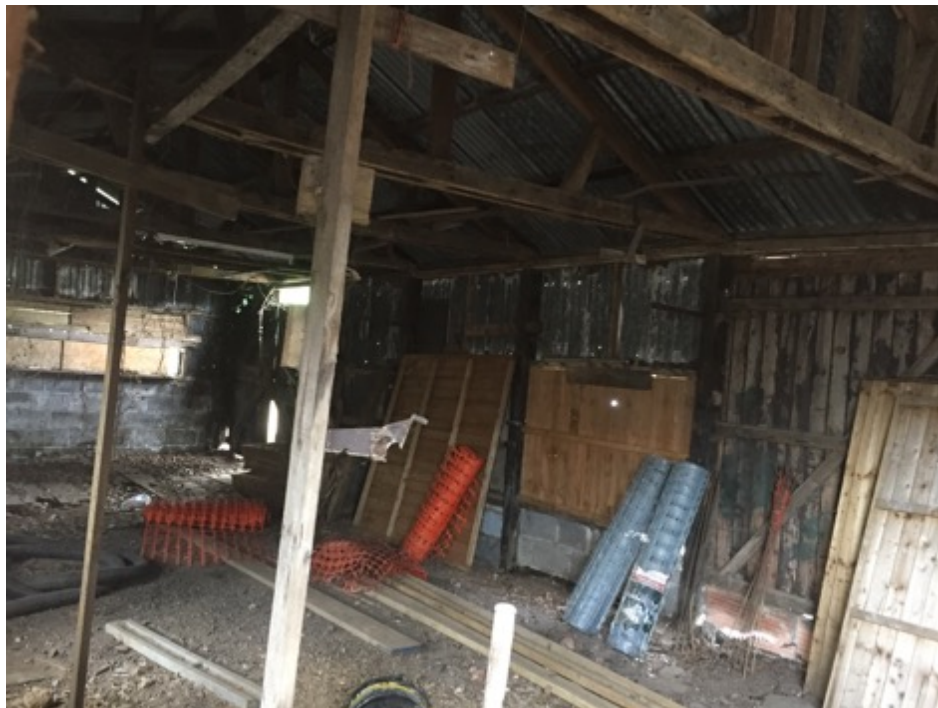
The storage of mixed building and domestic waste and equipment was noted within the building located in the centre of the site and the shed in the south of the site.

*Photograph 4 Interior of the building in the centre of the site, showing storage of building materials, fencing and wooden fence panels.*

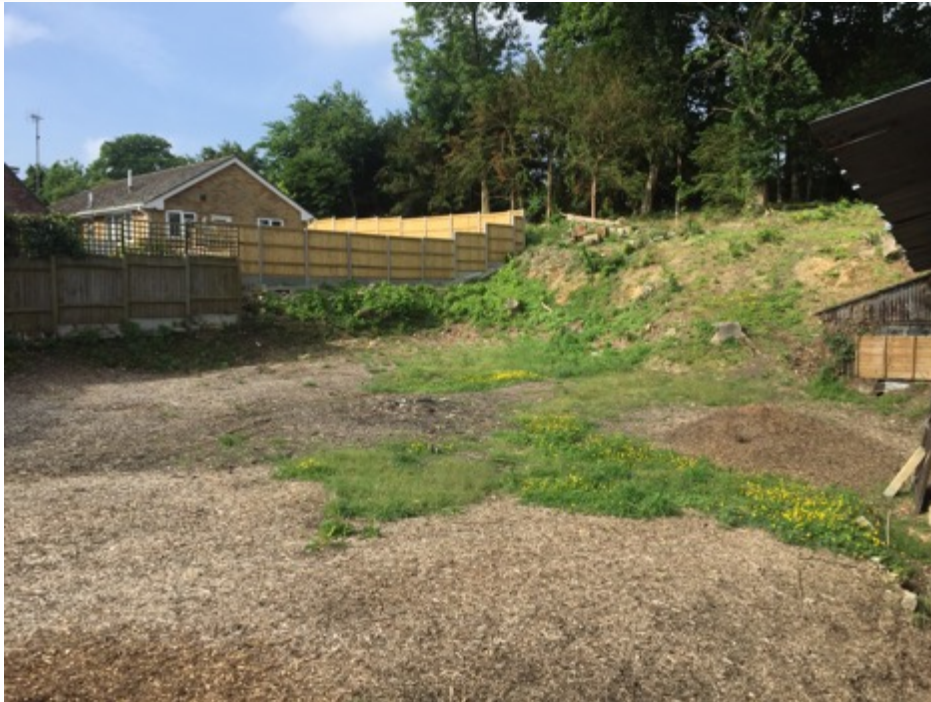
*Photograph 5 Facing south-west, showing the southern section of the site - an area of soft landscaping. to the west of the site an elevated area comprising densely spaced mature trees.*

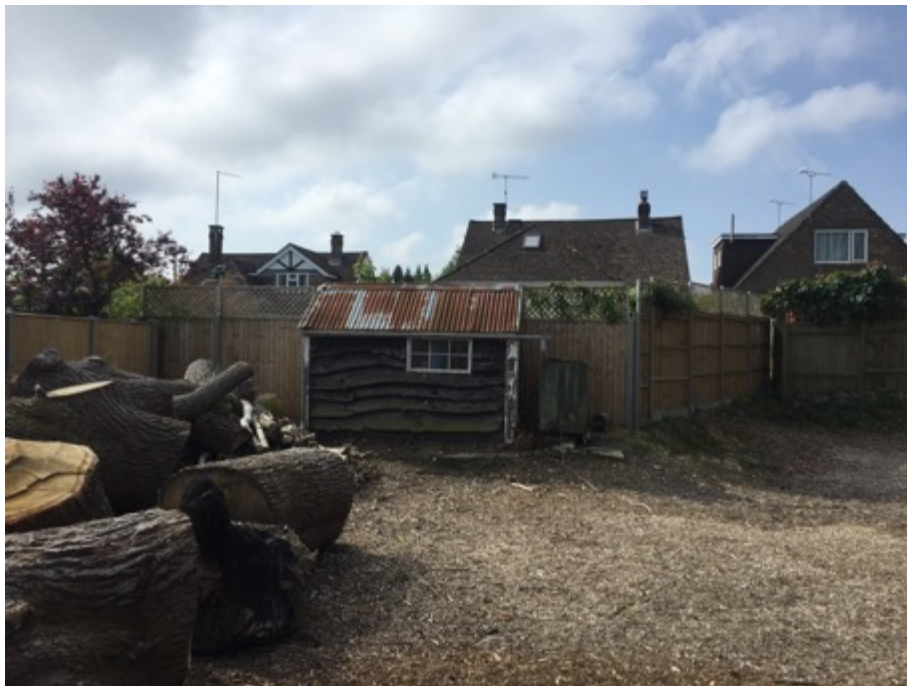
*Photograph 6 Facing south, storage of large timber logs (left), a wooden shed with a corrugated metal roof, a green metal water tanker with a tap is attached to the shed for the presumed collection of rainwater.*

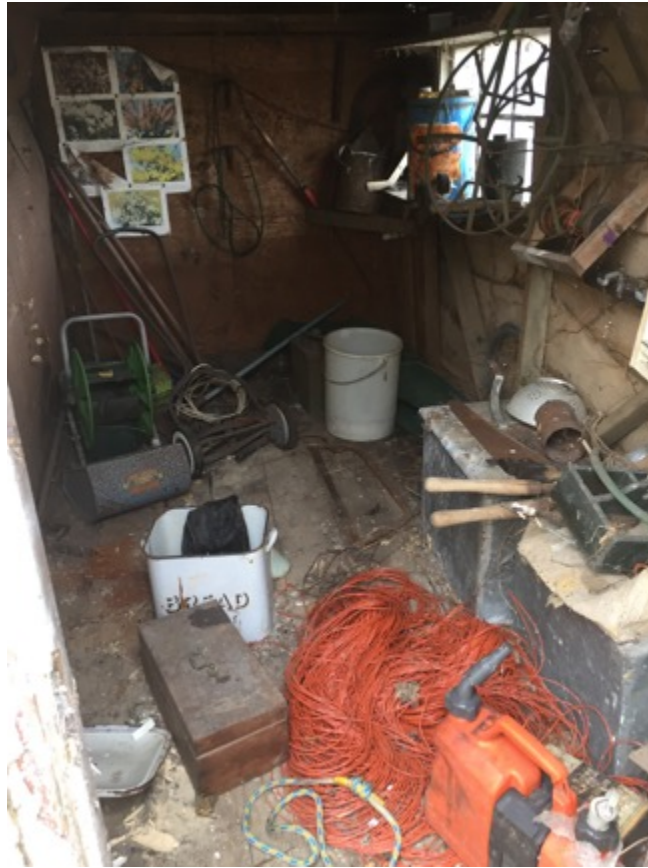
*Photograph 7 Interior of the shed in the south of the site for the storage of garden and household equipment.*
