**PADNELL GRANGE**

**BAT SURVEY REPORT**

**Prepared for Bellway Homes**

**October 2018**

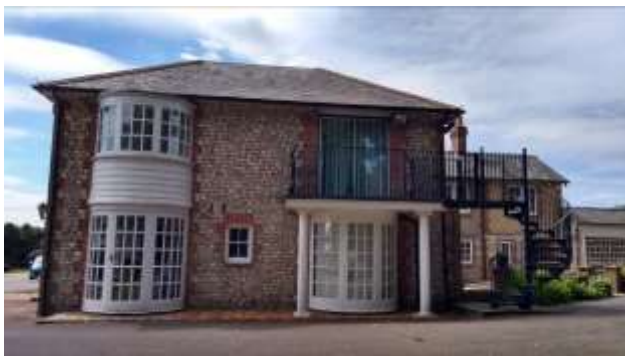
**Photo 1.** Eastern elevation of B1.

| Building | Description | Findings | Bat roost potential |
|---|---|---|---|
| <b>B1</b><br>(Photo 1 and 2) | Two storey 'L' shaped residential house with brick and flint walls and a hipped, valley slate tiled roof.<br><br>The building is connected on its western elevation to B2. | <b>External:</b><br>Potential bat access opportunities include gaps in the soffit on the western, eastern and southern elevations.<br><br><b>Internal:</b><br>The loft space is split into three voids, two of which were accessible for an internal survey. The roof voids were lined with roofing felt and insulation.<br><br><b>No evidence of bats recorded.</b> | <b>Moderate</b> |

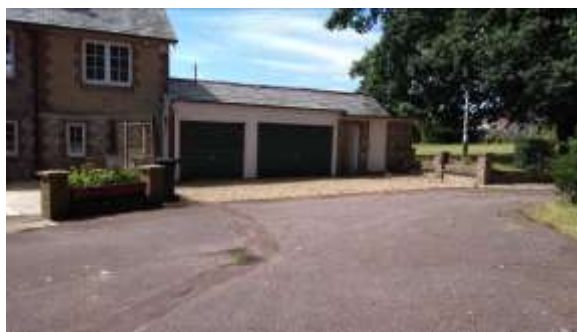
**Photo 2.** Northern elevation of B1 and B2.

| Building | Description | Findings | Bat roost potential |
|---|---|---|---|
| <b>B2</b><br>(Photo 3) | Single storey double garage with brick and flint walls clad with wooden shiplap on the northern elevation. The roof comprises a pitched gable slate tiled roof.<br><br>The building is connected on its eastern elevation to B1. | <b>External:</b><br>Potential bat access opportunities include slipped and raised ridge tiles and holes under barge boards on the western elevation.<br><br><b>Internal:</b><br>No loft space present.<br><br><b>No evidence of bats recorded.</b> | <b>Moderate</b> |

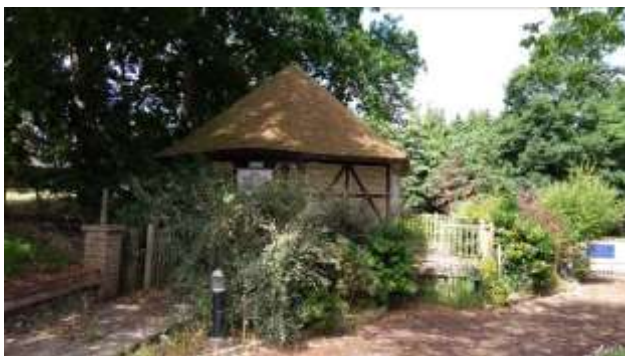
**Photo 3.** North-eastern elevation of B3.

| Building | Description | Findings | Bat roost potential |
|---|---|---|---|
| <b>B3</b><br>(Photo 3) | Elevated hexagonal 'grain store' with timber framing infilled with bricks and a conical tiled roof. | <p><b>External:</b><br/>Potential bat access opportunities include gaps and missing tiles, hole in soffit on southern elevation and a slit in the wooden beams on the western elevation.</p> <p><b>Internal:</b><br/>Internal survey not possible due to health and safety reasons.</p> <p><b>No evidence of bats recorded.</b></p> | <b>Moderate</b> |

5.2.4 Current proposals indicate that the proposed demolition of B3, B5, B7, B10 and B13 will result in the loss of these roosts. Where it is not possible to retain confirmed/probable bat roosts during development works, suitable replacement roosting opportunities should be provided during the construction phase prior to new roosting opportunities being created within the new buildings. The bats recorded roosting at the site are species which have been recorded roosting in both trees and/or bat boxes (University of Bristol, 2005; Schofield and Mitchell-Jones, 2004), with records of bat boxes having been used for successful breeding of Common Pipistrelle and Brown Long-eared bats.

- 5.2.17 Accordingly, to minimise any adverse impacts, any works affecting B3, B5, B7, B10 and B13 should be conducted during suitable climatic conditions within either the spring (April-May) or autumn (September-October).

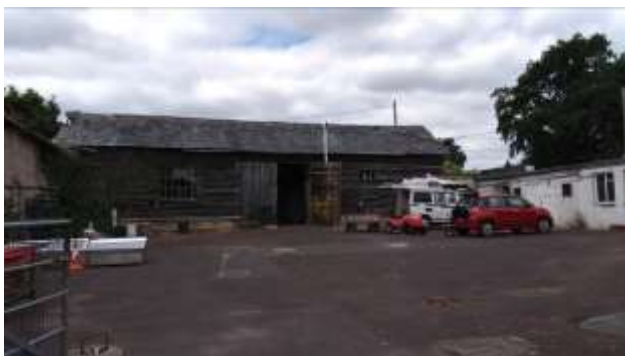
**Photo 7.** Eastern elevation of B7 and southern elevation of B6.

| Building | Description | Findings | Bat roost potential |
|---|---|---|---|
| <b>B7</b><br>(Photo 7) | <p>Single storey shed with wooden shiplap and brick and flint walls partially clad with wooden weatherboarding. The roof is pitched and slate tiled.</p> <p>Connected to the southern elevation is a lean-to with partially-open brick walls and a sloped corrugated metal roof.</p> <p>The building is connected on its western elevation to B8 and on its eastern elevation to B6 and B10.</p> | <p><b>External:</b><br/>Potential bat access opportunities include missing tiles on the western and eastern elevations and gaps in the wooden feather boarding on the southern elevation.</p> <p><b>Internal:</b><br/>The building is in a state of disrepair with many holes in the roof and walls. The building is open to the rafters, with no loft space present. There is no internal rendering to the property, with many exposed beams and wooden joists.</p> <p><b>No evidence of bats recorded.</b></p> | <b>Moderate</b> |

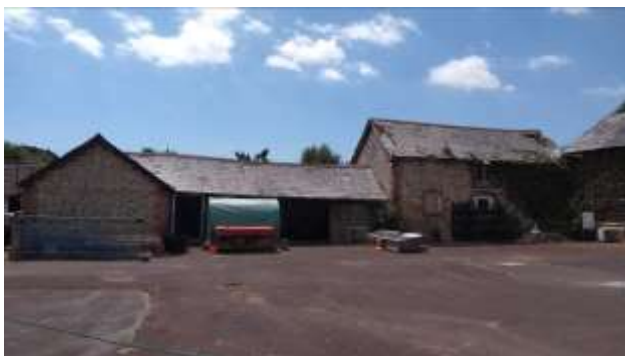
**Photo 9.** Northern elevation of B10.

| Building | Description | Findings | Bat roost potential |
|---|---|---|---|
| <b>B10</b><br>(Photo 9) | <p>Two storey building with brick and flint walls and a pitched, slate tiled roof.</p> <p>Connected to the eastern elevation is a single storey 'L' shaped storage building with brick and flint walls and a pitched valley slate tiled roof.</p> <p>Connected to the southern elevation is a single storey brick building with sections of sloped and flat corrugated metal roofs.</p> <p>The building is connected on its western elevation to B7.</p> | <p><b>External:</b><br/>Potential bat access opportunities include slipped/missing tiles, and gaps at the apex of the roof, under the eaves and around a pipe on the southern elevation.</p> <p><b>Internal:</b><br/>The roof is unlined and a false ceiling is present in sections.</p> <p><b>No evidence of bats recorded.</b></p> | <b>Moderate</b> |
