Ecological Report to assess the impact of the insertion of wooden stakes to retain mudbank to protect existing slipway at Emsworth Sailing Club

J.R.B. Environmental Ltd

## Emsworth Sailing Club Ecological Report

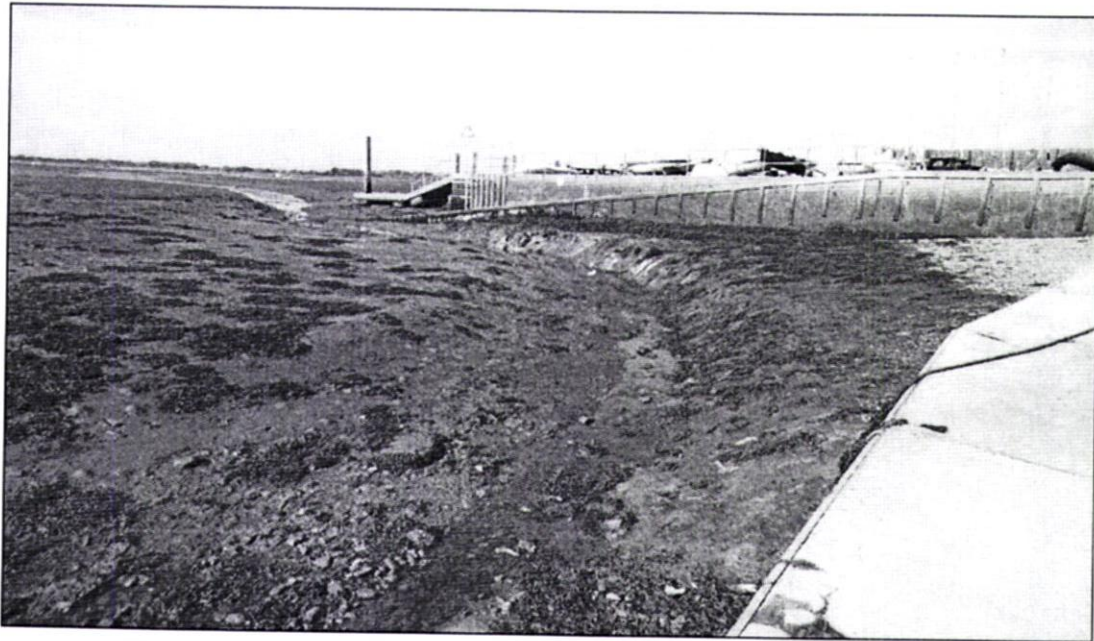
Photo 2. View of existing channel in its wider context from Sailing Club to the southwest showing slipway and outfall channel.

- 4.1. Photos 1, 2 and 3 show how water from the tidal mill pond outfall has become channeled over time towards the side of the slipway causing erosion to a clay bank as the tide goes out. This channel is now starting to undermine the foreshore beach and mud bank that supports the base of the slipway.

- 4.2. This erosion will have the effect of increasing the depth of water alongside the slipway and may increase the hazard to users launching from this facility. It may ultimately undermine the concrete base to the slipway. The movement of this channel has clearly resulted in erosion to the foreshore shingle and clay deposits forming an earth bank alongside this slipway.
