## Geo-Environmental Report

Land East of Castle Avenue, Havant, PO9 2RY  
for:

Persimmon Homes South Coast

| Ref: | CRM.1033.025.GE.R.001.B |

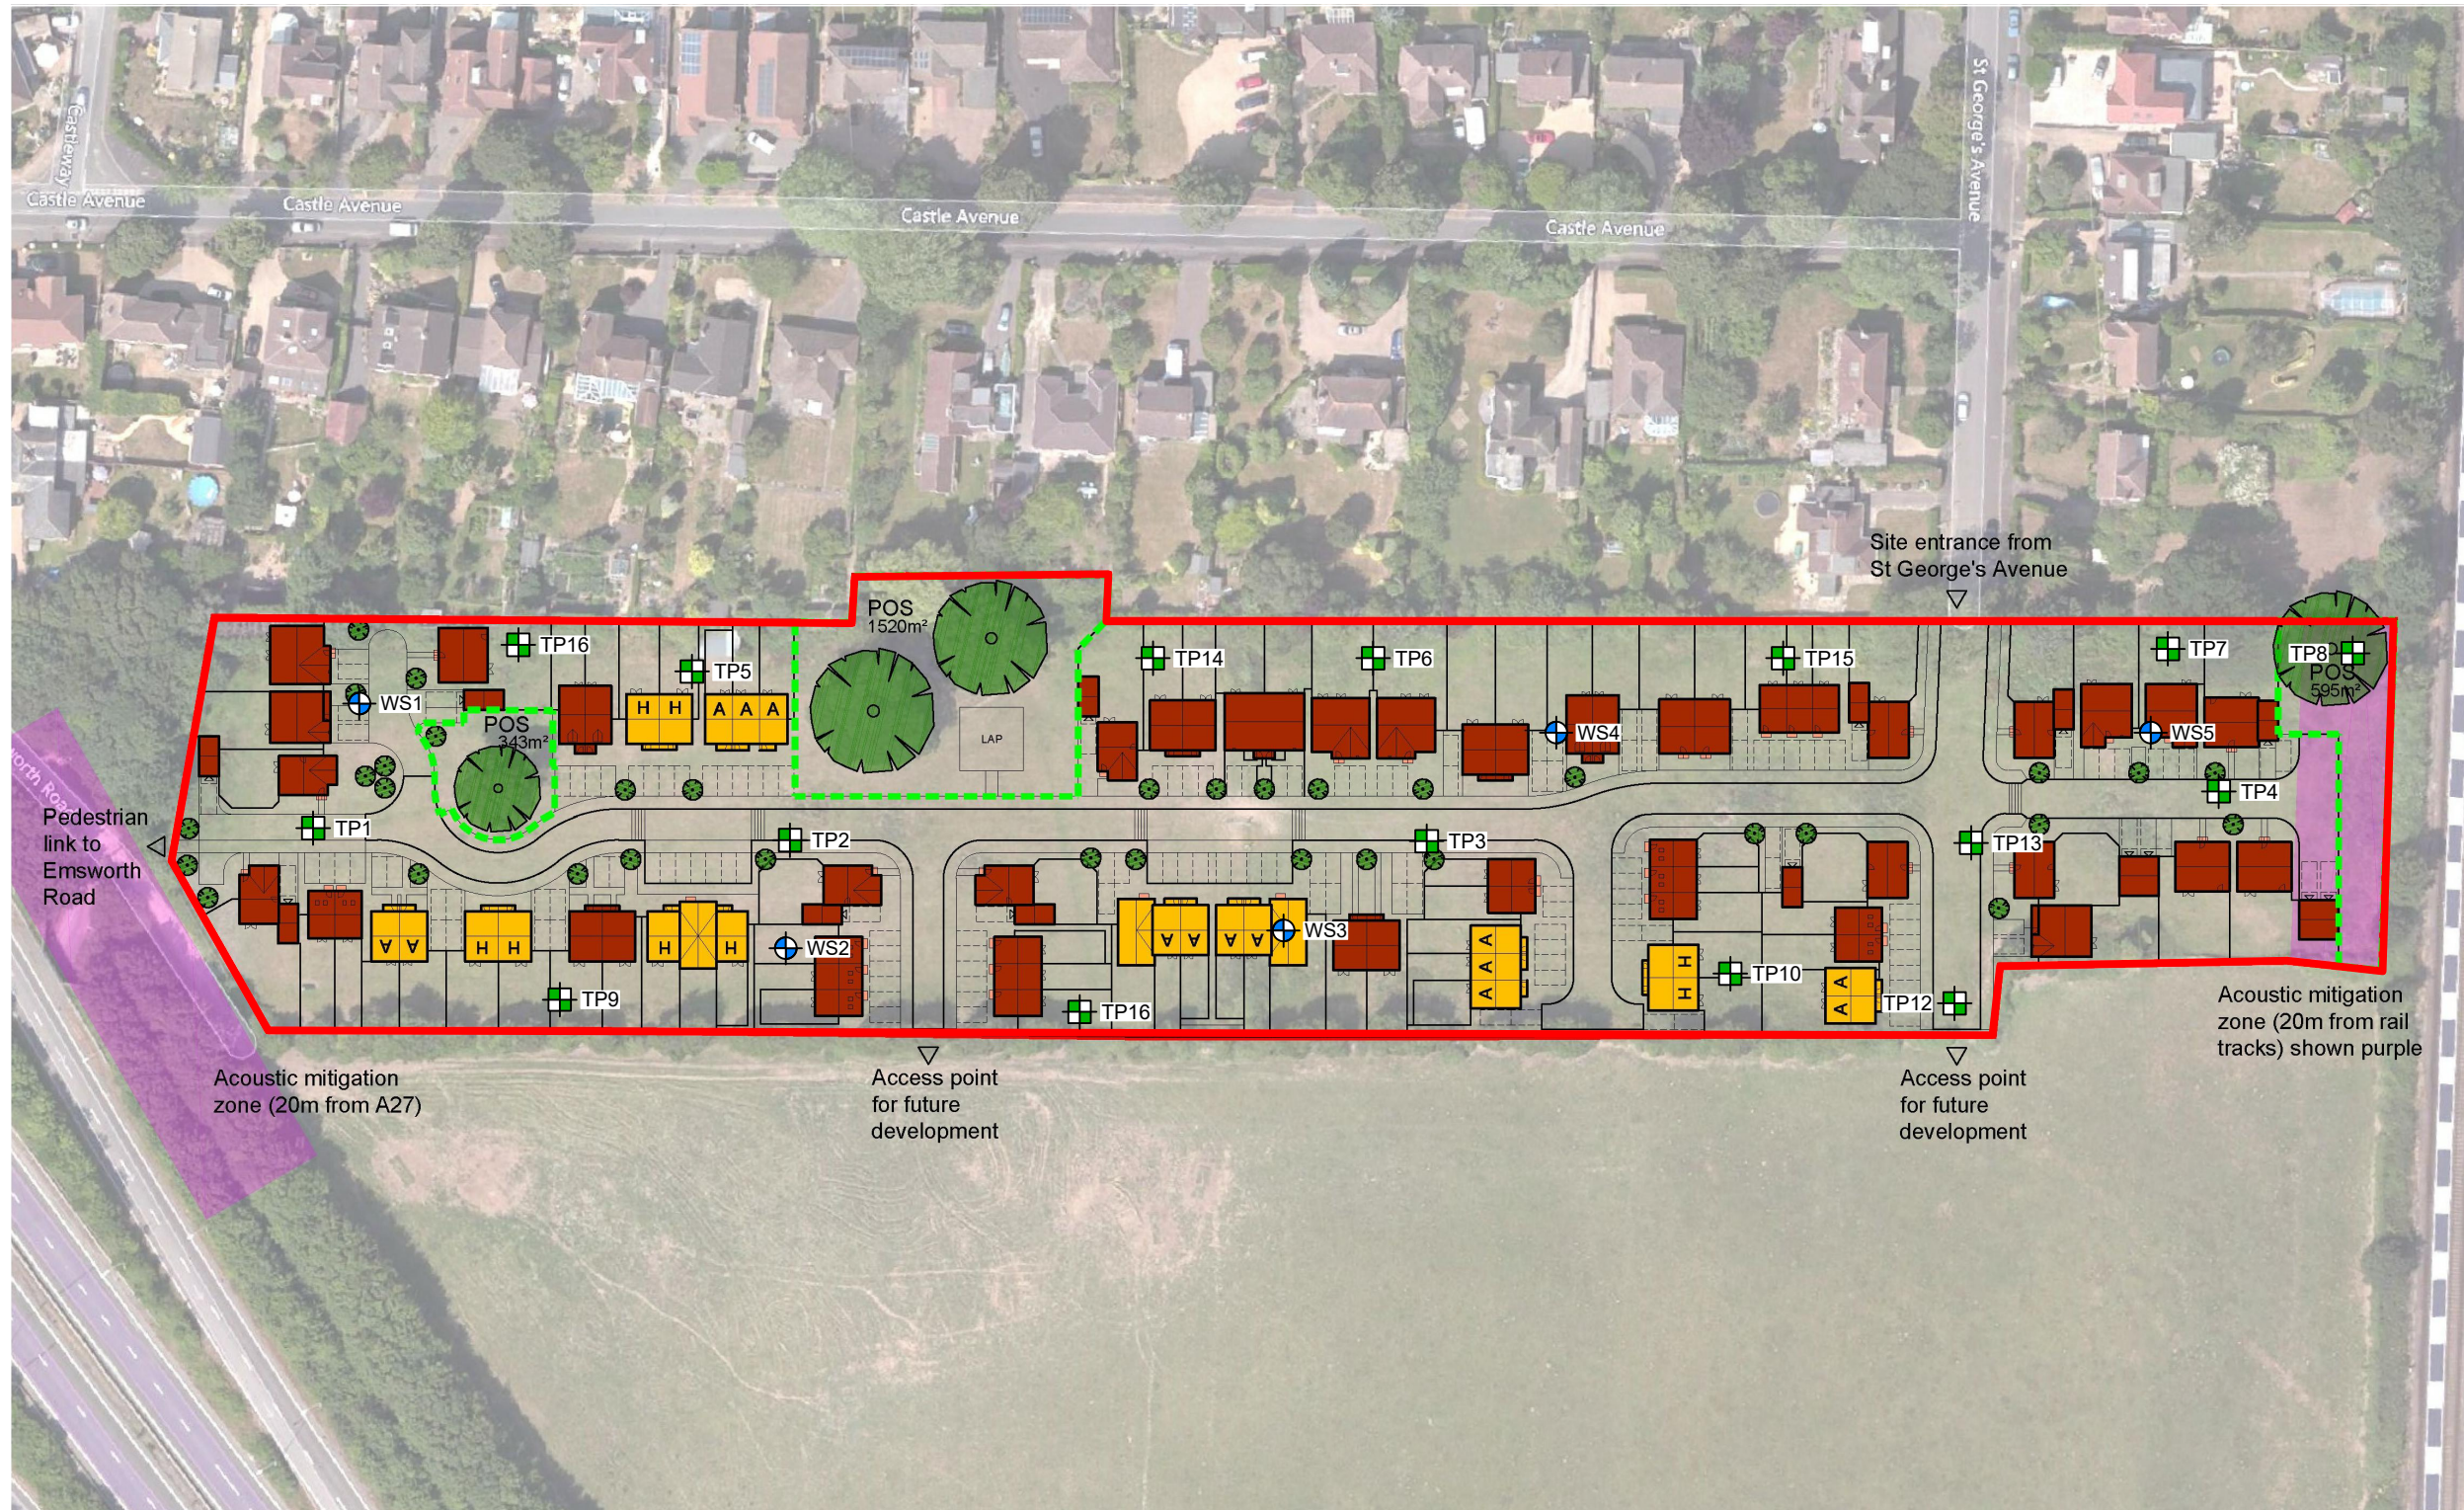
Trail Pit (TP)  
(TP1-TP16)

8.2 Details of the ground and groundwater conditions encountered are given on the exploratory hole records included in Appendix B and are summarised in the sections below:
