# Completion report relating to Japanese knotweed at

38-44 London Road, Purbrook, Waterlooville, Hampshire, PO7 5LJ

Prepared for Simon Bryant, Pre-Contracts Manager, McCarthy & Stone

Prepared By: Mark Prout  
[markprout@Ebsford.co.uk](mailto:markprout@Ebsford.co.uk)

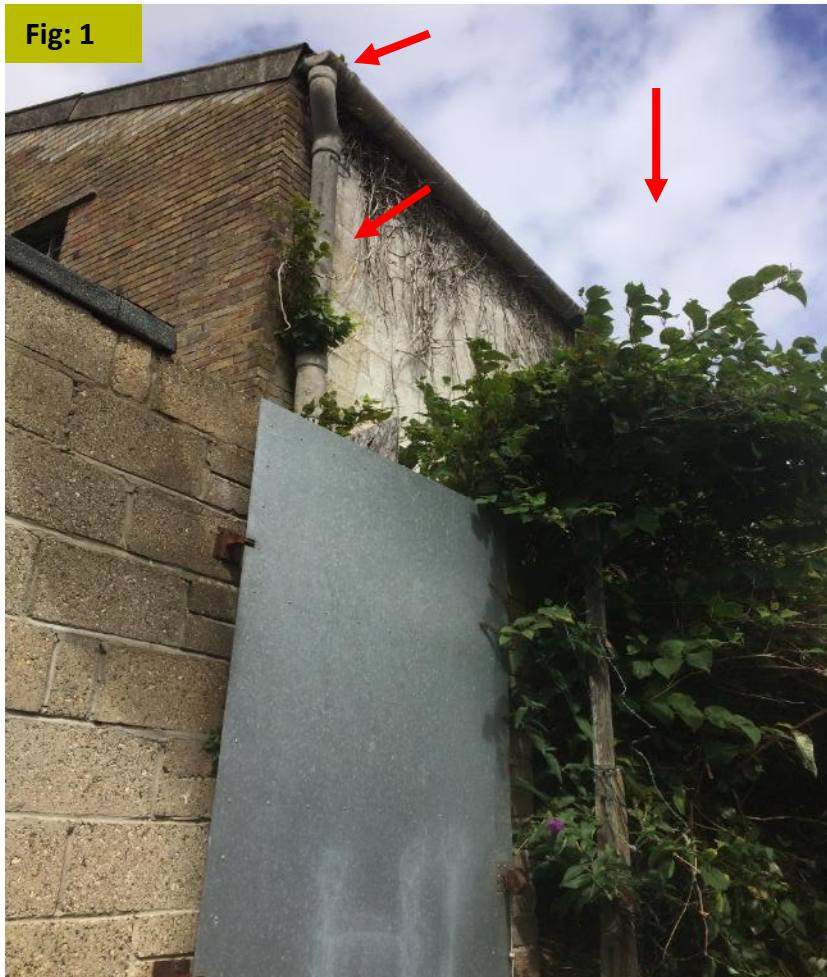
Fig: 1

JK-2: Within boundary at: SU 6737 0792 – note the Japanese knotweed in the down pipe.

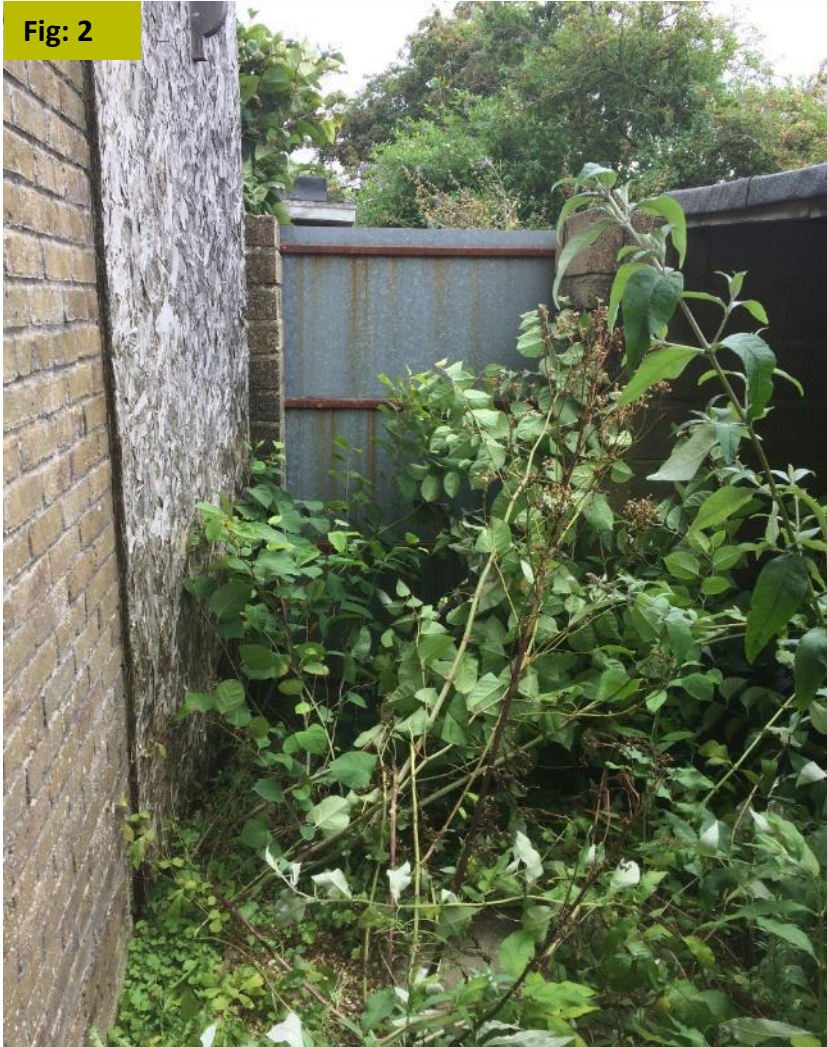
Fig: 2

JK-3: Within boundary at: SU 6736 0792

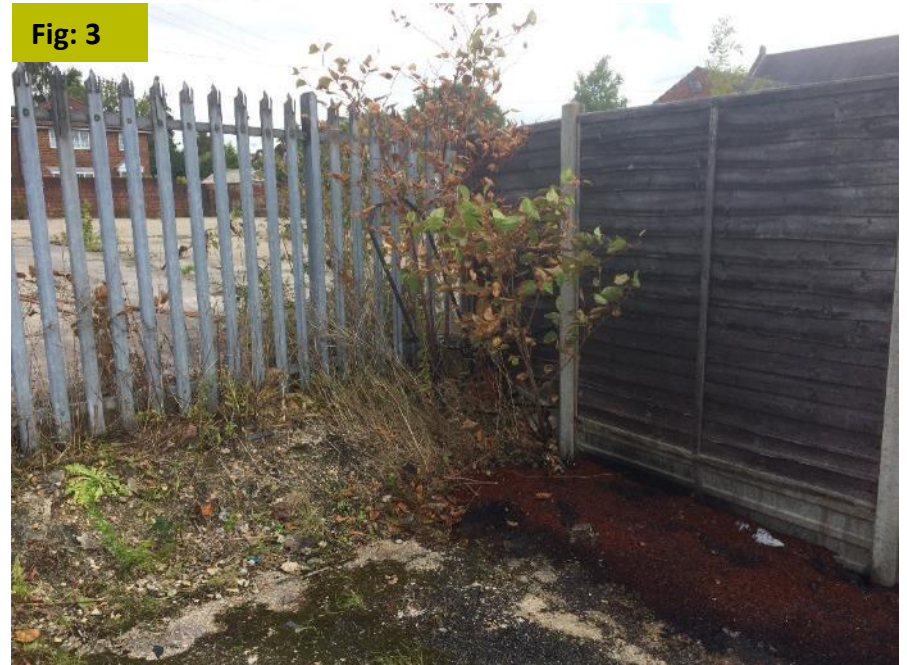
Fig: 3

JK-1: Within boundary at: SU 6734 0796 – the JK is growing between concrete hardstanding. The area is contaminated with hydrocarbons probably from the nearby fuel / oil tank.

Phase 1: Identify extent of rhizome and Hydrocarbon contamination around area JK1

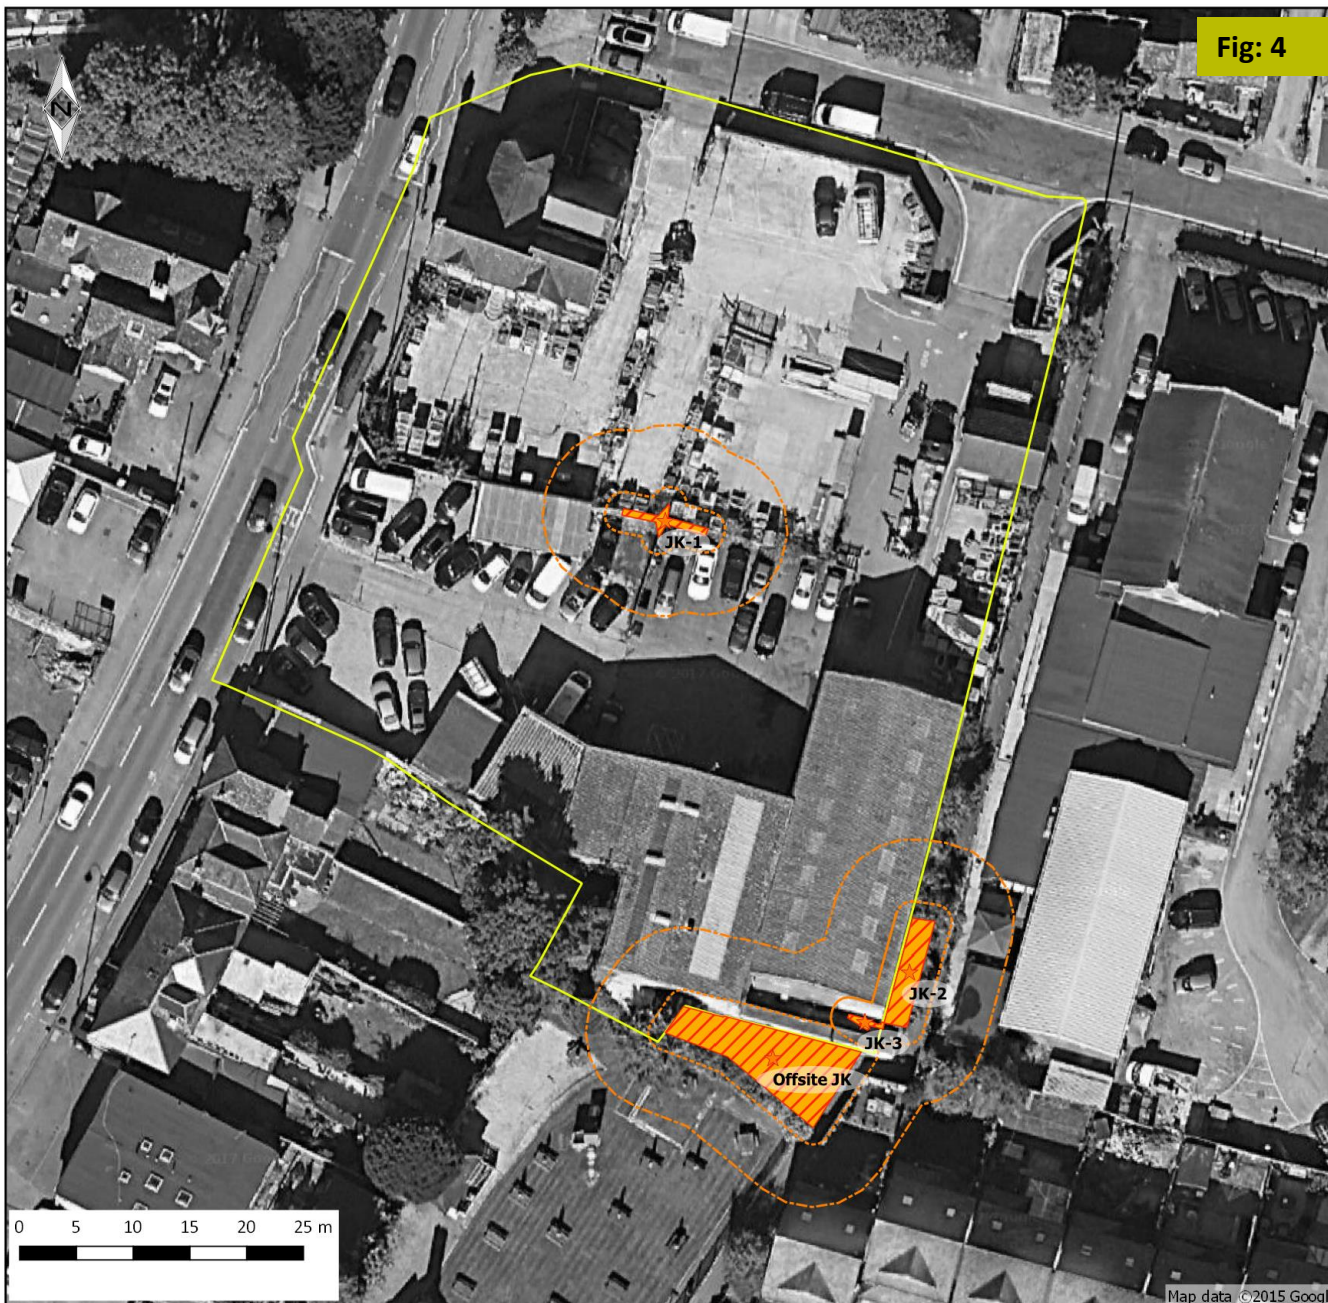
Fig: 4

Three areas of Japanese knotweed (*Fallopia japonica*) was located onsite, JK-1 - JK-3.

A further area of area of Japanese knotweed was located off site. This area contains scattered Japanese knotweed amongst bramble and hedge bindweed.

Japanese knotweed was found at three locations within the site (JK-1, JK-2 & JK-3, page 7-9, figures 4-6), in the centre and to the south east of the site bordering neighbouring land. The Japanese knotweed could also be seen amongst other vegetation on neighbouring land (Offsite JK). None of these stands appear to be under management as the growth was normal with substantial canes >2cm diameter and >2m tall and totalling 26.34m<sup>2</sup> (onsite JK). JK-2 and JK-3 were in close proximity to the site boundary. Note the Japanese knotweed growing in the downpipe, figure 1 (possibly asbestos). Also, given the nature of root (rhizome) spread we have added a 1.5m buffer to the onsite JK which increases the area to a potential 114m<sup>2</sup>.
