**GEO SITE ASSESSMENT  
LAND OFF WESTWOOD CLOSE  
EMSWORTH  
PO10 7QL****REPORT PREPARED FOR:****HAMPSHIRE HOMES  
8 CHATMOHR ESTATE  
CRAWLEY HILL NR ROMSEY  
HAMPSHIRE  
SO51 6AP****DATE OF ISSUE: NOVEMBER 2017**

| Document verification schedule | | | |
|---|---|---|---|
| Document title | Geo Site Assessment | | |
| Document ref | 20768R1 | | |

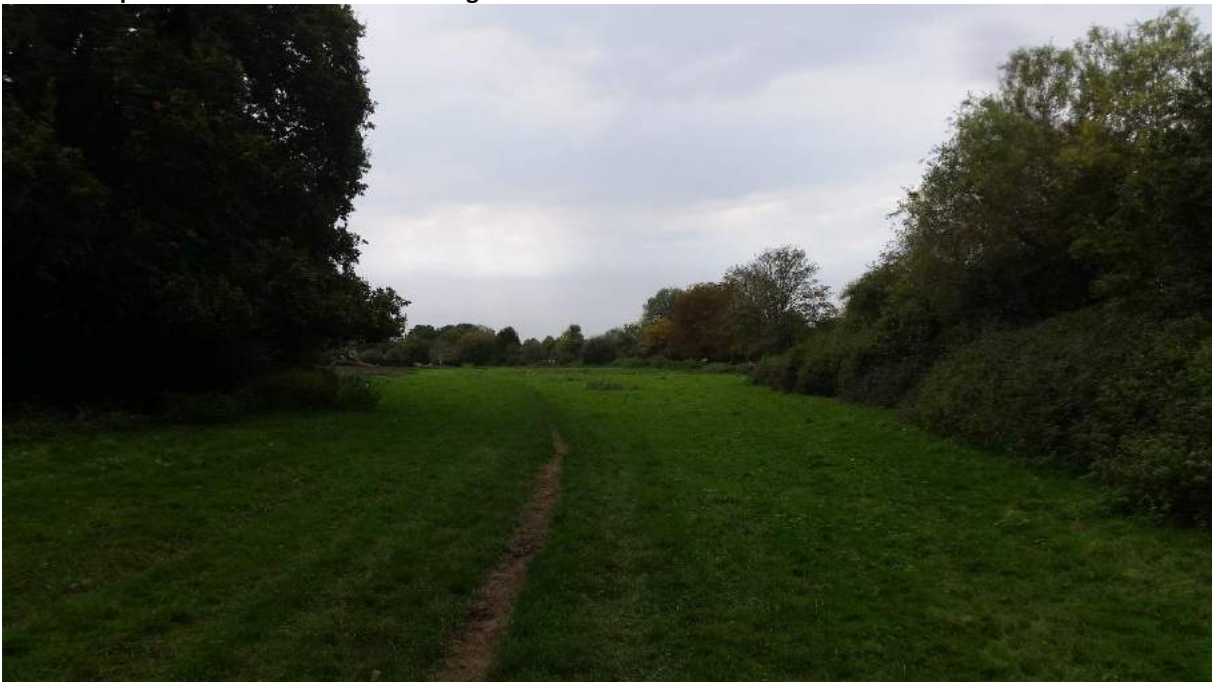
**Photo 2: Open land across the site. Looking from the north.**

Topography on site is slopes slightly downward from north to south. There was no evidence of any bulk tanks, surface staining or invasive plant species onsite.

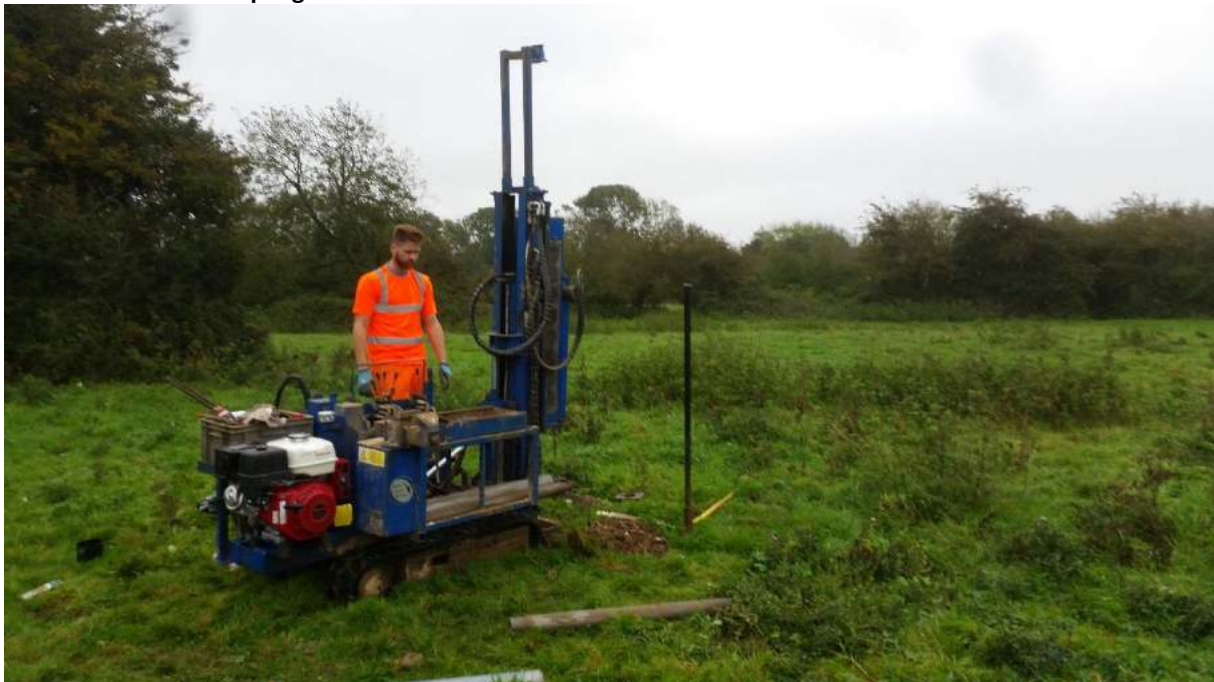
**Photo 4: Window Sampling at BH2.**

Boreholes were drilled using a mechanically driven window sampler (Photo 4) to investigate the ground conditions. Dynamic probes were also completed to establish the engineering properties of the underlying geology. Trial pits were dug using a JCB 3CX to investigate ground conditions and perform soakage tests (Photos 5 and 6).

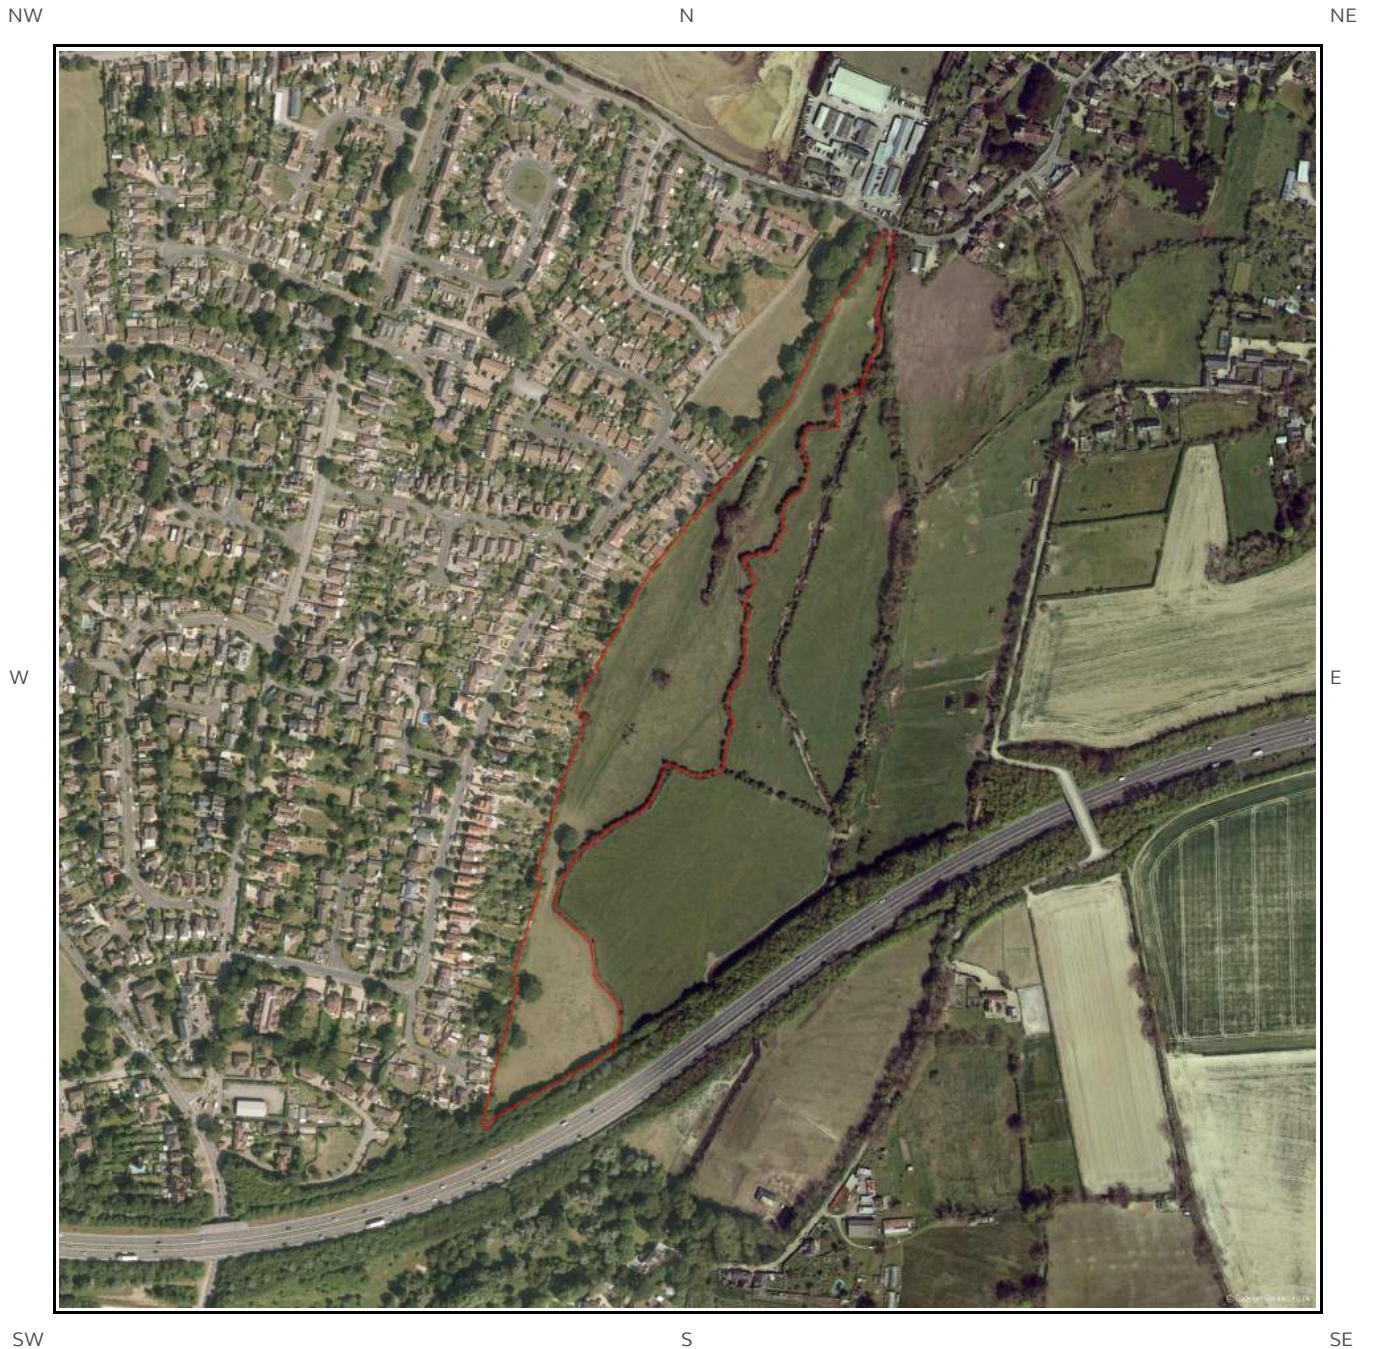
Aerial Photograph Capture date: 20-Aug-2013  
Grid Reference: 475256,106859  
Site Size: 4.93ha

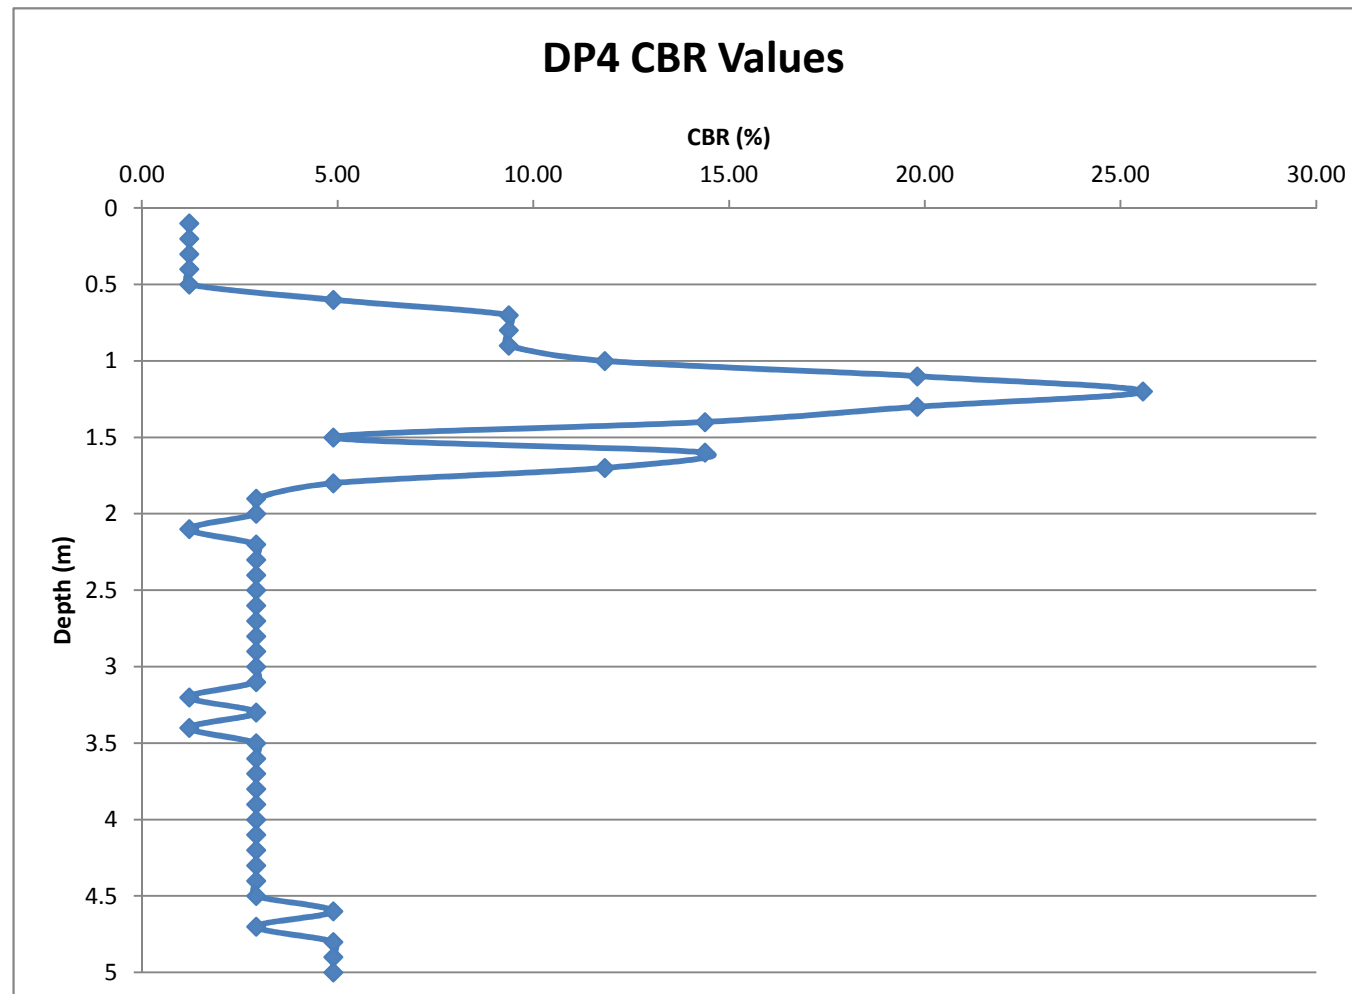
Values calculated using Kleyn & Van Harden (1983) conversion.

CBR Conversion Calculation  $\log CBR = 2.628 - 1.273 \log(DCP)$
