# **ALPINE GROUP LIMITED**

## **YACHTHAVEN, HAYLING ISLAND**

### **Contamination Risk Assessment - Additional Investigations**

August 2018

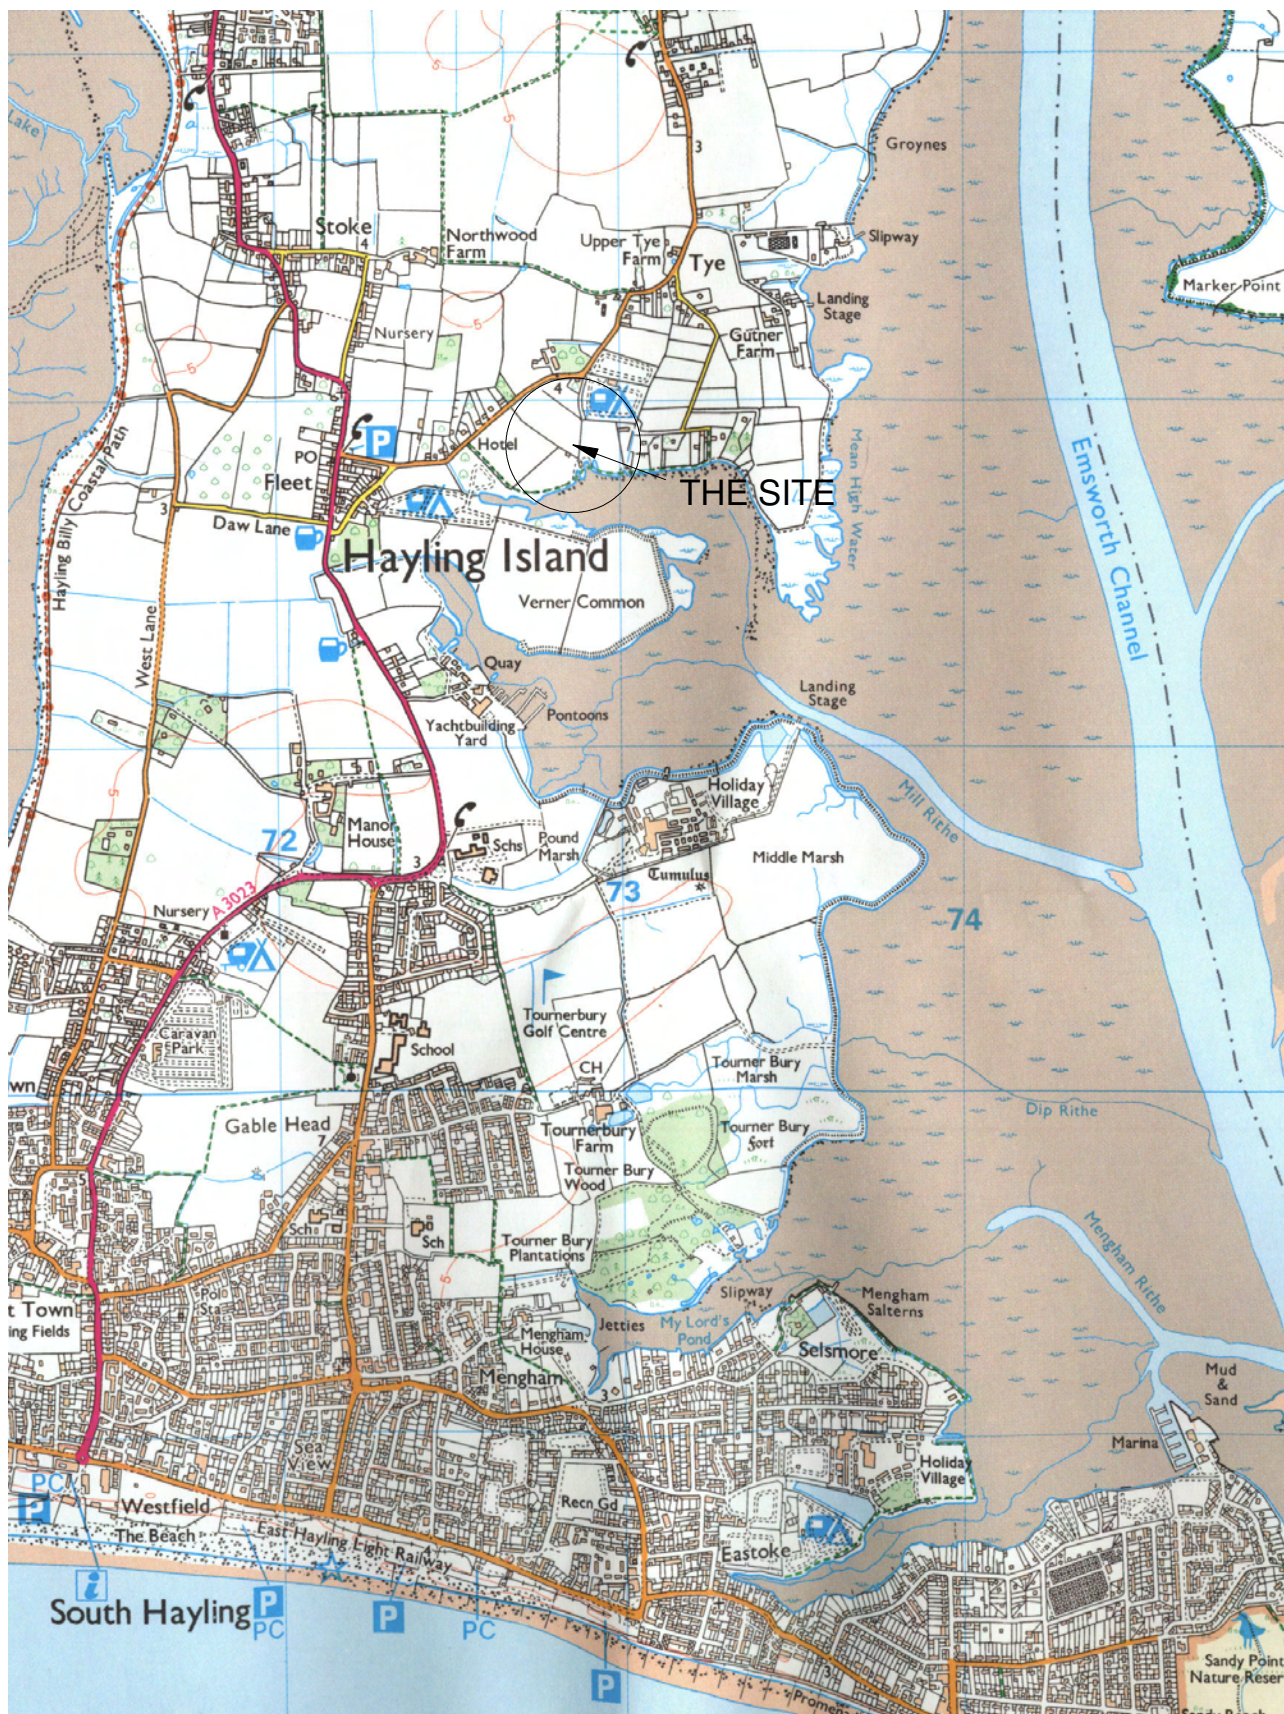
**Figure 1: Site Location**

- 1.1 The site comprises some 0.5 ha of currently disused industrial land adjacent to Chichester Harbour previously used for a boatyard and subsequently for materials, vehicle and plant storage. The levels of much of the site were raised with fill as part of this earlier development. The site location is at Ordnance Survey Map reference SU 7289 0183. See Appendix A Figure 1 for the site location and Figure 2 for the existing site layout..
