**HAVANT RFC, BEDHAMPTON,  
HAVANT**

**PRELIMINARY BAT ROOST  
ASSESSMENT**

A Report to: CBRE Ltd

Report No: RT-MME-126764C-02

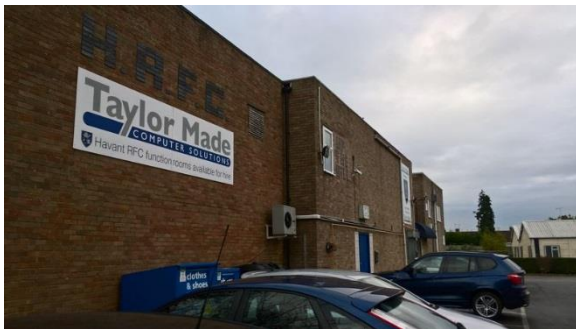
**Plate 4.1: Havant RFC**

Havant RFC was a large multi-storey brick building with a flat felt roof (Plate 4.1). The building was in generally good condition with no gaps or missing mortar identified within the brickwork that could be utilised by roosting bats. (Plate 4.2).

Havant RFC was fully inspected and no bat roost was identified. This building had no potential for roosting bats. The survey data obtained for the site is valid for 12 months from the survey date. If development works to the surveyed building have not commenced within this timeframe it will be essential to update the survey effort to establish if suitable features have developed and if bats have colonised the building in the interim. In the unlikely event that a bat is found during demolition works all works must immediately cease and a suitably qualified ecologist should be contacted.

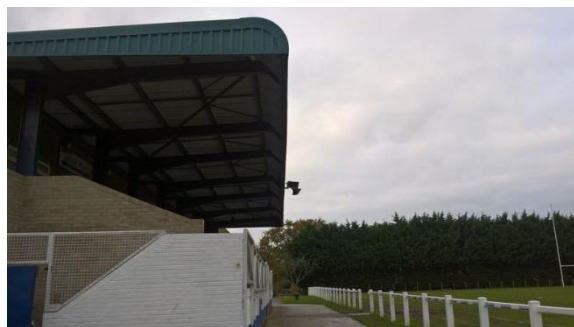
**Plate 4.3: View of Spectator Stand**

The northern elevation of the building had a spectator stand with metal rain shelter (Plate 4.3). The stand and shelter were both in good condition with no gaps or crevices that could be utilised by roosting bats.

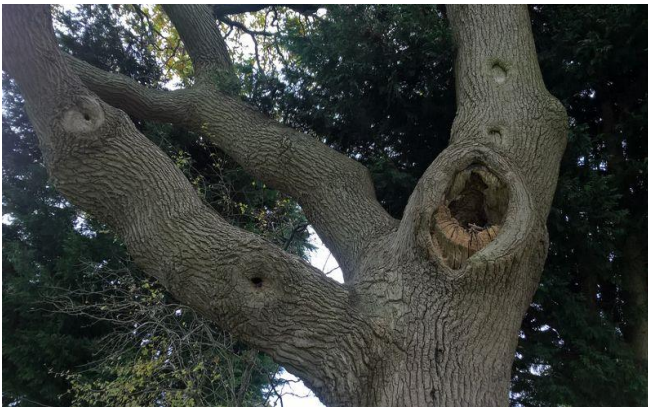
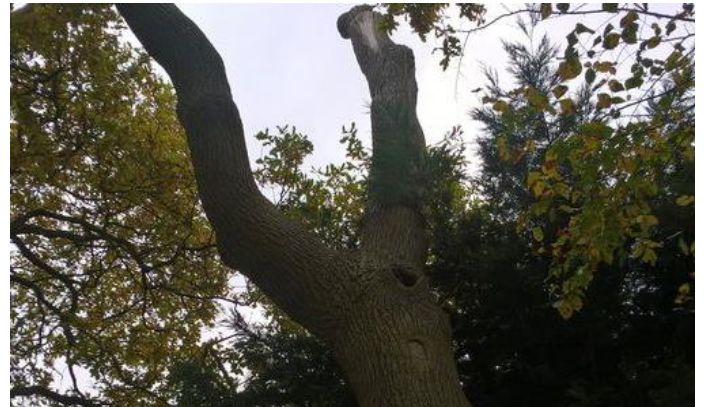
**Plate 4.4: Mature Oak Tree With Bat Roosting Features**

Only one mature oak tree located within the woodland on the western boundary was found to have features which included a small number of inclusion holes. This tree is not to be removed as part of the works. It was not possible to fully inspect the holes due to the height at which they were located and therefore ascertain whether any suitable crevice was located within the holes to support roosting bats. Due to the limited features, the tree was considered to have low potential to support roosting bats.

was considered to have low potential for roosting bats. The survey data obtained for the site is valid for 12 months from the survey date. If proposed site works have not commenced within this timeframe it will be essential to update the survey effort to establish if the tree has developed features that could be used by roosting bats in the interim. In the unlikely event that a bat is found during works to the trees all works must immediately cease and a suitably qualified ecologist should be contacted.
