## **Bat Scoping Assessment**

**Harbour View, Marine Walk, Hayling Island, Hampshire,  
PO11 9PQ**

**14<sup>th</sup> October 2016**

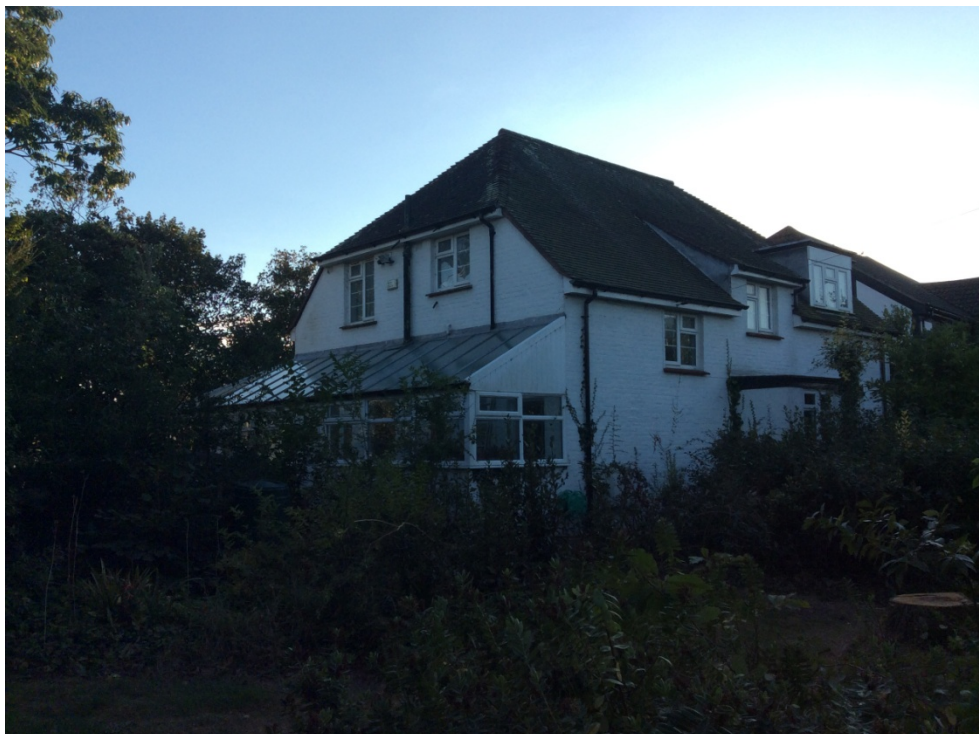
Much of the first floor of the southern and eastern external elevation of the house is clad in a PVC conservatory type structure (Figs. 2-4). The conservatory appears to be tight-fitting, including the lead flashing joining the structure to the wall of the house and is therefore devoid of any gaps that would be considered suitable as potential roosting space for crevice roosting bats such as the pipistrelle species.

**Figure 2.** The northeast facing aspect of the house at Harbour View.

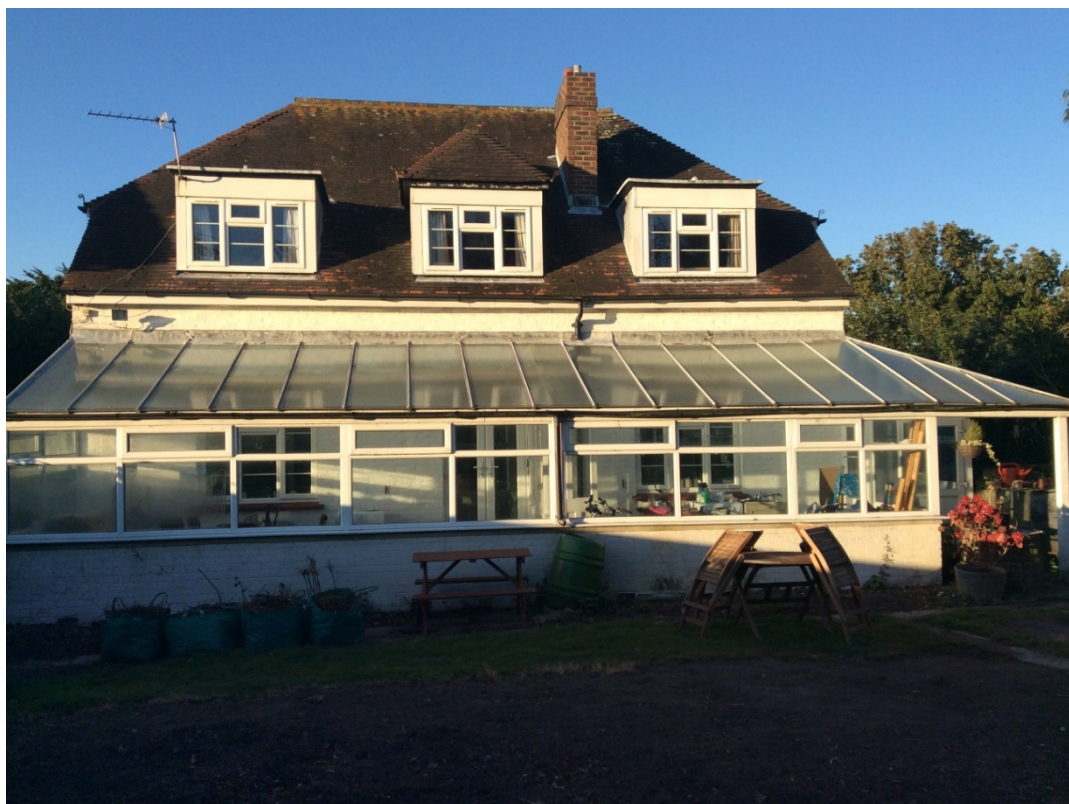
The soffits of the south and east facing aspects of the house are tight-fitting and devoid of gaps (Fig. 4). It is proposed that much of the roof is to be removed to make way for the new pitch when the proposed extension is completed. The roof is clad in largely tight-fitting machine made clay tiles, that are devoid of potential crevice roosting space. The lead flashing fringing the chimney and dormer windows upon the south facing aspect are tight-fitting and devoid of gaps (Fig. 3).

**Figure 3.**The south facing aspect of the house at Harbour View.

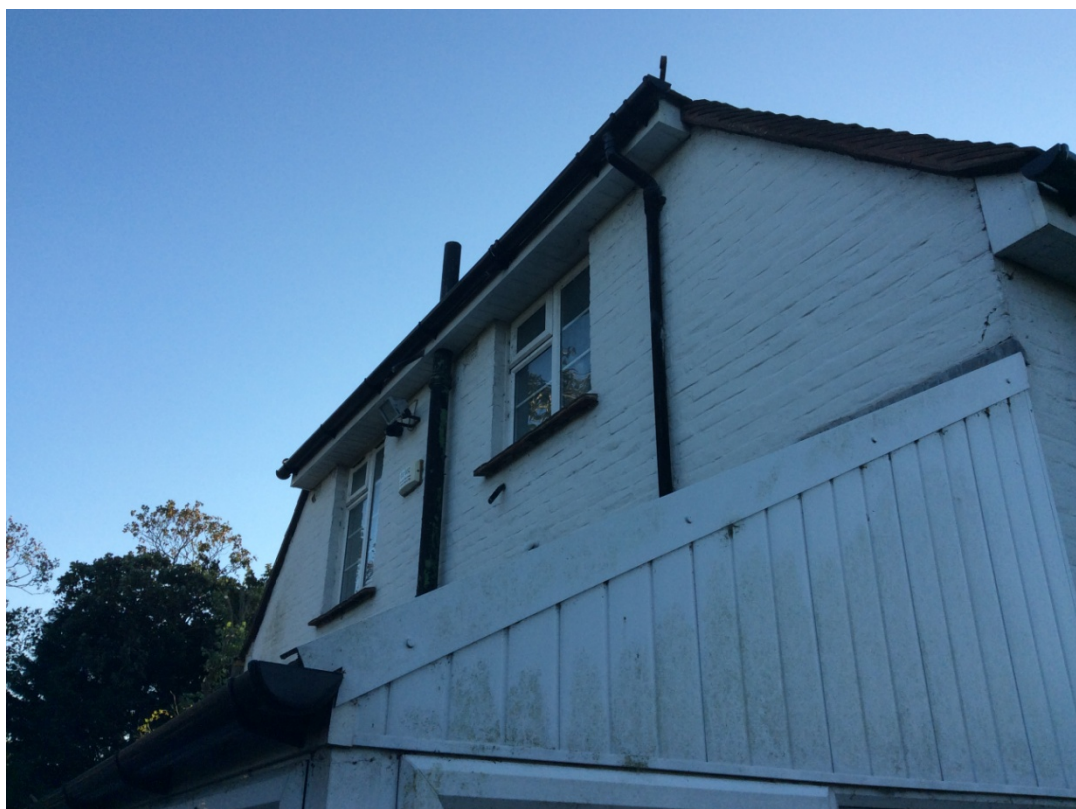
**Figure 4.**The east facing elevation of the house at Harbour View.

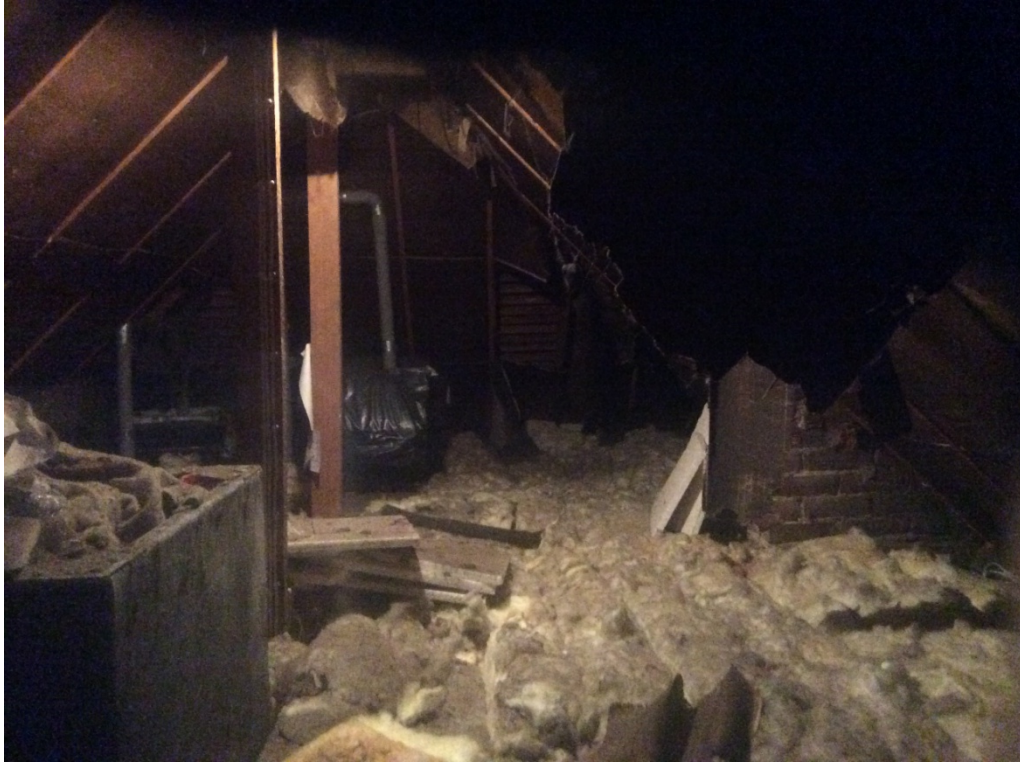
The roof void measures approximately 2m floor to apex height, with a floor space of approximately 3.5x10m. The void is timber framed and lined with a paper type material that is deteriorating and coming away in many places. There is no evidence to suggest that void roosting bats have been using the void space within the recent past.

**Figure 5.** The internal aspects of the roof void at Harbour View.
