Arboricultural Implications Assessment and Method Statement

**82A JUBILEE ROAD, WATERLOOVILLE**

Report Ref: **17953 - AIA**

Report Date: **6 October 2017**

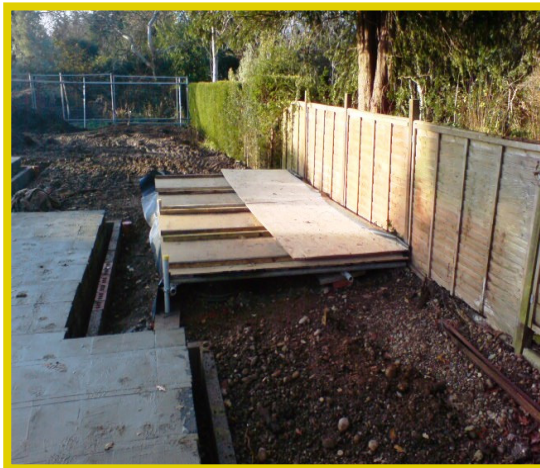
Photograph 1

- a) for pedestrian movements only, a single thickness of scaffold boards placed either on top of a driven scaffold frame (**Photograph 1**), so as to form a suspended walkway, or on top of a compression-resistant layer (e.g. 100 mm depth of woodchip), laid onto a geotextile membrane;
- b) for pedestrian-operated plant up to a gross weight of 2 t, proprietary, inter-linked ground protection boards (**Photograph 2**), placed on top of a compression-resistant layer (e.g. 150 mm depth of woodchip), laid onto a geotextile membrane;
- c) for wheeled or tracked construction traffic exceeding 2 t gross weight, an alternative system (e.g. proprietary systems or pre-cast reinforced concrete slabs) to an engineering specification designed in conjunction with arboricultural advice, to accommodate the likely loading to which it will be subjected.

this instance it is proposed that the ground protection will consist of closely spaced scaffold boards over a compressible layer.

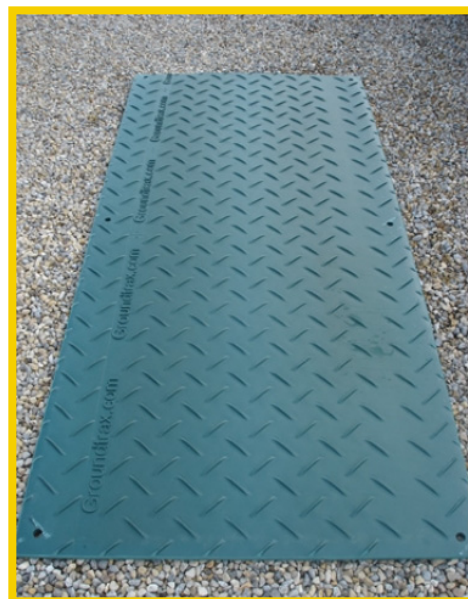
Photograph 2 (courtesy  
[www.groundtrax.com](http://www.groundtrax.com))

New temporary ground protection should be capable of supporting any traffic entering or using the site without being distorted or causing compaction of underlying soil.
