Ground floor west elevation. Window into existing door opening

**Reference - wg.39**

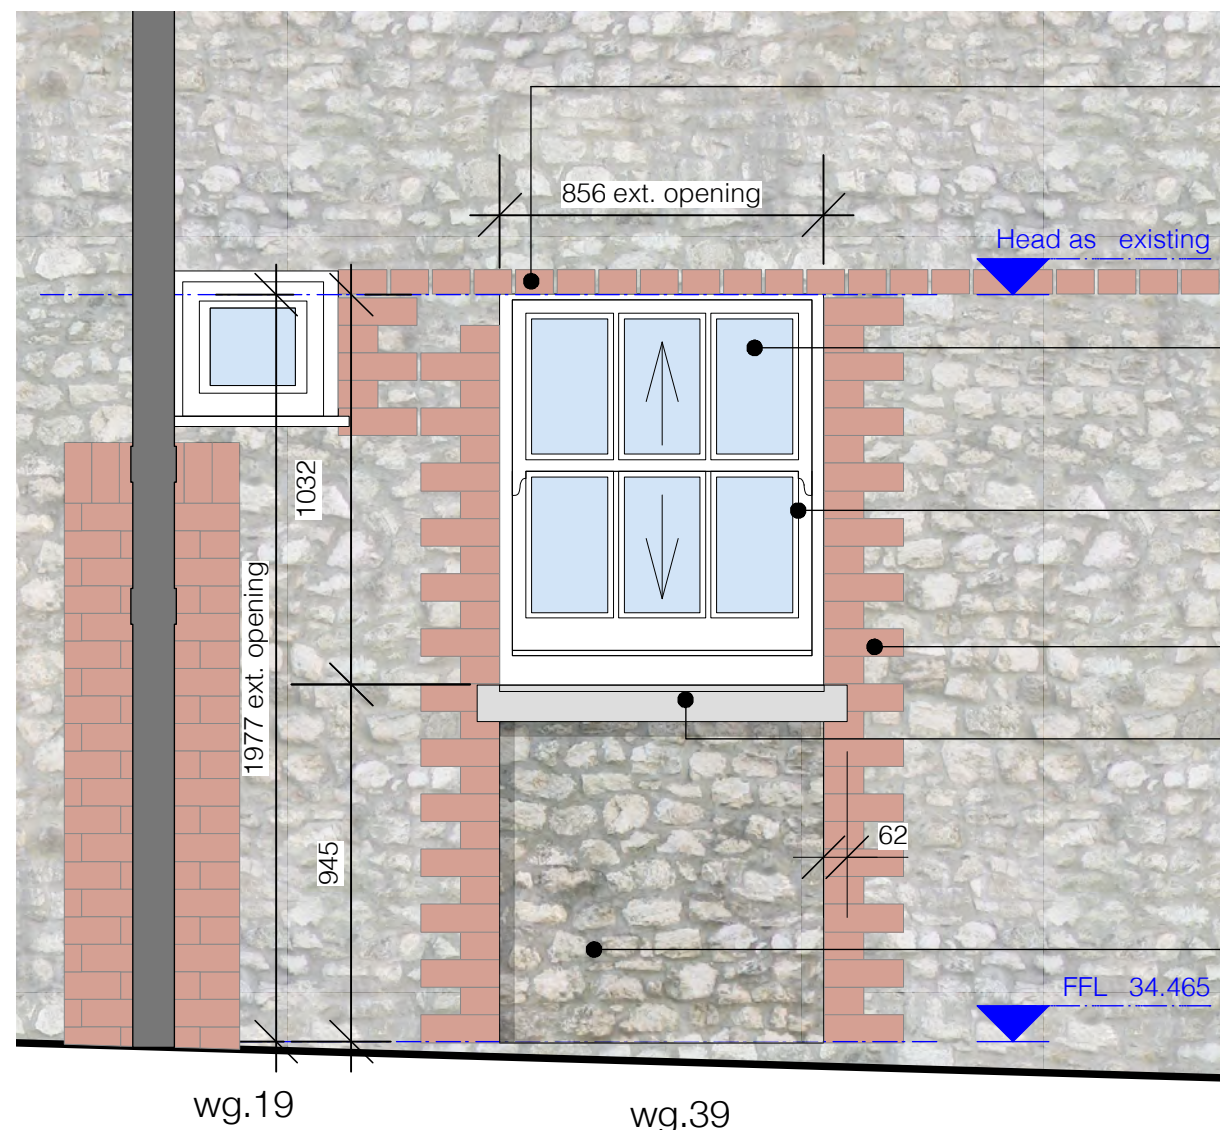
## 1:20 ELEVATION

Existing opening head profile retained

Timber framed vertical sliding sash window to match wf.18

Glazing bar and sash sections to match wf.18

Existing brickwork reveals to opening to be retained

Solid stone window sill to match existing

Flint infill to lower section of window to match existing, slightly recessed from existing building face

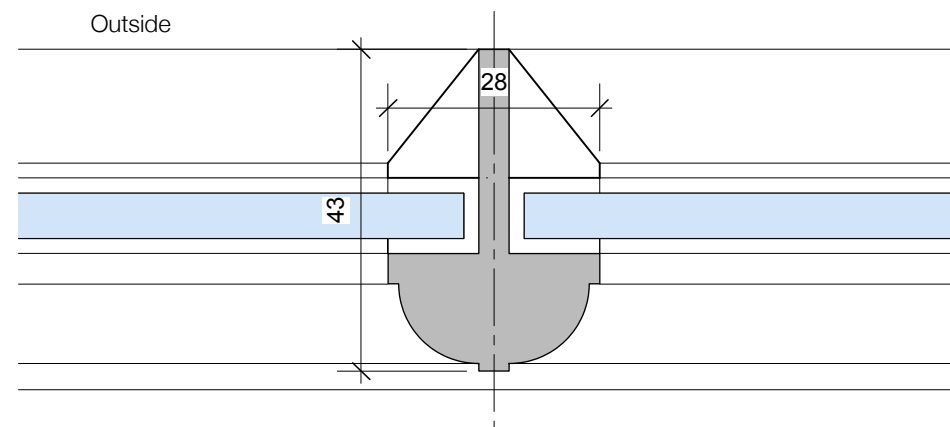
## 1:1 GLAZING BAR SECTION

To match existing window wf.18
