## **Ecological Appraisal**

***Hampshire County Council –  
Highways***

### **Trosnant Junior School, Havant, PO9 3BD**

*2FE to 3FE expansion*

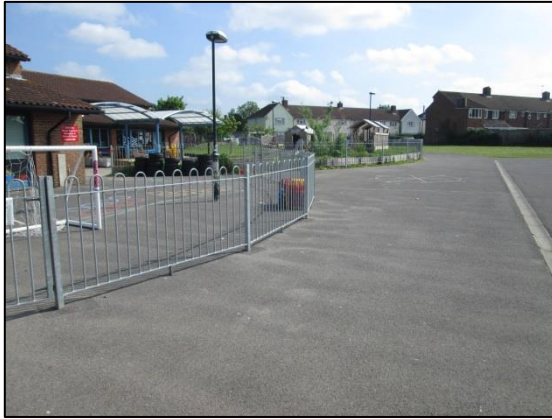
Figure 3 (left): Hardstanding playground to south of school buildings  
Figure 4 (right): School buildings with corrugated concrete pitched roof

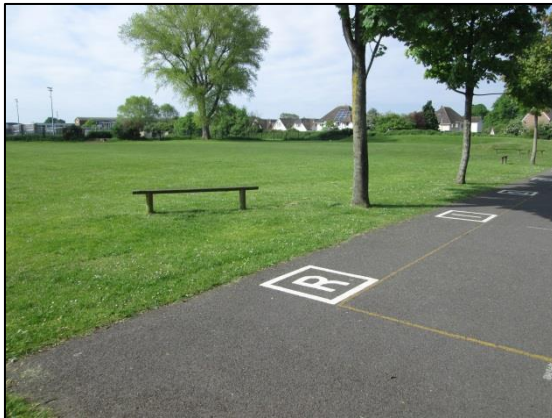
The site comprised of mainly hardstanding (**Figure 3**) and school buildings (**Figure 4**), amenity grassland (**Figure 5**) and scattered planted trees (**Figure 6**) comprising semi-mature sycamore *Acer pseudoplatanus*, silver birch *Betula pendula* and ash *Fraxinus excelsior*.

Figure 5 (left): Amenity grassland on the southern side of the school site  
Figure 6 (right): Planted scattered trees

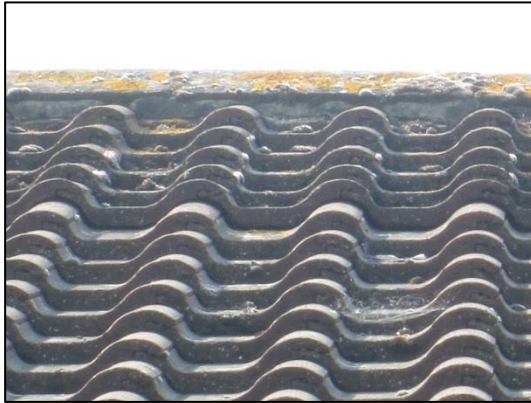
The school buildings on site comprised single storey structures with corrugated concrete tiles. Gaps were identified under loose or broken tiles at points throughout the building (**Figure 7**), with further gaps identified under loose lead flashing (**Figure 8**). In addition, wooden cladding on a north-west section of the building was seen to have several loose boards (**Figure 9**) and gaps from missing mortar (**Figure 10**) were seen on the southern aspect of the building facing the central courtyard of the school, which showed potential to allow space for roosting bats. Overall, the site is considered to offer low potential for supporting roosting bats.

Figure 7 (left): Raised tiles found throughout building on pitched roof

In the unlikely event that a bat or evidence of bats is found during works, all works must cease immediately and professional ecological advice should be sought. In this event it is likely that a licence would be required from Natural England in order to avoid unlawful actions. The process of obtaining a licence can take up to ten weeks, and is subject to requirements of adequate assessment.

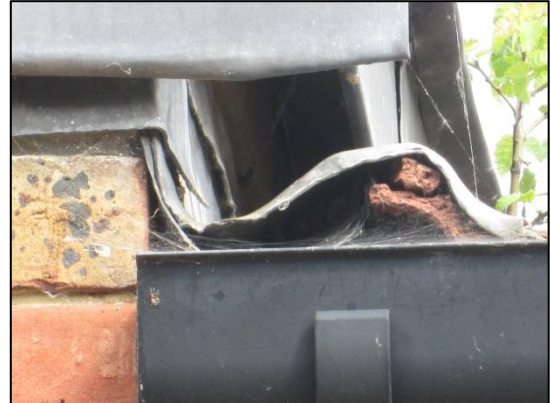
Figure 8 (right): Loose/lifted lead flashing

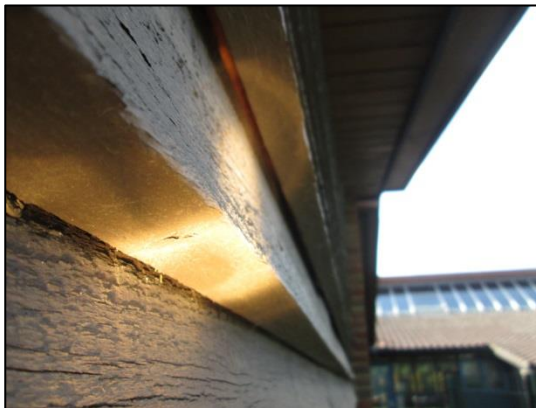
Figure 9 (left): Loose wood cladding on western elevation

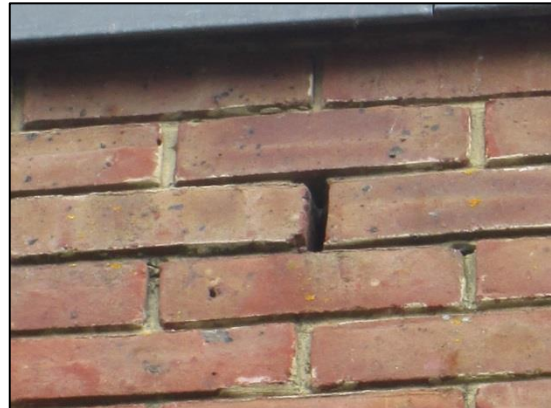
Figure 10 (right): Gap in wall from missing mortar

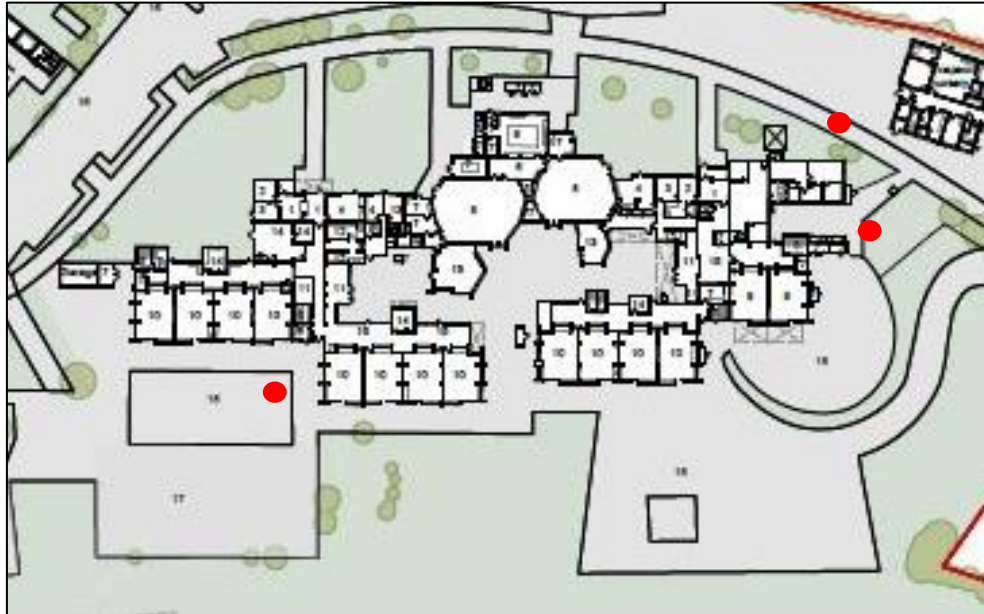
**Figure 11: Existing site plan showing location of surveyors (red circles)**

The surveyors were positioned in order to enable full coverage of the identified gaps in the cladding. The emergence surveys commenced 15 minutes prior to sunset and continued for 1.5 hours after sunset, as detailed within **Table 5** below.

No bats were seen to emerge from any of the features. Other activity on site included recordings of two soprano pipistrelles *Pipistrellus pygmaeus* and four common pipistrelles *Pipistrellus pipistrellus* on the north-eastern side of the site, as well as one distant serotine *Eptesicus serotinus* and a common noctule *Nyctalus noctula* commuting at distance at approximately 20:30.
