## **Bat Scoping Assessment and Emergence Survey**

**The Shallows, Woodgaston Lane, Hayling Island,  
Hampshire, PO11 0RL**

**29<sup>th</sup> June 2016**

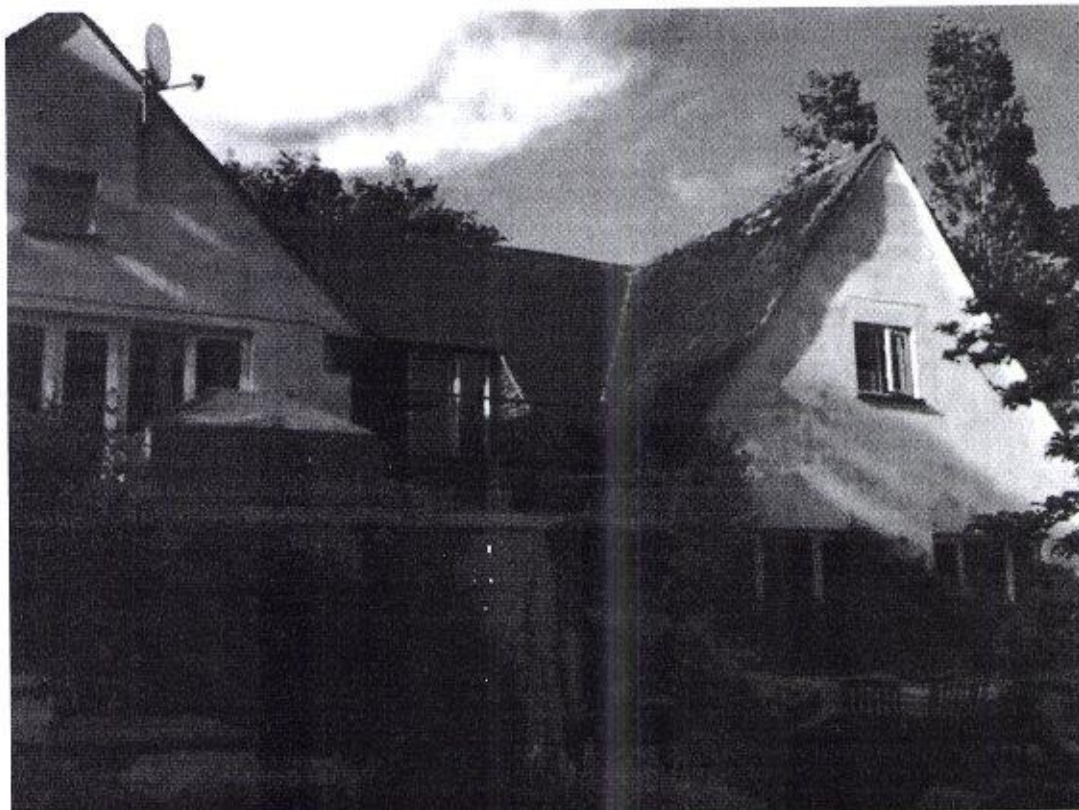
The main house and double garage is set within a large footprint and is surrounded by tightly mown lawns, a patio and a large area of hard standing, parking and turning area to the north of the house (Figs. 3 & 4). The large double garage is to the west of the house.

The house is constructed of brick and is rendered (Figs. 3 & 4). The structure supports largely tight-fitting concrete roof tiles (Figs. 3, 4 & 6), with small areas of hanging tiles upon the east and south facing aspects, fringing small balcony areas (Fig. 5). A small area upon the southwest facing roof pitch, supports a small number of looser fitting tiles (Figs. 2 & 6). These loose roof tiles have a moderate potential to support small numbers of crevice roosting bats. A number of the hanging tiles upon the east and south facing aspects of the house support missing or loose fitting tiles (Fig. 5). These gaps were inspected with an endoscope. There was no evidence to suggest that the gaps between the hanging tiles have been used by bats as roosting space recently.

Figure 4. The south facing aspect of the house at the Shallows.
