## Ecological Appraisal

### **Godbey House, Hayling Island**

*Children's home to be vacated*

January 2015

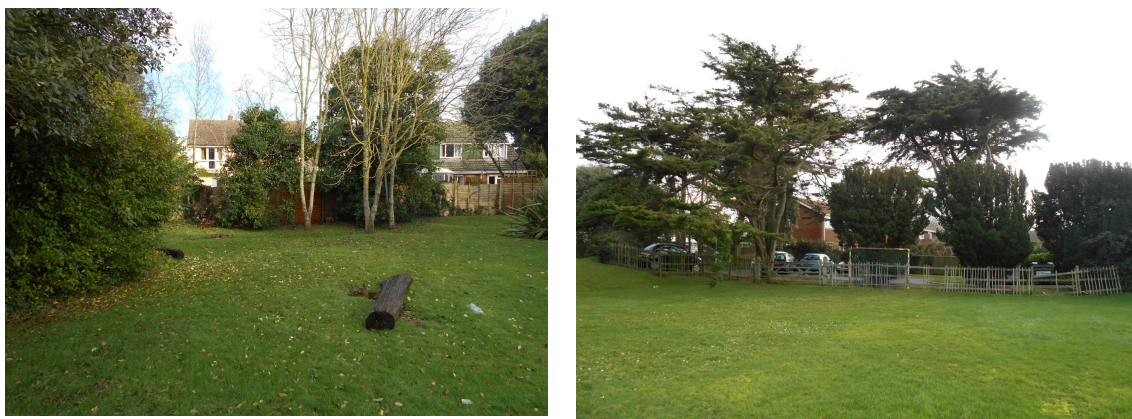
The garden areas include unmanaged boundaries no more than 0.75m wide with species such as ivy *Hedera helix* and thistles *Cirsium* spp. prominent.

Figure 1: Habitats in the garden areas of the site include amenity grassland and scattered mature trees

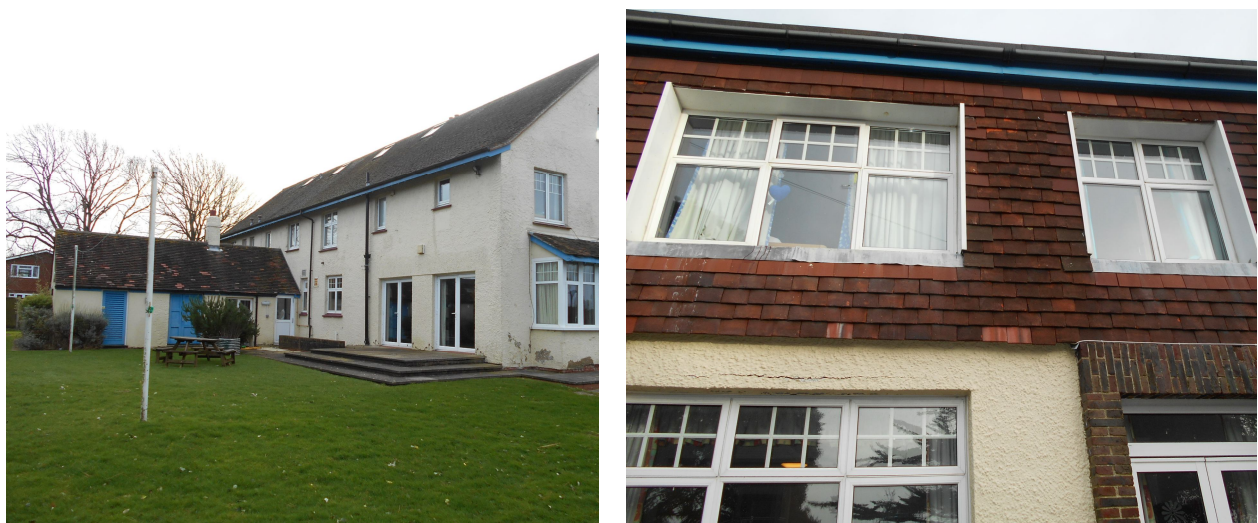
structure were observed to be in good condition with no gaps observed. Photographs of the building are included on Figure 2 below.

It was possible to access all of the main roof voids. These generally contained rock wool insulation and *Tyvek* membranes to the roof. Exposed brick walls formed the eastern and western ends of the building. No evidence of roosting bats was found within the voids and no potential egress/ entry points were identified.

Several gaps underneath the clay tiles on the roofs of the main structure and extensions to the north and east were observed. In addition, gaps underneath the hanging tiles on the southern, eastern and western aspects of the southern extension were observed.

**Overall, the building is assessed to have moderate potential to support low numbers of common bat species.**

Figure 1: (left) Showing the northern elevation of the building and (right) showing the extension to the south of the building. No evidence of roosting bats was identified in the roof voids, but

numerous gaps under clay tiles have the potential to support small numbers of roosting bats.

Stage 2 bat surveys are likely to be required to determine the presence or likely absence of bat roosts from the building, and will therefore be required prior to the submission of planning permission. Stage 2 bat surveys should include at least two visits spaced month apart during the suitable survey season of May-August inclusive. Where bats are found to be roosting, a European Protected Species Licence from Natural England is likely to be required, informed by an appropriate mitigation strategy.

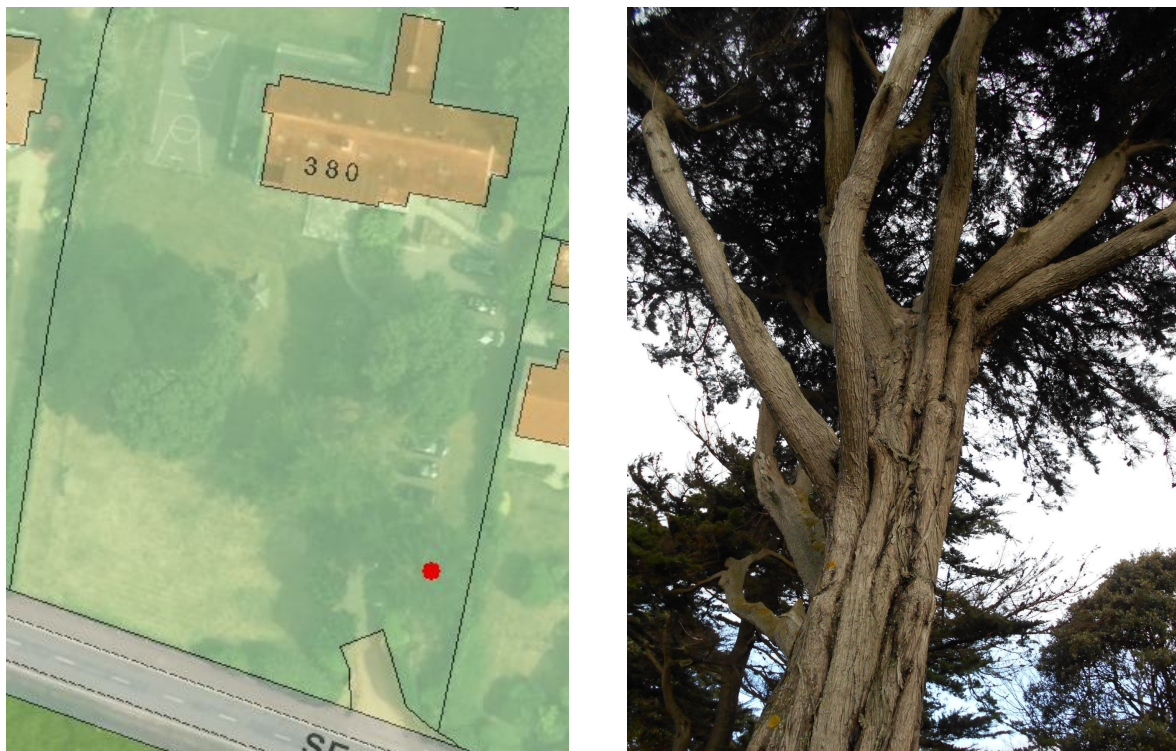
A mature Cypress tree to the south east of the site was observed to have deep crevices at a height of approximately 5m. The tree has been assigned to Category 1, and is assessed to have **low potential to support roosting bats**, see Figure 3 below.

Figure 3: One of the trees on site was assessed as having potential to support roosting bats. The location of the tree is indicated by the red dot.
