### **ZETICA LTD UXO DESK STUDY AND RISK ASSESSMENT**

## St Mary's Road, Hayling Island - UXO Desk Study & Risk Assessment

**Document Title** UXO Desk Study & Risk Assessment  
**Document Ref.** P6125-16-R1  
**Revision** A  
**Project Location** St Mary's Road, Hayling Island  
**Client** The LK Group  
**Date** 9<sup>th</sup> September 2016

### St Mary's Road, Hayling Island

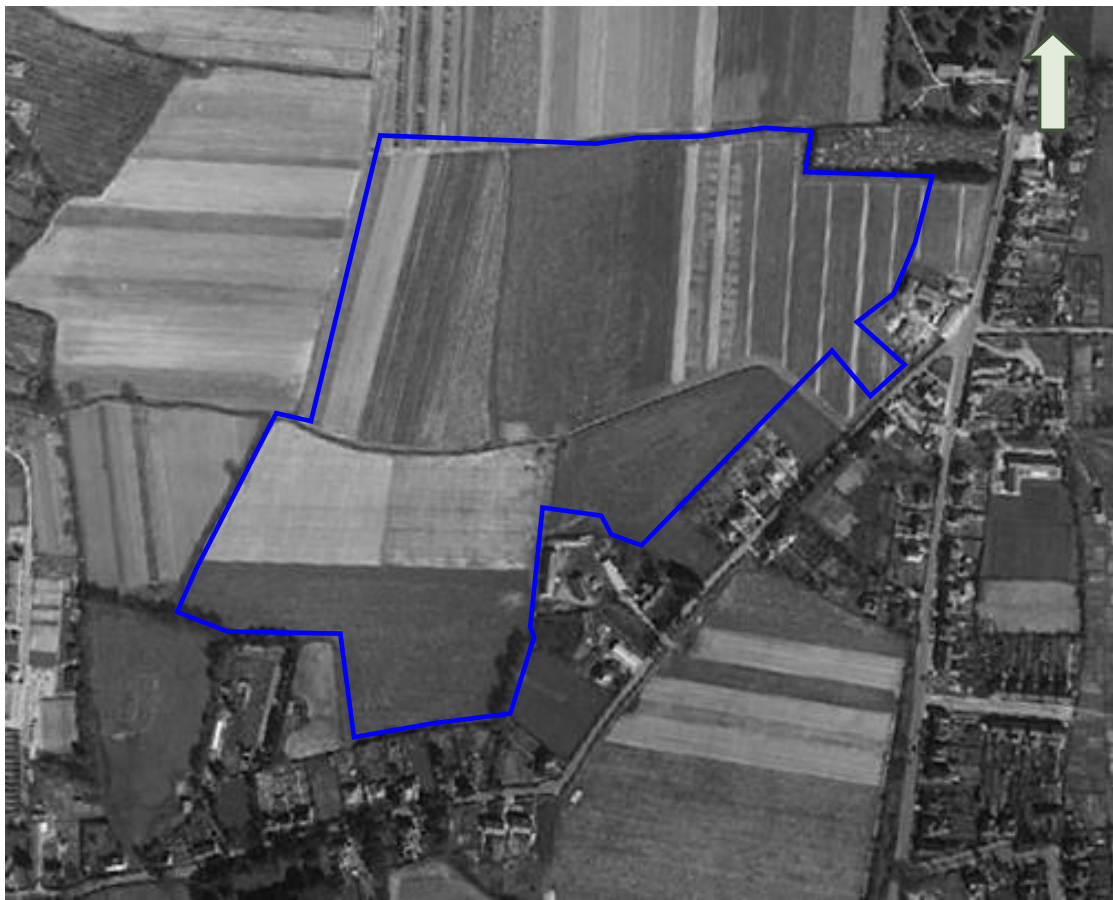
Plate 2, an aerial photograph dated the 17<sup>th</sup> April 1951, shows that no significant changes had occurred on the Site post-WWII.

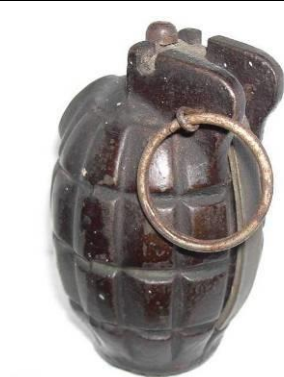
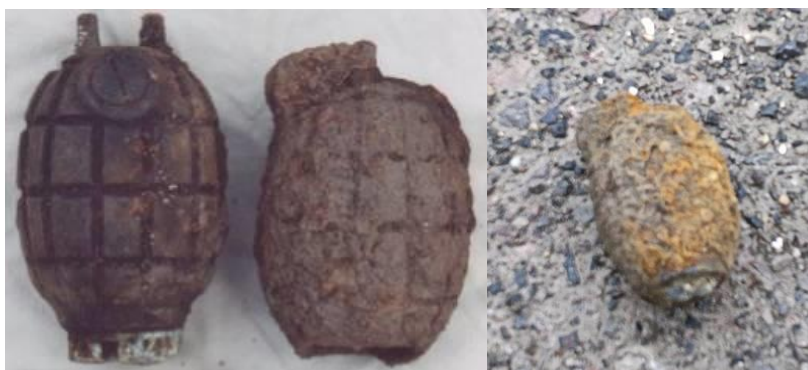
| <b>Plate</b> | Photographs of a typical and an excavated WWII No. 36 hand grenades |

Some, such as smoke grenades, are activated instantly when the lever is released. The Plate below illustrates the typical character and condition of No. 36 hand grenades (Mills Bombs) that have been excavated from a site.

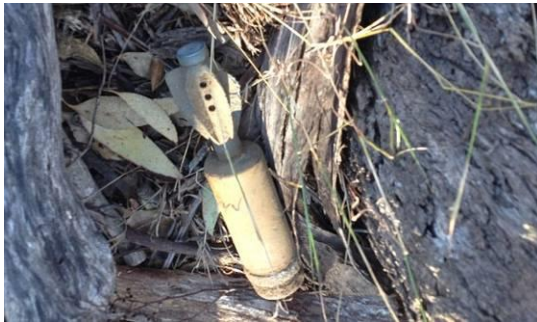
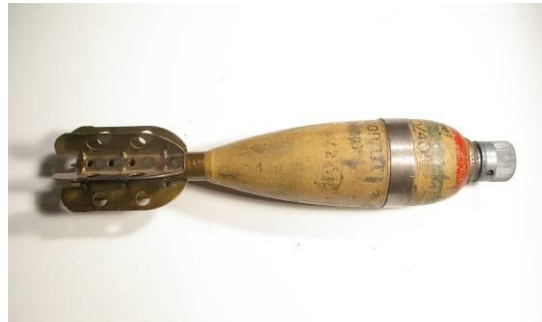
| <b>Plate</b> | Photographs of WWII 2-inch and 3-inch mortars |

The Plate below shows a typical 2-inch mortar bomb found (left) and a demonstration 3-inch mortar bomb (right).

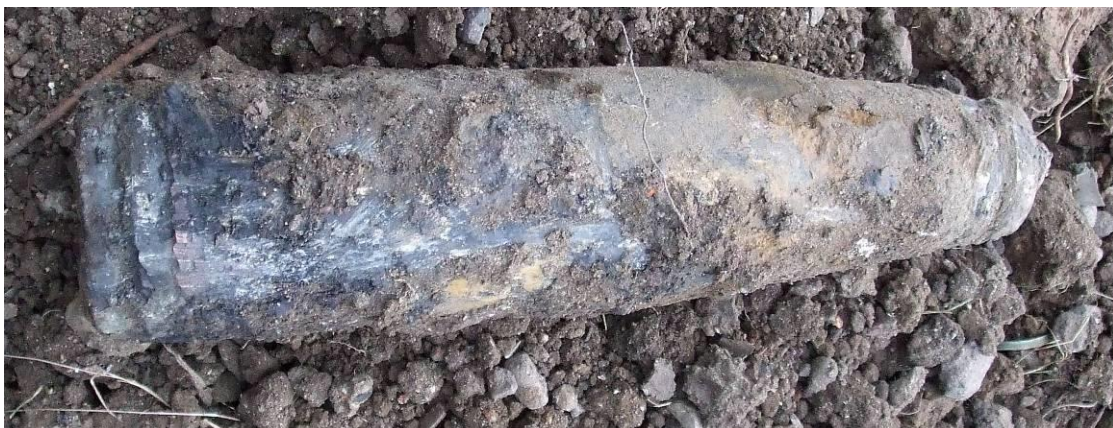
| <b>Plate</b> | Photograph of a recently excavated 3.7" AA shell |

The Plate below is a photograph of a 3.7" UXAA shell found in Camberwell, London.

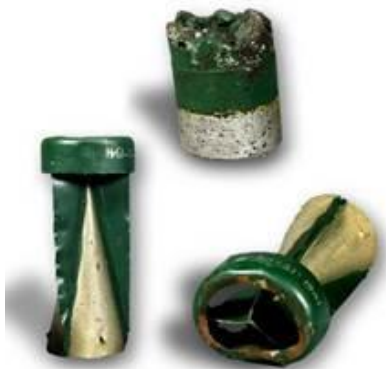
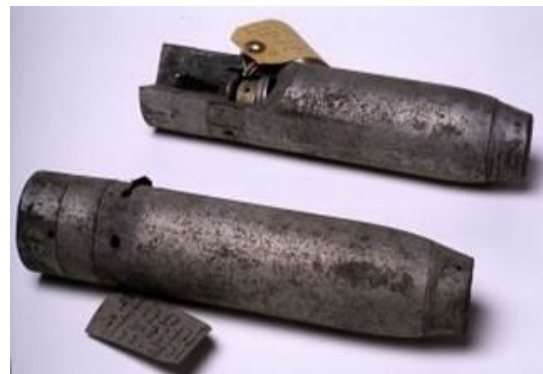
| <b>Plate</b> | Photographs of typical fragmentary remains of IBs and a UXIB |

The Plate below shows a typical variety of fragmentary remains of IBs and 2No. IBs recovered by the Civil Defence during WWII.

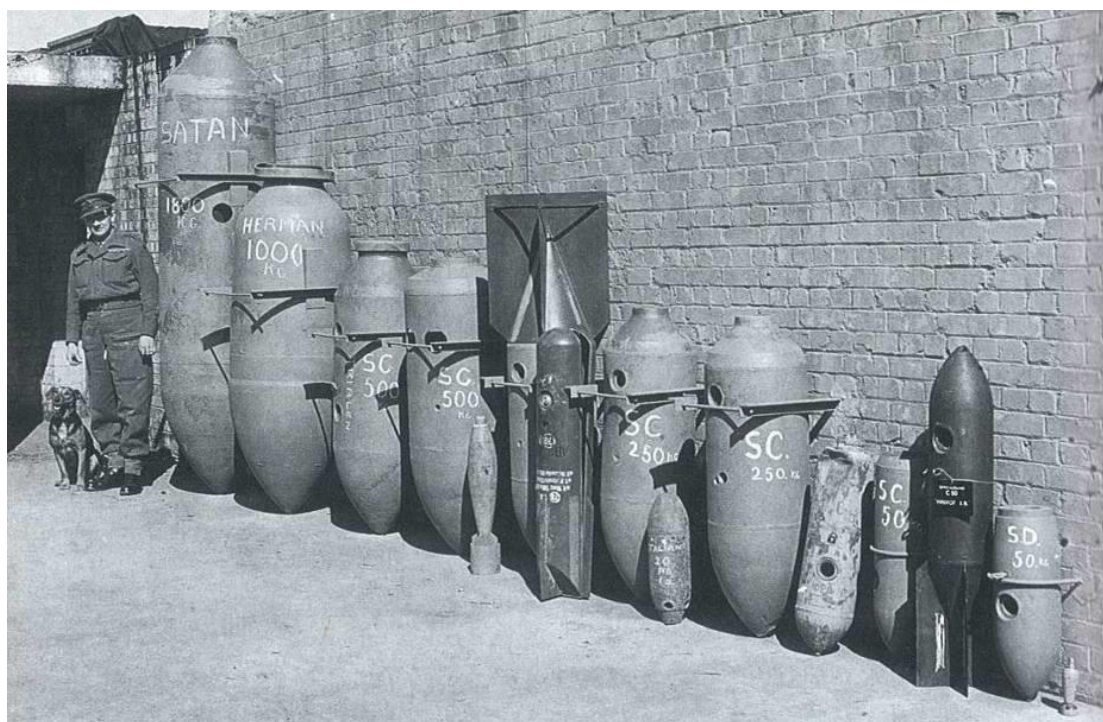
| Plate | Photograph of a variety of UXB recovered by the Civil Defence during WWII |

The Plate below shows the variety of UXB recovered by the Civil Defence during WWII.

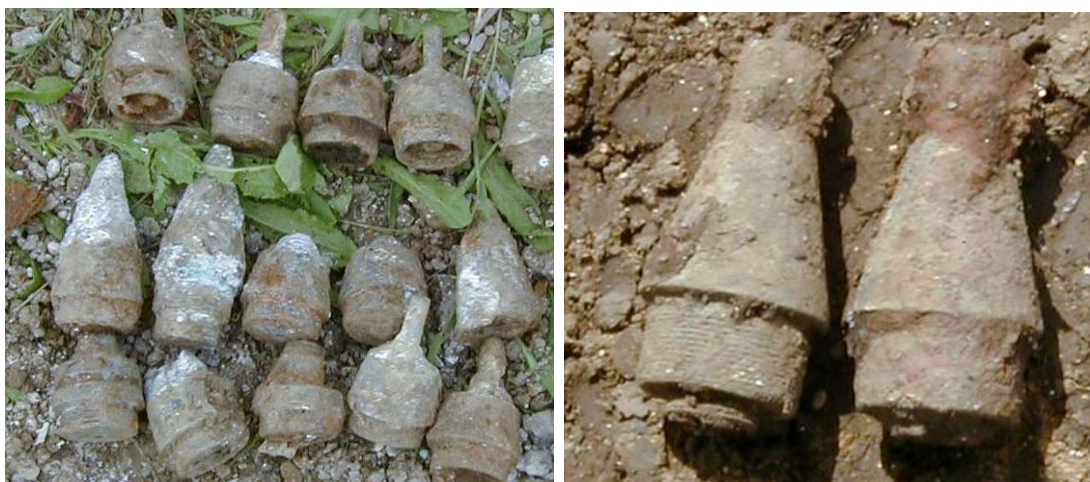
| Plate | Photographs showing examples of WWII fuzes |

A wide variety of these components were used and examples of some common fuzes are shown in the Plate below.

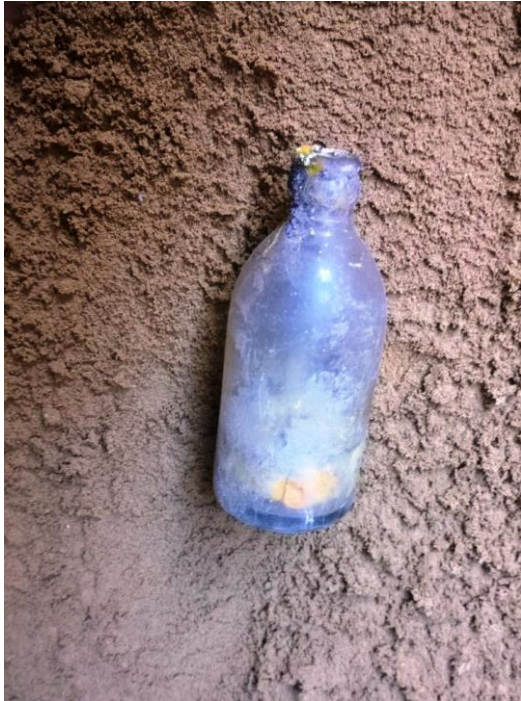
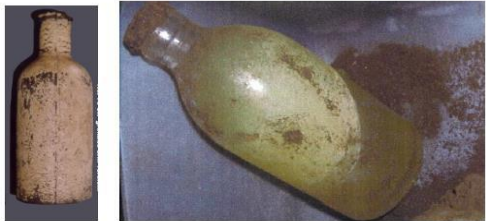
The Plate below is a photograph of a No. 76 SIP grenade (LHS) with an explanatory leaflet produced by ZeticaUXO for site staff (RHS).

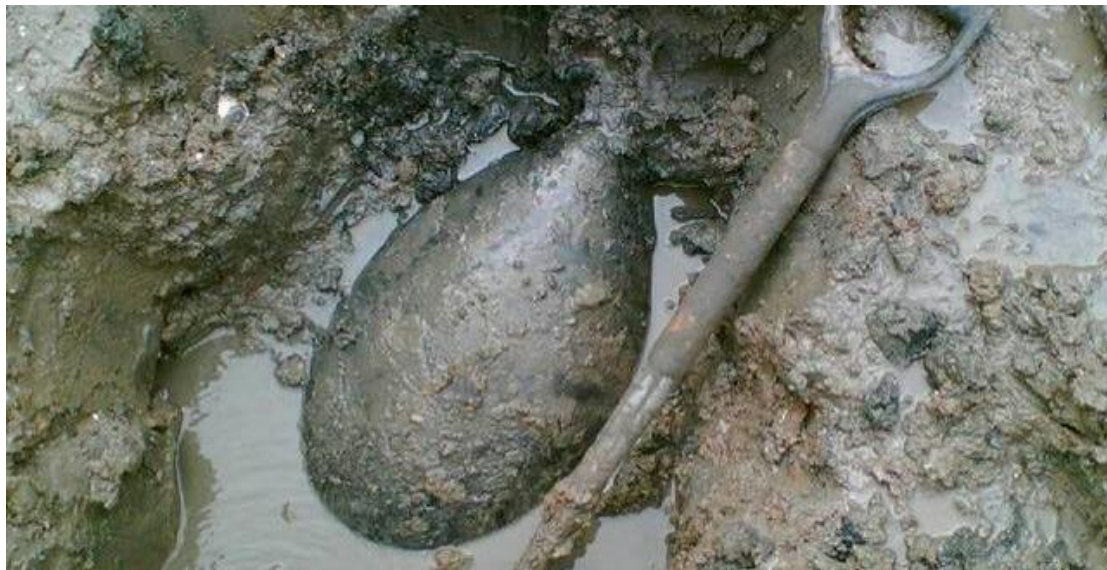
| <b>Plate</b> | Photograph of the 500kg WWII UXB at Bowers Marsh, 8 <sup>th</sup> March 2010 |

The Plate below is a photograph of the bomb in situ.

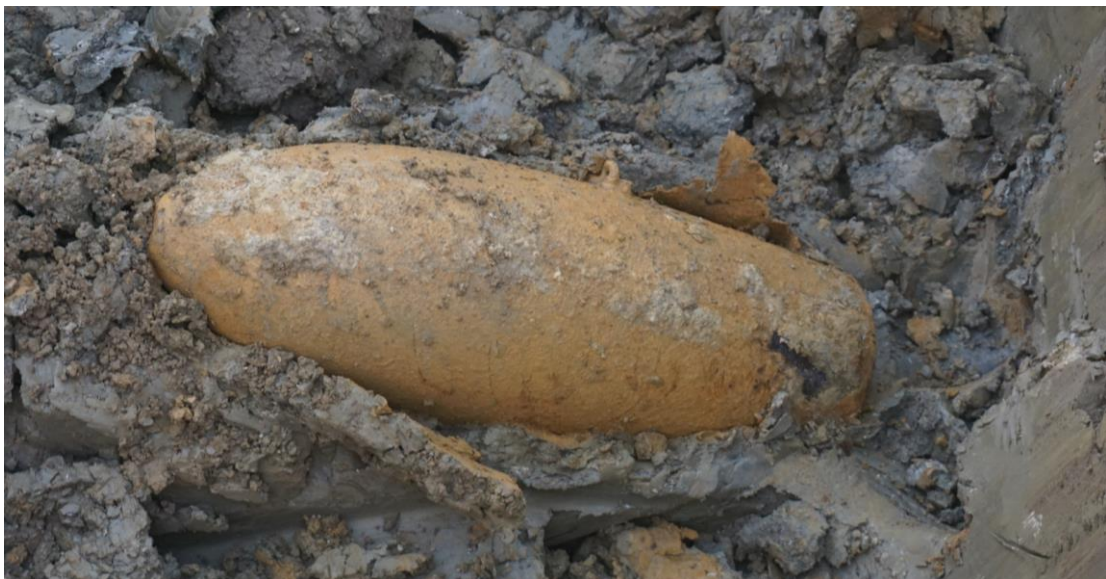
In January 2016, Zetica discovered 3No. 500lb British UXB at a former airfield in Cambridgeshire. These were destroyed in controlled explosions. The Plate below is a photograph of one of the bombs.

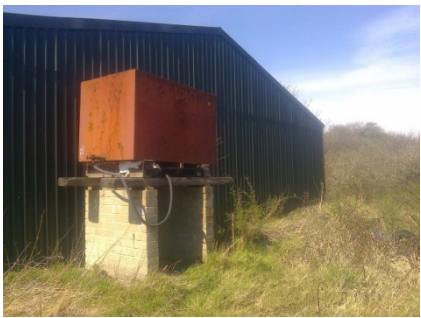
Photograph 8 (P8)  
Above ground fuel tank in the centre of the study area.

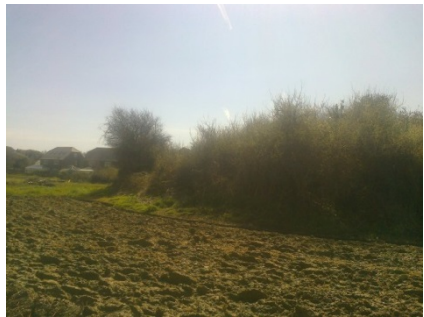
Photograph 10 (P10)  
Mound in the centre of the study area.
