Our Ref: **16381-Let1-AN**

21 February 2017

**Re: Pre-commencement tree protection visit at Woodcroft Farm, Waterloooville.**

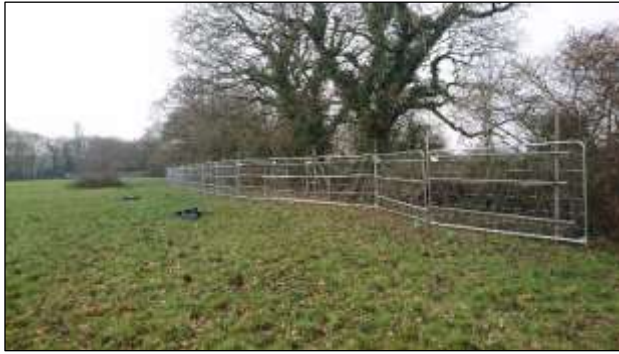
Whilst on site I took several photos for reference which are included below. I can confirm that all the tree protection fencing was erected in the correct locations and was fit for purpose. I noted that the ground protection opposite trees 13 to 16 had not yet been installed. Mr Smith confirmed that it is his intention to erect fencing in this area prior to commencement to ensure these areas are protected. Mr Smith has agreed to photograph these areas after installation and forward me those photographs. I will in turn send these on to you via email.

**Photo 1:** Protective fencing within paddock looking south.

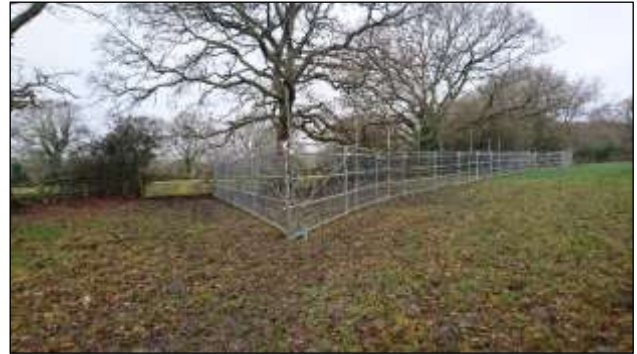
**Photo 2:** Protective fencing within paddock looking north.

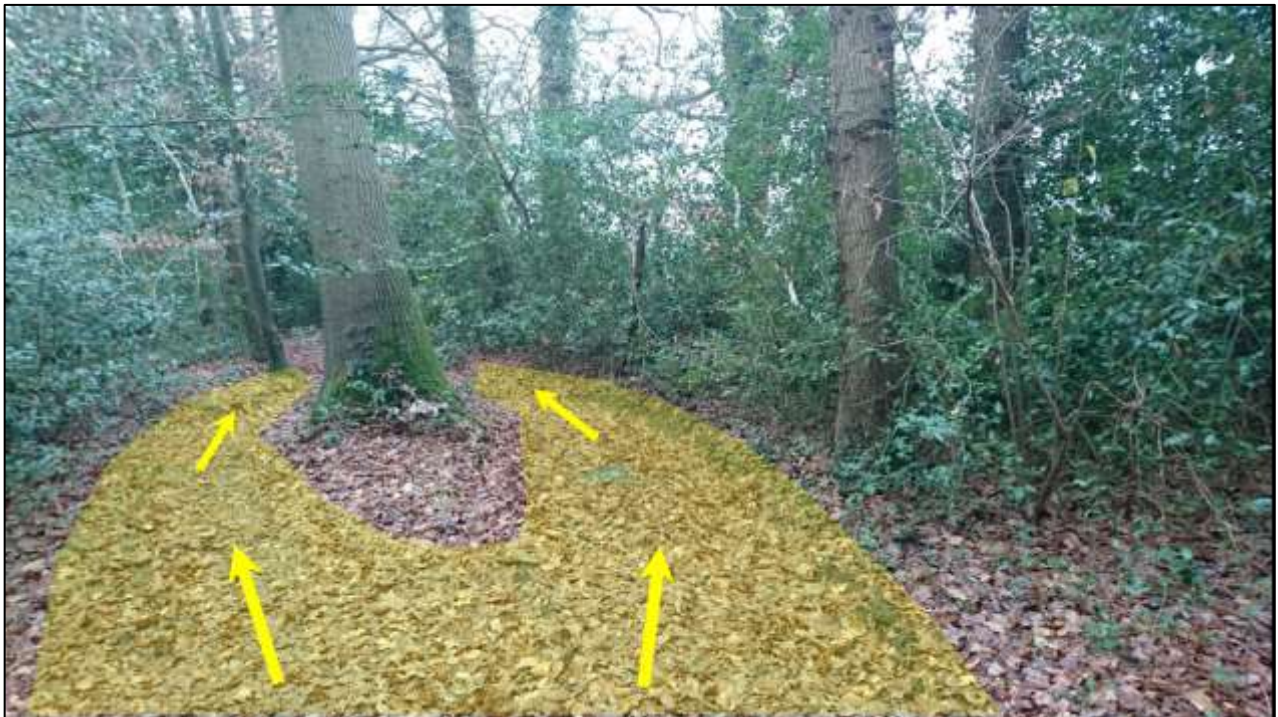
During the site visit I was able to identify with Ms McGinty and Mr Smith a preferred route through the north-western section of woodland 22 which allows the bridleway to meet the existing byway without the need to remove any large trees. It was also agreed that the new bridleway could be installed either side of tree 23 to prevent a pinch point with trees to the south. We discussed the large dead stem at the eastern end of woodland 22 with the ecologist and agreed on its retention at this stage of the development. For the sake of clarity, I also spray marked each tree marked for removal along the byway.

**Photo 3:** Showing T23 with the bridleway routed either side.
