## **SITE INVESTIGATION & CONTAMINATION APPRAISAL REPORT**

**CONTRACT:** Hayling Billy Public House  
117 Elm Grove  
Hayling Island  
Hampshire  
PO11 9ED

**REPORT NO:** 16-73724/BG/SI&CAR

**DATE:** 7 July 2016

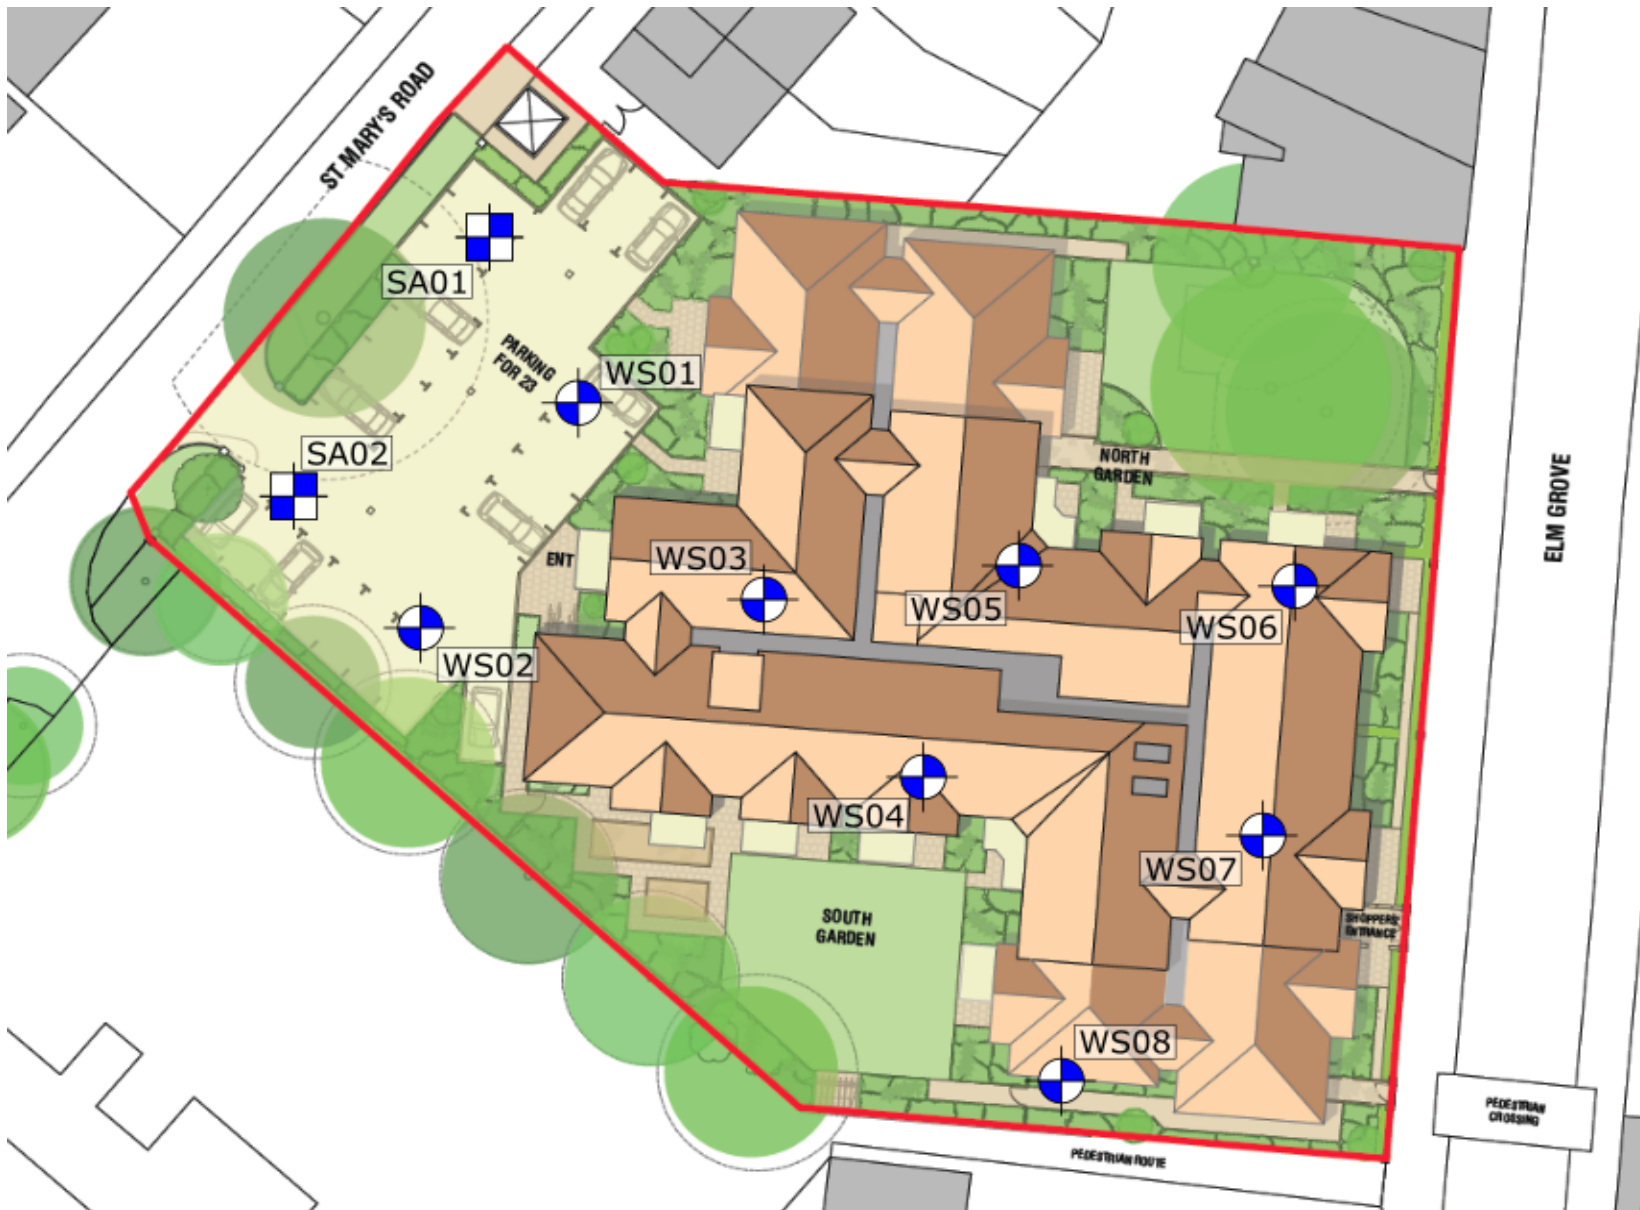
EXPLORATORY HOLE LOCATION PLAN – 16-73724/02

- 3.0.1 An intrusive investigation was undertaken by ACS in June 2016. Exploratory hole locations were selected by ACS to give good coverage of the site enabling decisions to be made in relation to contamination and to provide geotechnical information to aid with future foundation design.
- 3.0.2 Utility plans supplied to ACS by the Client were assessed prior to the intrusive works. A Cable Avoidance Tool (CAT) was used to confirm the location of services prior to drilling at each exploratory hole location. Hand dug pits were excavated to 1.00m as a precaution against unidentified buried services before drilling commenced.
- 3.0.3 An Exploratory Hole Location Plan showing the ACS investigation is included as Appendix B.
