# Havant Thicket Reservoir New Pipeline Scheme

## Bat Survey Report

Portsmouth Water Ltd.

November 2024

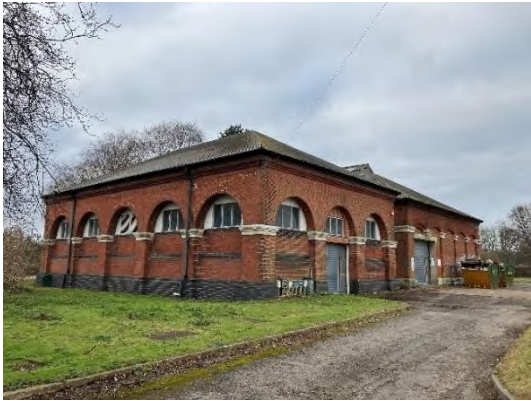
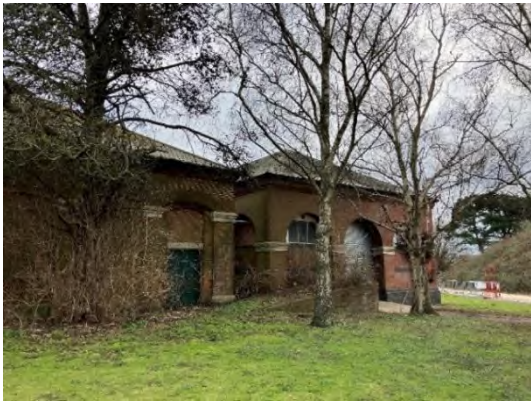
| Location | Description | Photo |
|---|---|---|
| The Training Room | <p>Lifted slate tiles that provide potential access points for bats</p> <p>Large gaps above the drainage pipes.</p> <p>Gaps under barge boards at the top of the walls that may provide access to bats into cavities.</p> | |

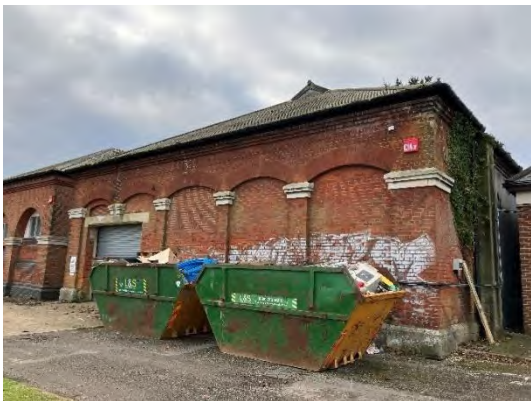
| Location | Description | Photo |
|---|---|---|
| The M & E Store | <p>This building was previously confirmed as a common pipistrelle roost.</p> <p>Lifted slate tiles and gaps under roof boarding on the apex that provide potential access points for bats.</p> <p>Large gaps above the drainage pipes into inaccessible (to surveyors) cavities.</p> <p>Gaps under barge boards at the top of the walls that may provide access to bats into cavities.</p> | |

- 4.1.4. No bats were recorded emerging from the M & E Store during the surveys, however, as this building is a historical roost, it is recommended the works are conducted under a Precautionary Method of Works (PMW). Further details are outlined in Section 4.2 below.

- 4.2.1. The works to Bedhampton 1 are considered unlikely to cause disturbance to the existing bat roost and therefore can be undertaken under a PMW, subject to final details on the ceiling works. The PMW will cover suitable timings for the works, suitable methods to be used during the works and actions to take in the unlikely event a bat is encountered during the works. The PMW will also detail the requirement for the presence of a bat licensed ecologist and a toolbox talk to be delivered to all contractors prior to the commencement of works. As the building has been assessed as having suitable hibernation habitat for common pipistrelles, it is recommended the works avoid the hibernation period for bats (November to March, temperature dependant).

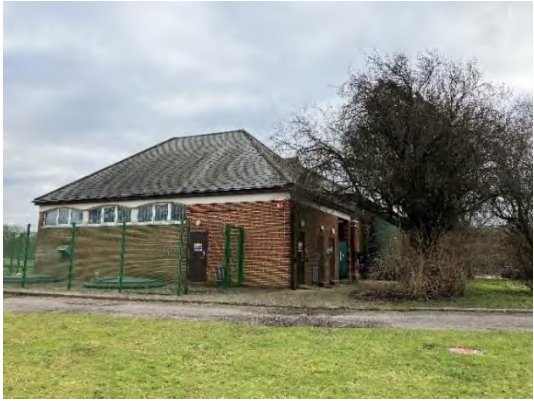
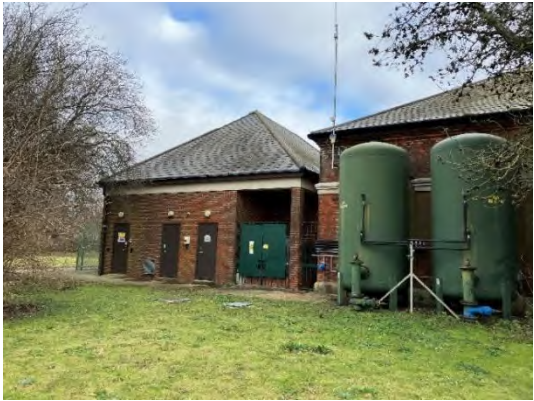
| Location | Description | Photo |
|---|---|---|
| The Pumping Station | Missing hip tiles on the roof of this building, that may lead to gaps in the mortar providing access to bats.<br>Gaps under roof tiles that bats may access. | |

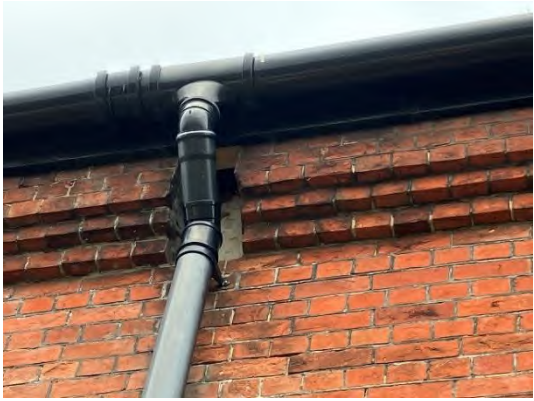
| Location | Description | Photo |
|---|---|---|
| The M & E Store | Potential entrance / exit point from gap behind drainage pipe.<br>Emergence point of previous roost recorded here <sup>33</sup> . | |

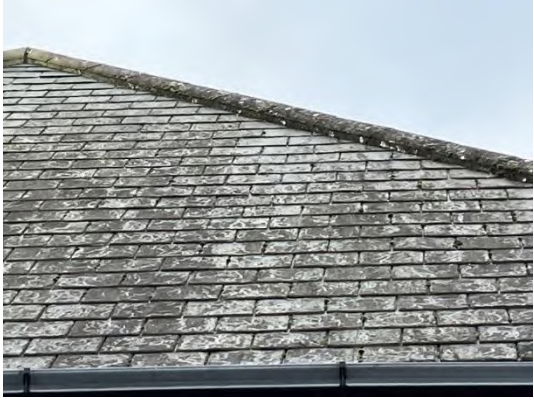
| Location | Description | Photo |
|---|---|---|
| The Pumping Station | Gaps under roof tiles potentially providing access points into roof void. | |

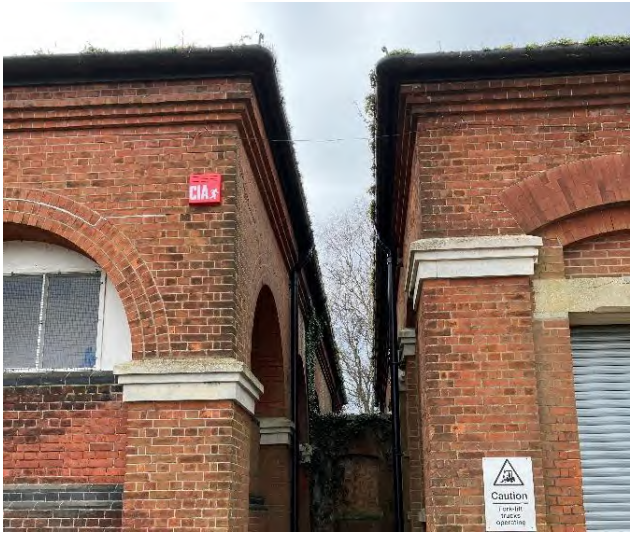
| Location | Description | Photo |
|---|---|---|
| The Training Room and M & E Store | Potential roosting features between loose roof tiles and guttering, as well as loose bricks and cracks in external walls between the Training Room and M & E Store. | |

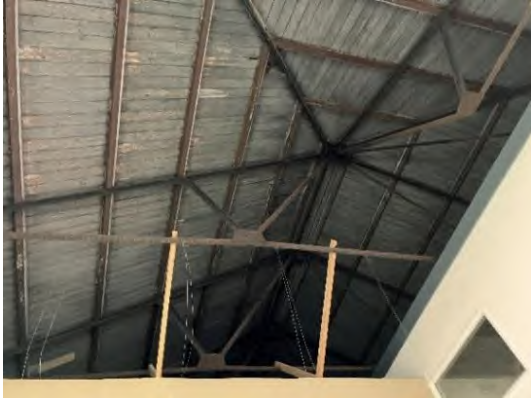
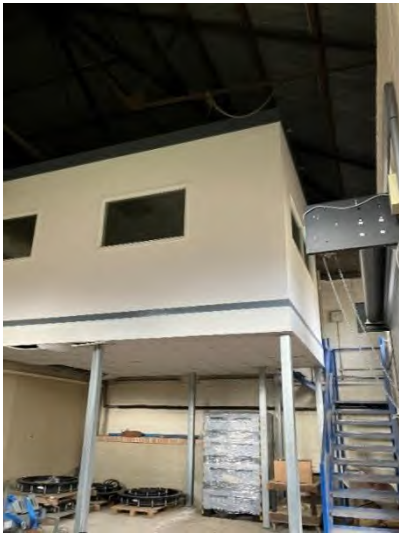
| The Training Room (eastern side) | <p>The building was split internally into two rooms: the eastern and western rooms.</p> <p>The building interior had a timber / metal framework, with timber cladding directly beneath the roof tiles. There was potential for crevices between the roof tiles and cladding with occasional bat access points to the building interior visible.</p> <p>The eastern room is open to the roof void.<br/>Bottom photo shows setup of static detector.</p> | |

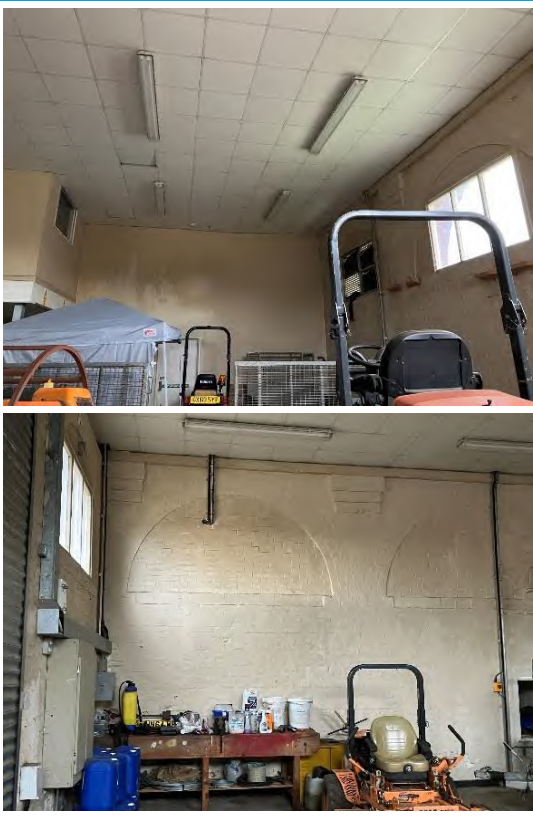
| Location | Description | Photo |
|---|---|---|
| The Training Room (western side) | Suspended ceiling with occasional missing panels leading to open roof void. Occasional gaps into interior cavities from pipework. | |

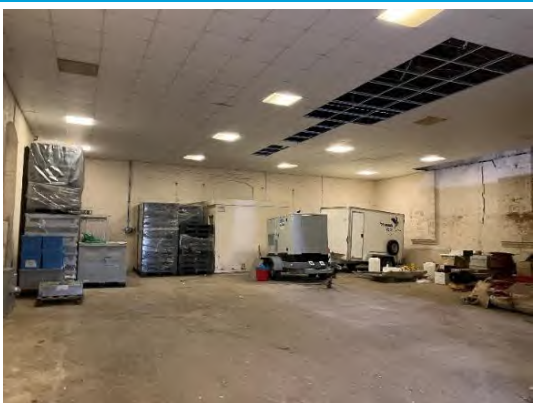
| Location | Description | Photo |
|---|---|---|
| The M & E Store | <p>Large roof void above partial suspended ceiling.</p> <p>The building interior has a timber / metal framework, with timber cladding directly beneath the roof tiles, there was potential for crevices between the roof tiles and cladding with multiple bat access points to the building interior visible.</p> | |

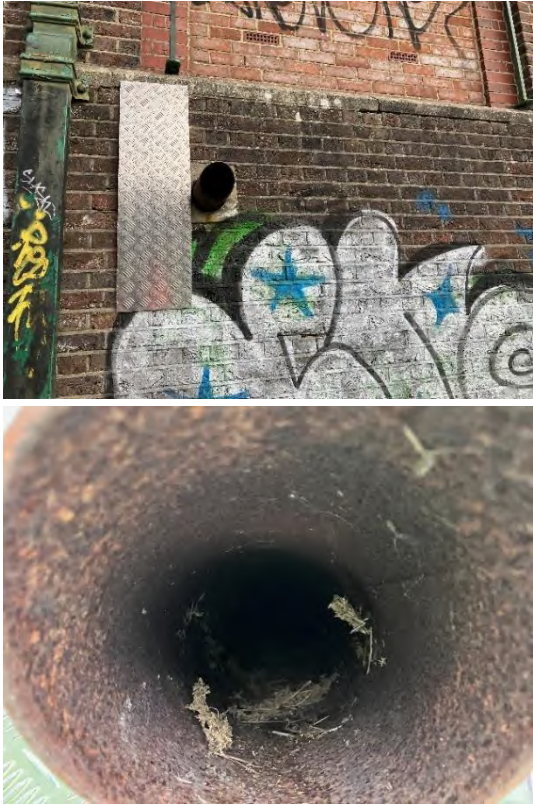
| Location | Description | Photo |
|---|---|---|
| | <p>External pipe on Bedhampton 2 with evidence of disused birds nest inside, potential access point for bats, does not lead directly into interior of building.</p> | |

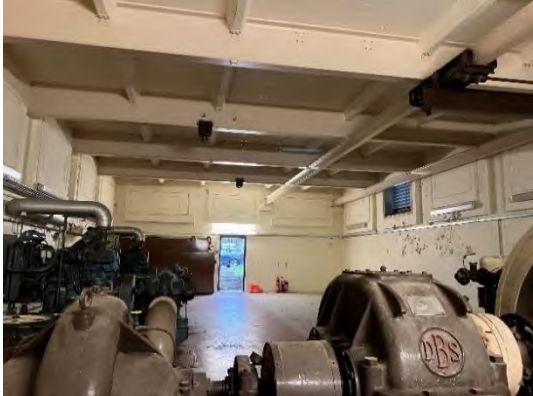
| Bedhampton 2 – Internal Assessment | | |
|---|---|---|
| | <p>Single window with grill on the north-eastern elevation.</p> <p>A gap under the grill the length of the window on the north-eastern elevation was present and considered to offer access to bats.</p> <p>A cavity directly under the window was present. This feature was inspected with an endoscope and no evidence of bats was found at the time.</p> | |

- 4.2.2. Although no roost was recorded within Bedhampton 2, due to the presence of suitable roosting features, the proximity of the building to a confirmed roost, suitable adjacent habitat and bat activity in the area, it is recommended that the works to the building are undertaken under a PMW as detailed above.

- 4.2.3. It is recommended that integrated bat boxes are installed on the newly constructed section of Bedhampton 2 to provide an enhancement for local bat populations. Details for locations, specifications, positioning and management will be detailed in an Ecological Management Plan (EMP) for the site.

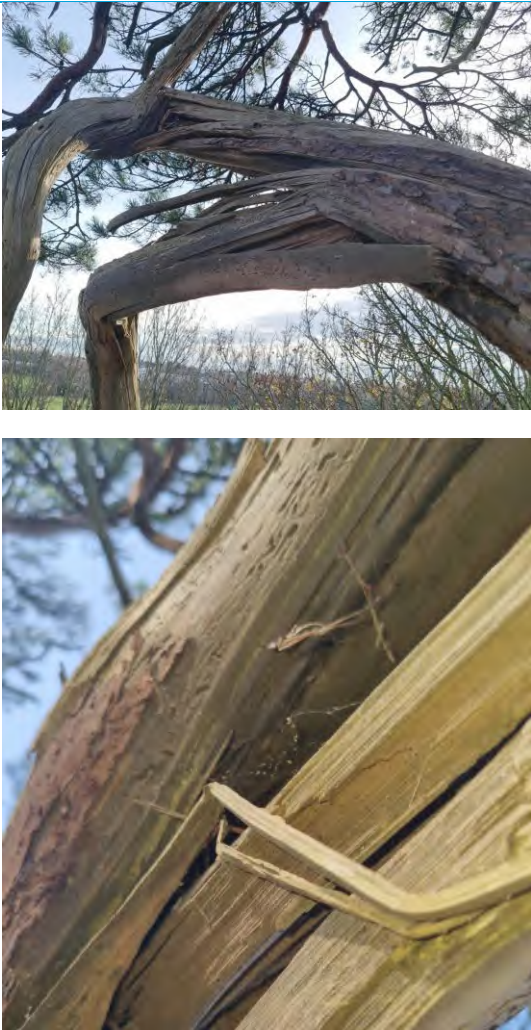
| Tree Number | Image |
|---|---|
| T191 | |

| Tree Number | Species | Feature Number, Height and Orientation | PRF | Estimated Suitability | Further Surveys |
|---|---|---|---|---|---|
| T191 | Scot's pine | F1: 12m, W | Hazard beam with numerous small locations suitable for multiple roosting bats | PRF-M | Climbing surveys |

| Tree Number | Species | Feature Number, Height and Orientation | PRF | Verified Suitability | Result |
|---|---|---|---|---|---|
| T191 | Scot's pine | F1: 12m, W | Hazard beam with numerous small locations | PRF-I | No bats recorded present; suitability of hazard beam reduced from PRF-M to PRF-I. New PRF-M feature discovered. |

- 3.2.18. Two of the trees were subject to climbed inspection surveys between 10/08/2024 and 24/09/2024. The climbed surveys resulted in the change in assessment for the hazard beam feature on T191, with the assessment being reduced from PRF-M to PRF-I. A new feature was also encountered on T191 during the climbed surveys. This was a woodpecker hole and was assessed as being PRF-M. The assessment of the oak in G192 remained the same following the climbed inspections.

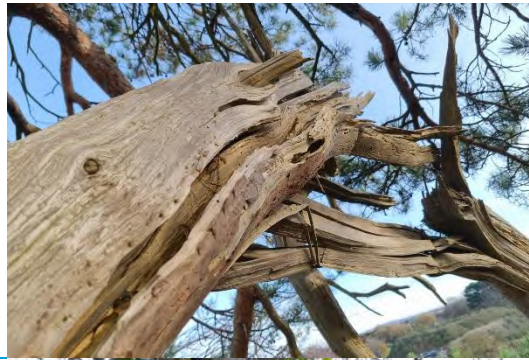
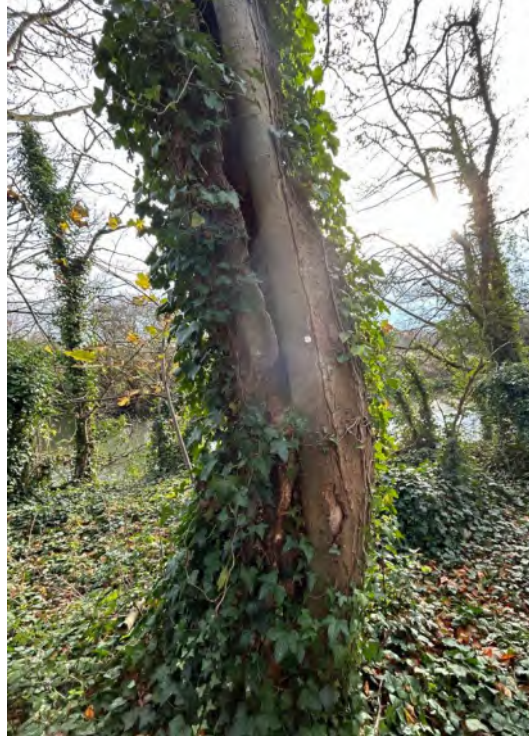
Sycamore  
G192

- 3.2.20. The sycamore in G192 was assessed as being unsafe to climb as the tree was dead and therefore was subject to emergence surveys. The oak in G192 was safe to climb in parts, however other sections were considered less safe, and the features PRFs could not be fully inspected, therefore emergence surveys of this tree were undertaken in conjunction with the climbs.
