Project: CHY01

**Site: 50-56 Creek Road, Hayling Island, PO11 9RE**

## Appendix A – CCTV Survey

## Appendix B – Drainage Layout Plan

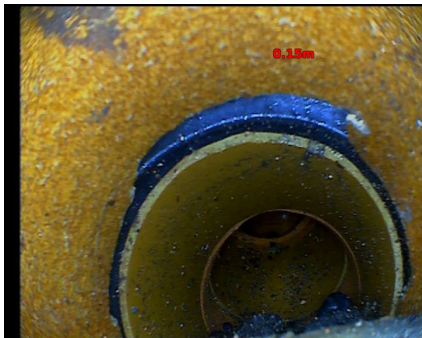
Observation [3]:  
damaged plastic to clay pipe

- The drains are 4" plastic.
- Depth 300mm - 420mm.
- MH2 to gully – Broken clay to plastic.
- MH2 – Lateral 1 redundant.
- MH2 – Lateral 2 redundant.
- MH4 – Lateral 1 redundant.

**It is recommended that the following repairs are carried out to restore full function to the system.**

- Excavation to access pipework.
- Gully to be refitted.
- To install 1m of OSMA pipe.
- Gound to be reinstated – Concrete.

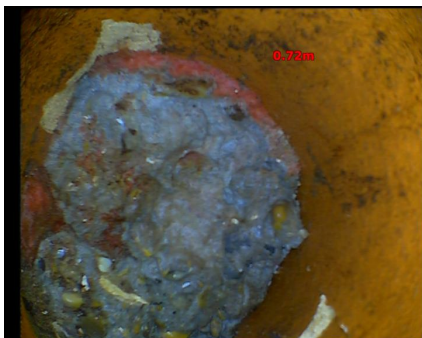
Observation [4]:  
concreted redundant pipe
