**Shore House,  
Mill Lane,  
Langstone,  
Havant,  
PO9 1RX**

## **BAT EMERGENCE SURVEY**

**June 2024**

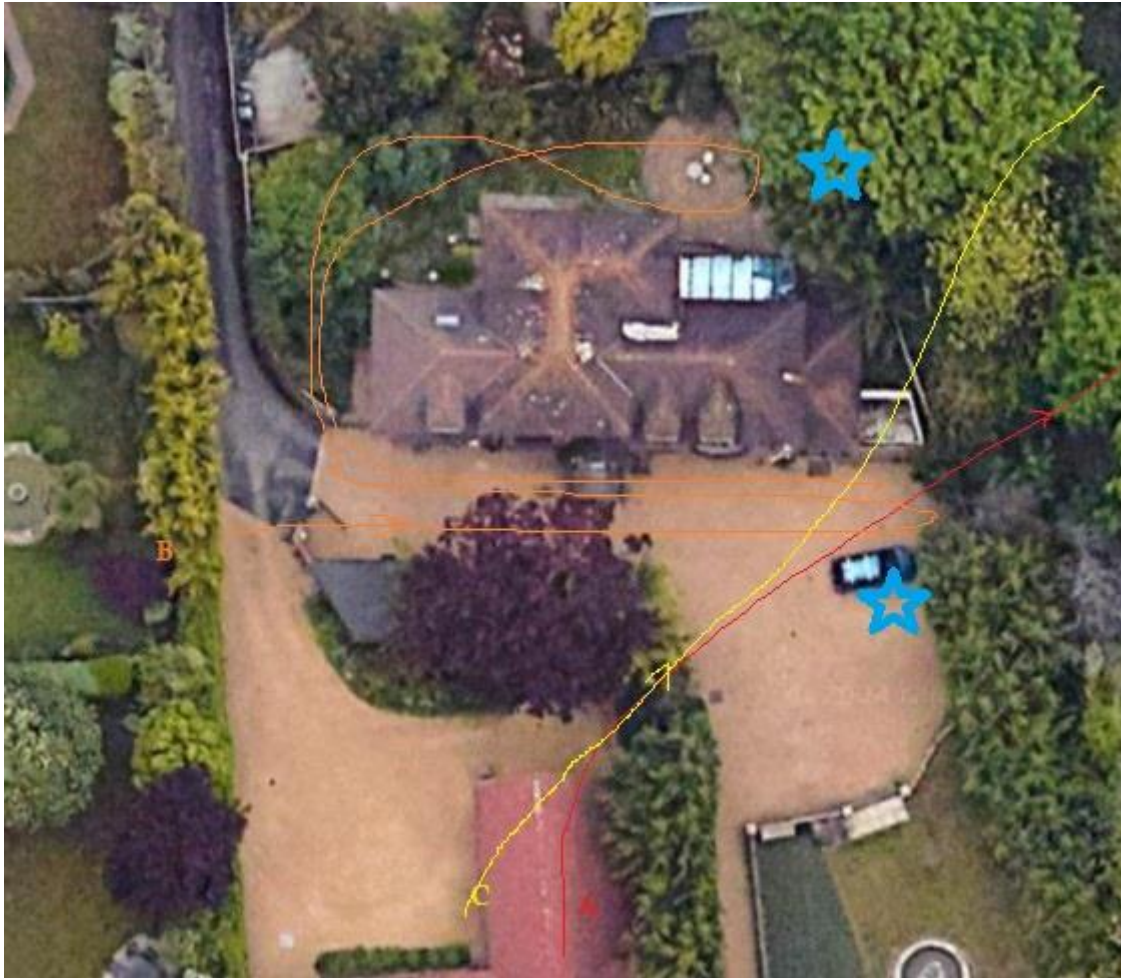
**Fig 1. Location of viewers, cameras and flightpaths of bats**

Surveyors were stationed to the north-east (viewing the northern elevations and east gable, and south-east viewing rear roof and dormers where Canon XA40 HD digital camcorders IR illumination were also placed to cover the entire southern elevation. Survey commenced 30 minutes before sunset and continued until 90 minutes after sundown. *EchotouchPro*, *Echotouch*, and *Batbox Duet* detectors were employed to monitor and record bat activity.

At least three individuals were seen two of which flew in from garden to southwest and third up driveway from west. One foraged for long periods around the house following a regular flightpath.

| S | 21.27 | Common pipistrelle | 1 | 1 | Flew in over yard from house to southwest ( flightpath A on fig 1) | | |
| S, N | 21.11-13 | Common pipistrelle | 1 | 5 | Flew in over yard from house to southwest ( flightpath C on fig 1) | | |
| S, N | 21.33-37 | Common pipistrelle | 1 | 20+ | Circling around house (flightpath B on fig 1) | | |
| S,N | 21.41-43 | Common pipistrelle | 1 | 10+ | Circling around house (flightpath B on fig 1) | | |
| S | 21.55 | Common pipistrelle | 1 | 2 | Foraging south of house (flightpath B on fig 1) | | |
