# Bat Survey Report – Preliminary Roost Assessment

Goodwood Block, Crookhorn College

For  
Hampshire County Council  
Property Services

April 2024

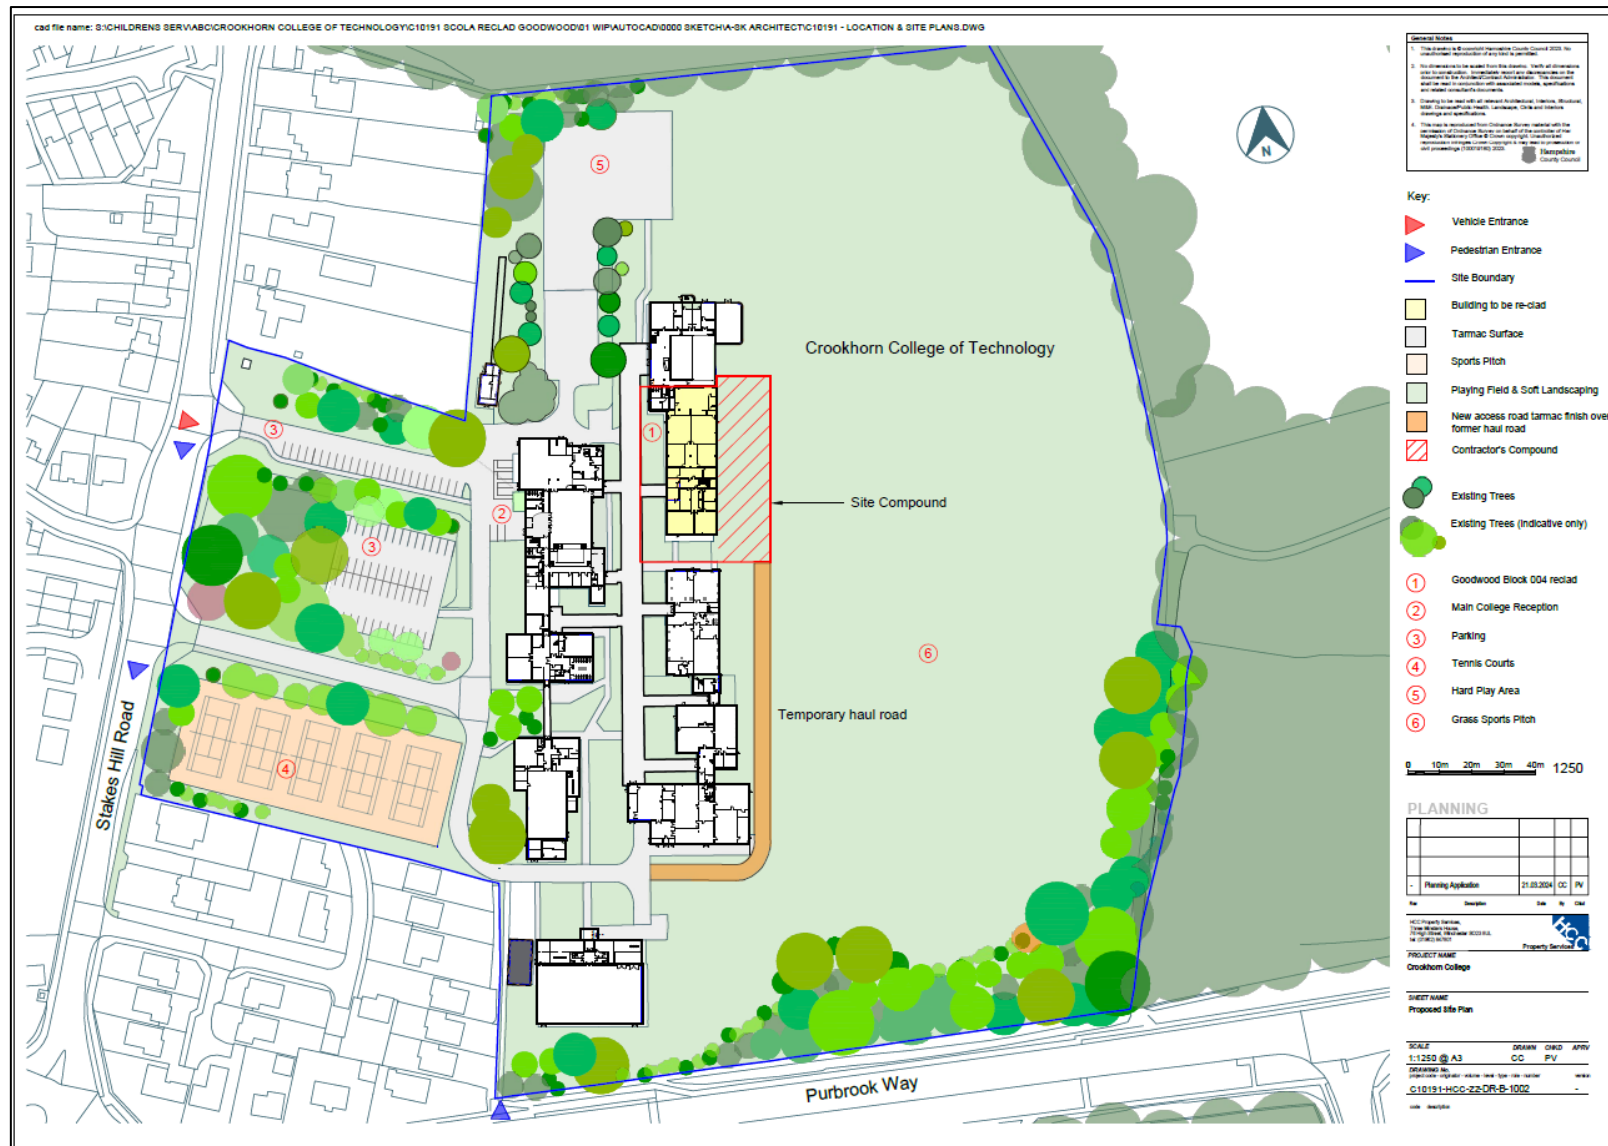
Figure A1.3 Proposed Site Plan - March 2024.

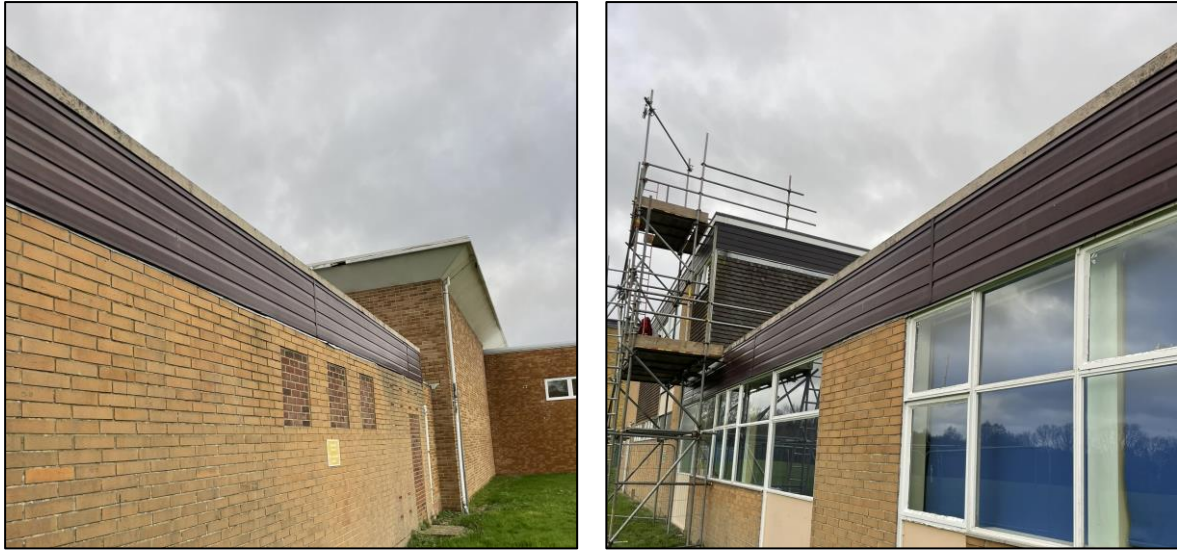
- 3.10. The timber cladding covering space between the top of windows and the roof edge, which extends around the exterior of the building, appears to be in good condition with no evidence of damage, lifting or rot (Photos 6 and 7). The building's brickwork was in generally good condition with one area of damage to a brick above a fire escape door on the east elevation (Photo 8).
- 3.11. There are several missing or damaged hanging tiles (Photos 9 to 12) on the north elevation of the two-storey part of the building. There are gaps to each side of the window at the northeast corner of the two-storey section of the building between the hanging tiles and the window frame edges (Photos 13 and 14). There is a missing hanging tile on the eastern elevation of the building (Photos 15 and 16). The gaps created by missing or damaged hanging tiles and

**Photos 6 and 7** Views north and south along east elevation of single storey section; timber cladding above windows, typical of that around the building exterior, appears in good condition.

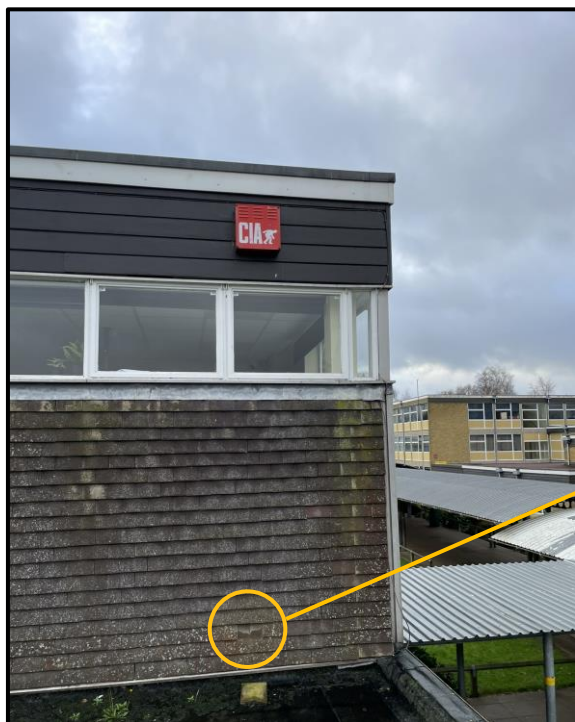
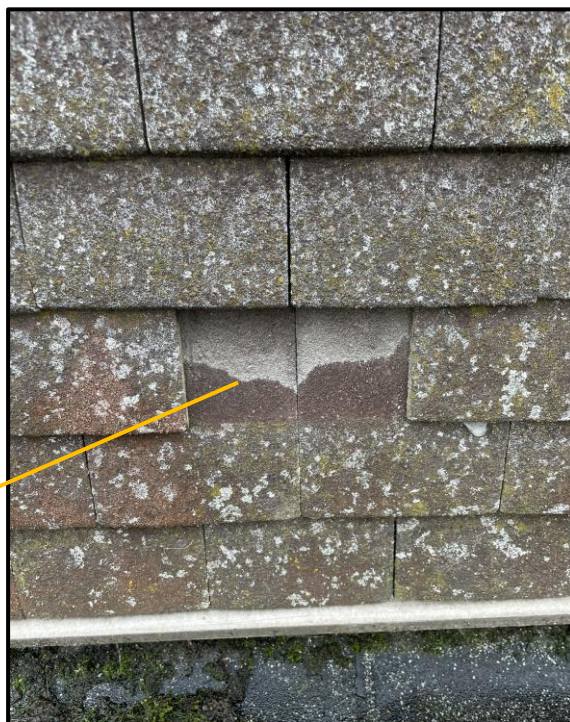
those around the window frames are suitable roost features for crevice dwelling bats such as Pipistrelle species. The aerial map at Appendix 4 shows the locations of the PRFs identified during the PRA.

**Photos 9 and 10 PRF A** - missing tile to southern side of north end of two-storey section.

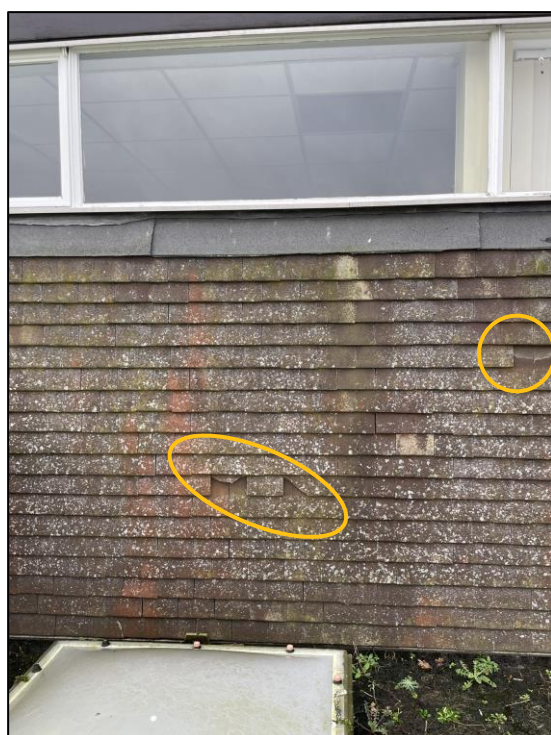
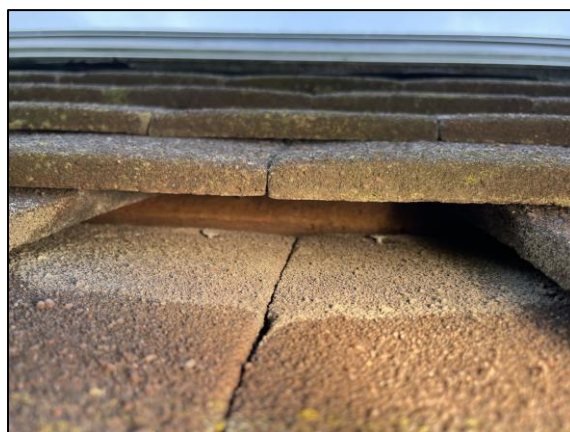
**Photos 11 and 12 PRFs B1-B2-B3** – missing and damaged hanging tiles to central area of north end of two-storey section; view into gap created by missing tile.

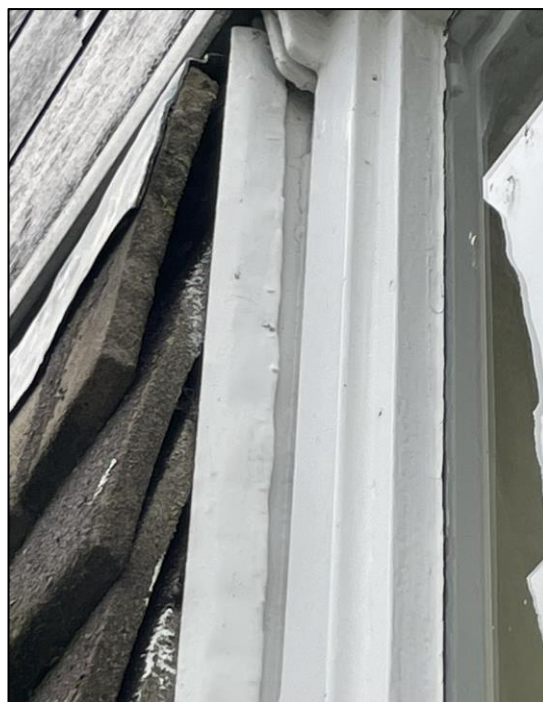
**Photos 13 and 14** PRFs C and D – gaps along edges of hanging tiles where they meet the the northeast window corner and window frame. Photo 15 shows the north edge of the window where it meets the corner of the two-storey section; photo 16 shows the south edge of the window, further along the east elevation.

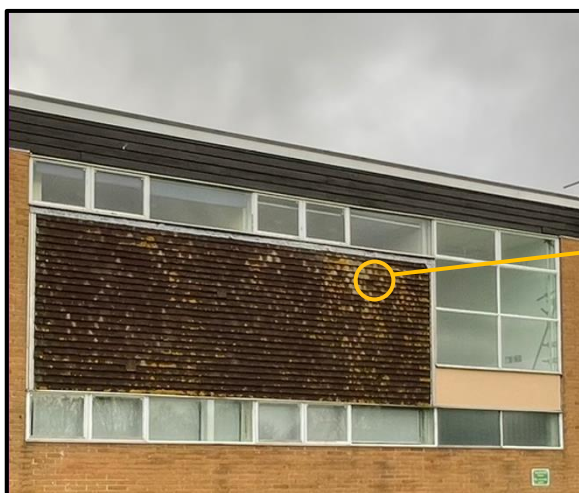
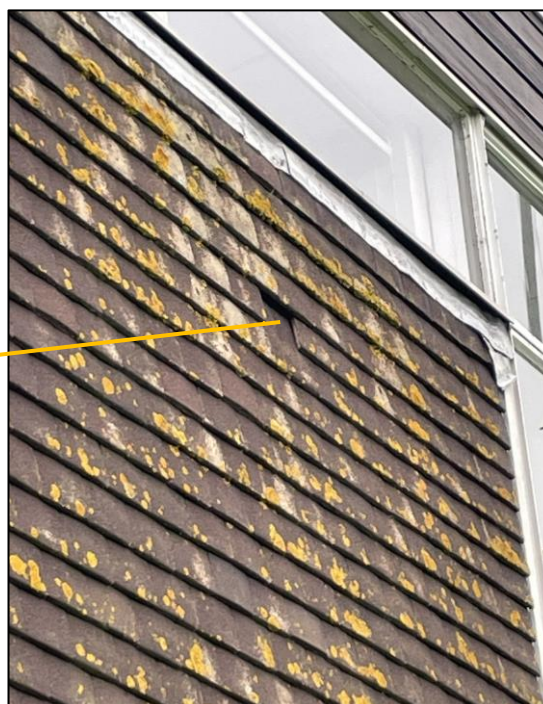
**Photos 15 and 16** PRF E – missing hanging tile on east elevation of two-storey section of building.
