# Havant Thicket Reservoir Project

### Appendix A9.19: Pipeline Kingfisher Survey Report

Portsmouth Water Ltd.

Atkins Doc No.: HTR-ATK-XX-XX-RP-Z-0085

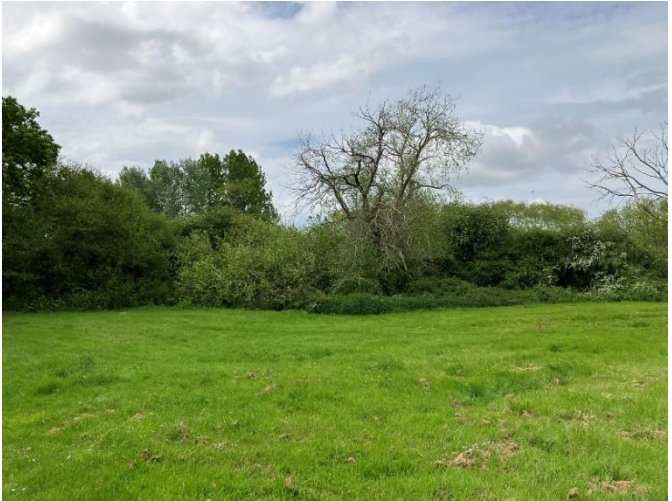
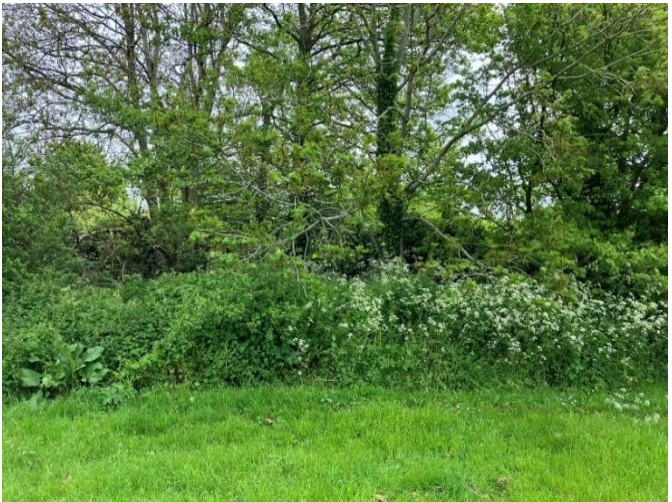
| Target Note ID | Description | Evidence |
|---|---|---|
| TN1 | Dense scrub and a line of trees along the river banks provide potential screening from disturbance for any kingfisher. | |

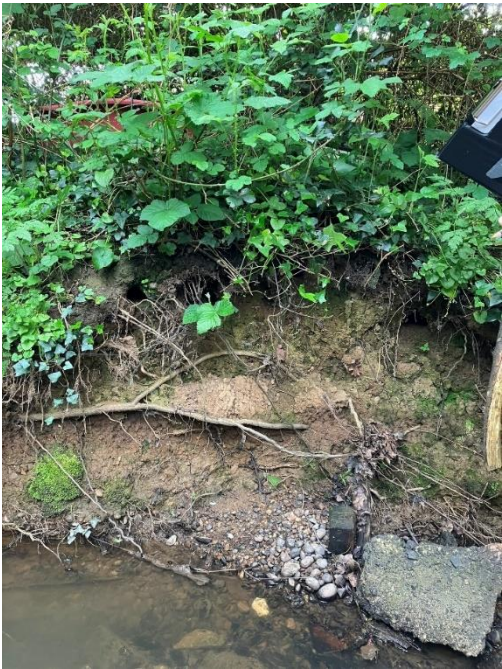
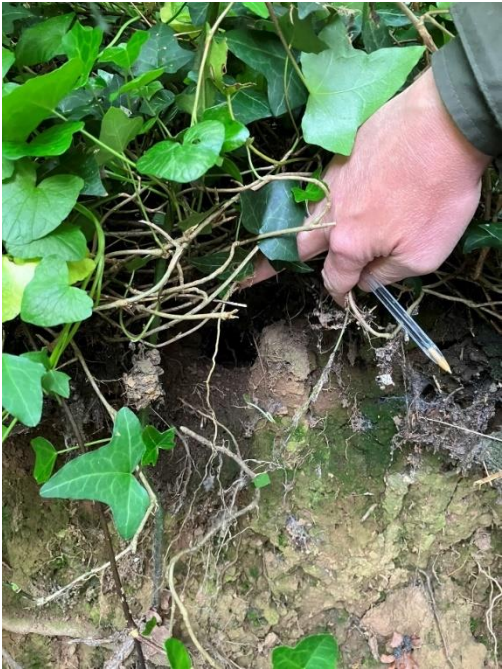
| Target Note ID | Description | Evidence |
|---|---|---|
| TN2 | <p>Mammal holes present along the bank showcase the suitability of the bank substrate for nest building.</p> <p>Rat burrows also present a risk of predation to kingfisher.</p> | |

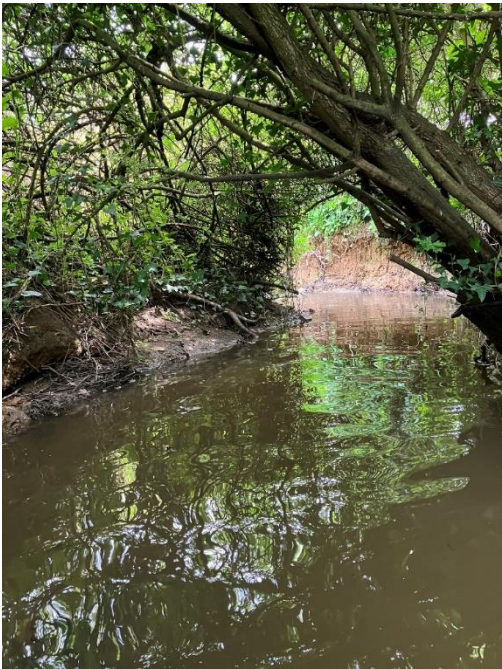
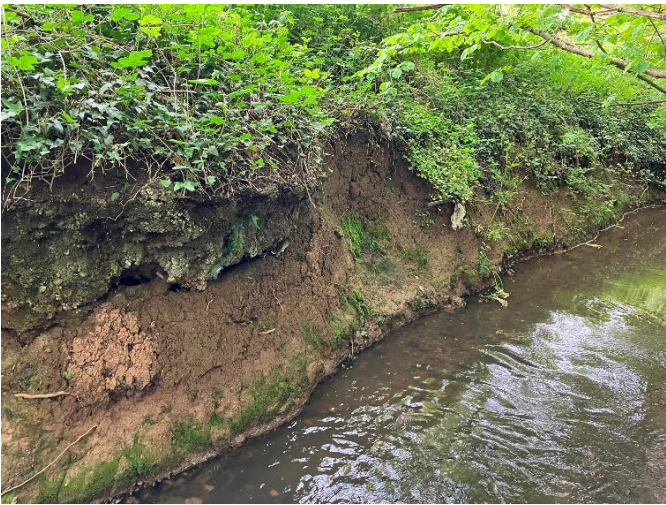
| Target Note ID | Description | Evidence |
|---|---|---|
| TN3 | <p>Example of optimal kingfisher nesting habitat comprising:</p> <ul style="list-style-type: none"> <li>• Steep sided banks, between 1 m to 2 m height;</li> <li>• Slow-moving deeper backwater;</li> <li>• Feeding perches provided by overhanging branches; and</li> <li>• Screening from disturbance provided by dense, overhanging, vegetation.</li> </ul> <p>However, the poor water quality reduces the suitability of the habitat for breeding kingfisher due to a lack of fish.</p> | |

- 3.2.2. The total length of stream with potential suitability to support kingfisher was approximately 180 m, with the original kingfisher sighting located here. Steep exposed natural banks between 1 m to 2 m in height, slow-moving deeper backwaters and thick vegetation cover to provide screening were all recorded along this section (TN1, TN3). The bank substrate is suitable for the creation of nests, being earth, with multiple overhanging branches providing perching opportunity (TN2, TN3). The water has a medium to slow pace and is relatively clear, however, it appears to be of poor quality with an abundance of debris and rubbish present within the watercourse. Therefore, fish abundance may not be high enough to support breeding kingfisher.

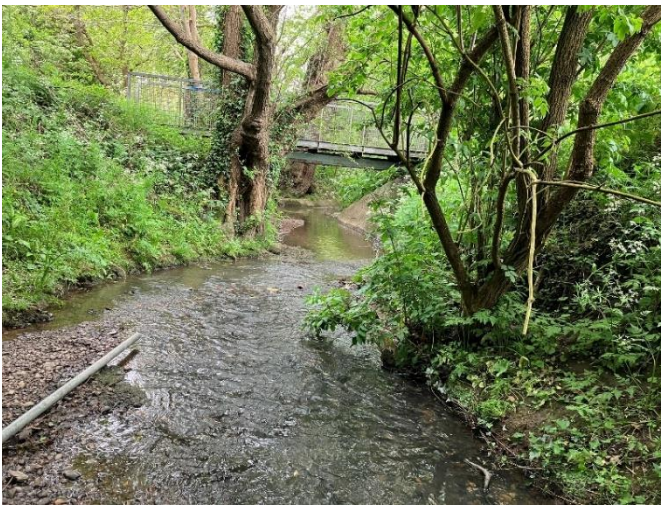
| Target Note ID | Description | Evidence |
|---|---|---|
| TN4 | <p>Publicly accessible bridge crossing Riders Lane Stream.</p> <p>This stretch of river is largely inaccessible to the general public due to the dense vegetation, however domestic dogs and cats are still able to reach the bankside.</p> | |

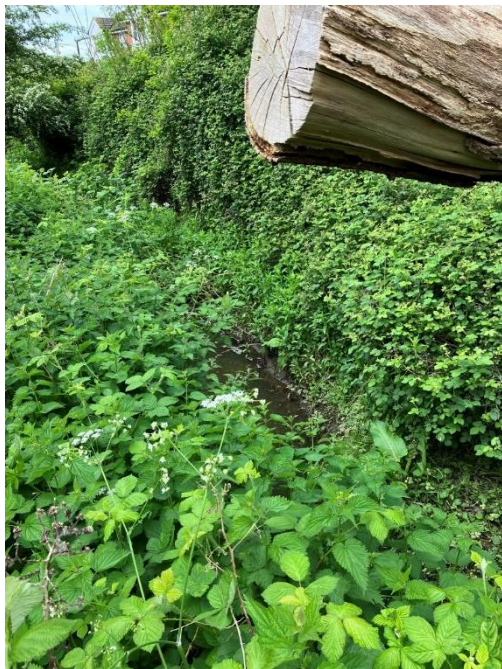
| Target Note ID | Description | Evidence |
|---|---|---|
| TN5 | <p>Suitability to the north of VP1, as the stream reaches Shaft 5, is generally of poor suitability for kingfisher due to a lack of exposed earth banks for burrowing, and limited feeding opportunity due to dense vegetation covering the waterway.</p> | |

- 3.2.4. Further north from this point, as the stream flows from Shaft 5, the habitat becomes much less suitable for kingfisher. There is an absence of exposed banks which prevents nest creation, and the watercourse is largely covered by dense vegetation (TN5).

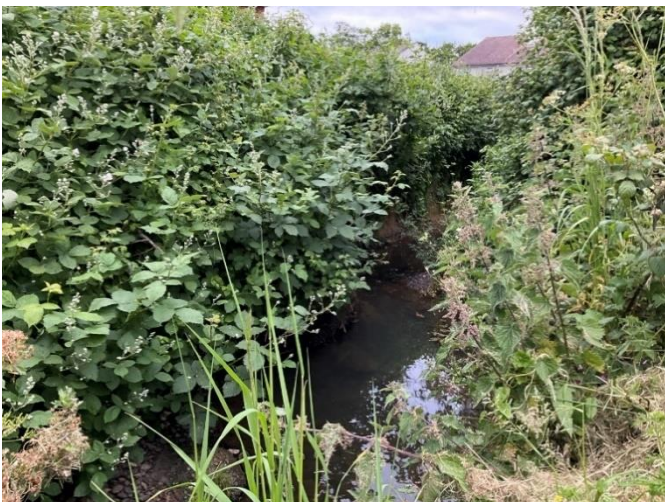
| Target Note ID | Description | Evidence |
|---|---|---|
| TN8 | VP3 upstream (1 surveyor)<br>Located at OSNGR SU 71100 07636 | |

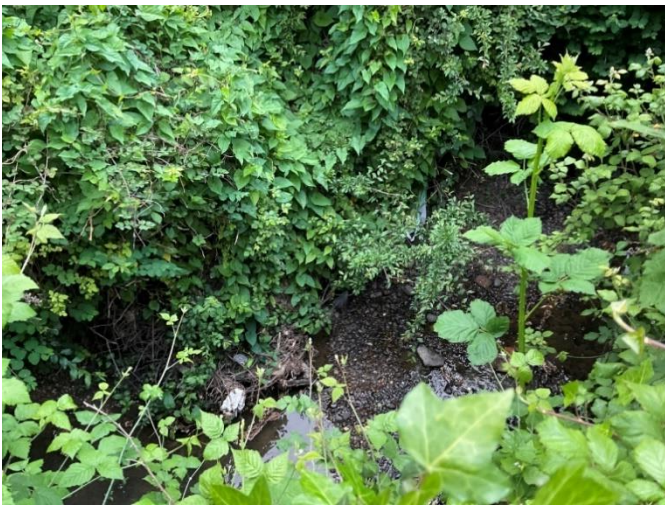
| Target Note ID | Description | Evidence |
|---|---|---|
| TN9 | VP4 above most suitable bank (1 surveyor)<br>Located at OSNGR SU 71090 07614 | |

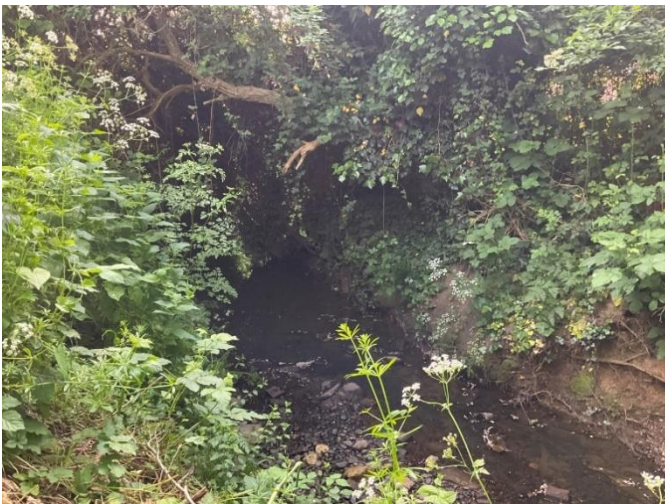
| Target Note ID | Description | Evidence |
|---|---|---|
| TN10 | VP5 upstream (2 surveyors)<br>Located at OSNGR SU 71074 07609 | |

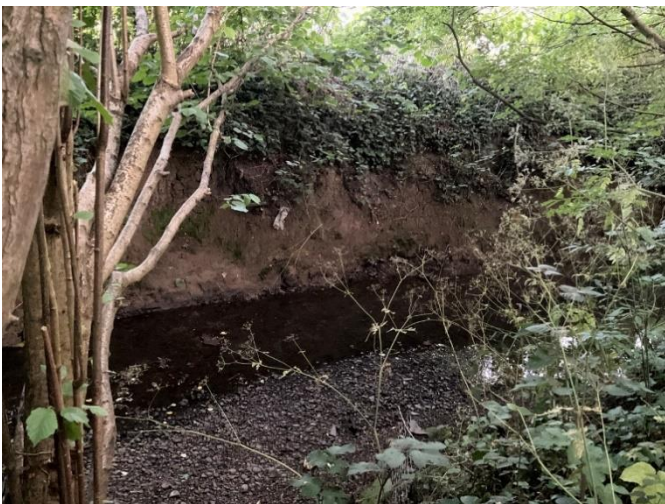
| Target Note ID | Description | Evidence |
|---|---|---|
| TN11 | VP6 upstream (1 surveyor)<br>Located at OSNGR SU 71039 07519 | |

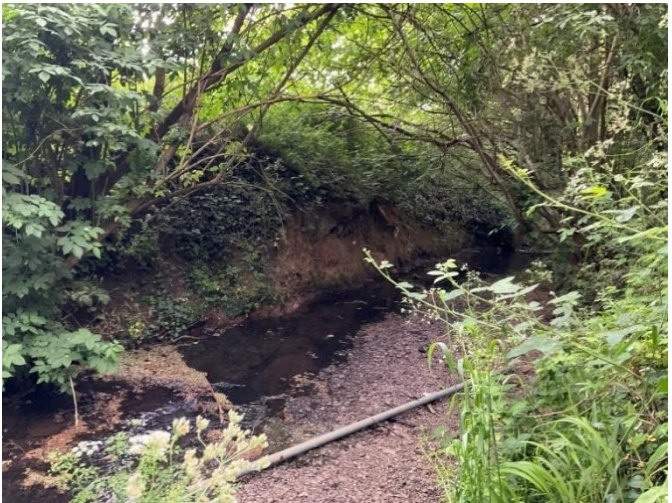
| Target Note ID | Description | Evidence |
|---|---|---|
| TN12 | VP7 upstream (1 surveyor)<br>Located at OSNGRSU 71033 07510 | |

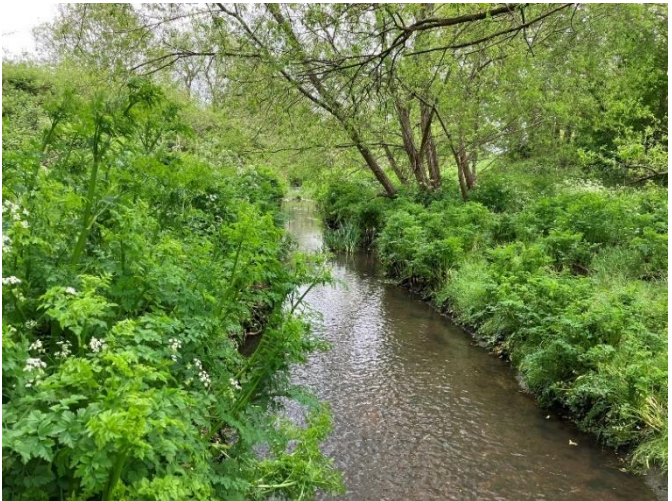
| TN13 | <p>This stretch of stream may be utilised as a subsidiary feeding habitat for kingfisher.</p> <p>The riverbanks are short (less than 0.5 m) therefore unsuitable to support kingfisher nests as they are susceptible to flooding and predation.</p> | |

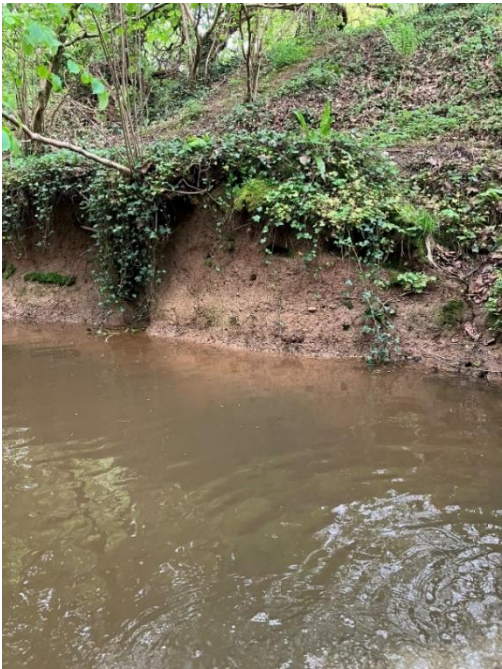
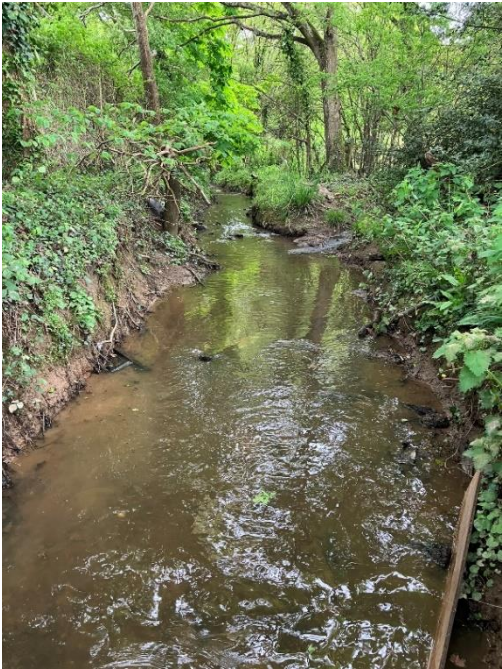
| Target Note ID | Description | Evidence |
|---|---|---|
| TN15 | <p>Stretch of bank suitable to support nesting kingfisher.</p> <p>The bank has already been burrowed into by rats, however they appear to be disused.</p> <p>Overhanging branches throughout Great Copse provide perching spots for foraging kingfisher.</p> <p>The water is of poor quality as a result of silt being stirred up from the adjacent culvert outflow and domestic debris along the watercourse.</p> | |

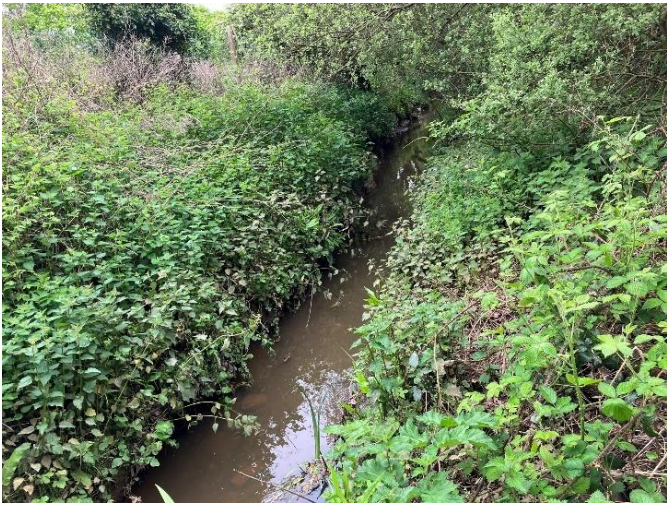
| Target Note ID | Description | Evidence |
|---|---|---|
| TN16 | The absence of exposed banks and poor water quality renders the bankside habitat throughout Staunton Country Park as unsuitable to support breeding kingfisher. | |
