## Bat Emergence and Re-Entry Surveys (BERS)

Bulbeck Road Car Park, Havant, Hampshire PO9 1HN

Havant Borough Council

“The demolition of the existing multilevel car park. There are no further plans proposed following the demolition at the time of this report.”

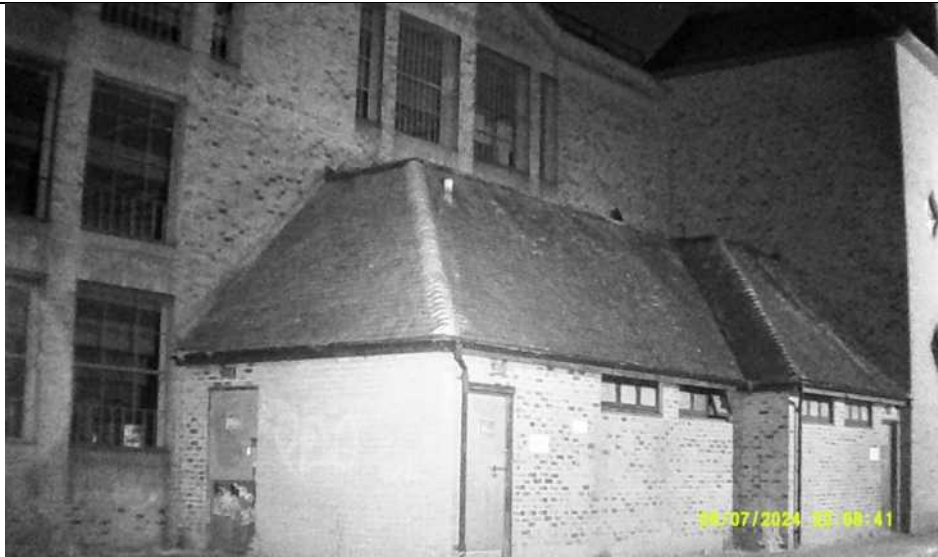
| Surveyor 1 | | <b>No Emergences.</b> First Common Pipistrelle seen at 21:01 commuting north parallel to the western elevation of the building. One seen not heard at 21:07, reviewed on IR and confirmed as no emergence. Intermittent commuting from common pipistrelle until the final common pipistrelle, heard not seen, at 21:36. | | | | N/A | |

| <i>IR position</i> | The footage reflected the view of the surveyor. No emergences were observed. | |

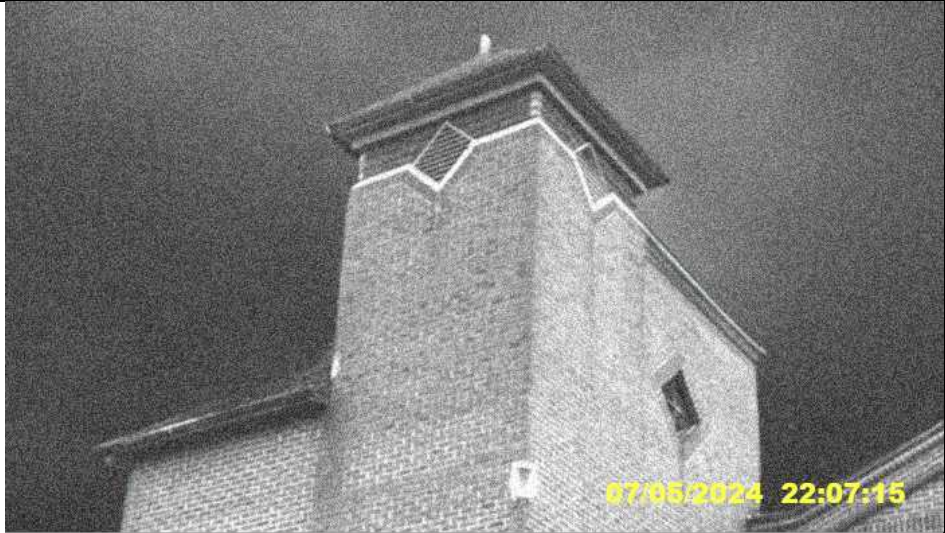
| <i>Surveyor 2</i> | <b>No emergences observed.</b> 21:08 - The first bat was a common pipistrelle seen foraging from the south to north along the hedges behind where I was sat. 21:16 - Last Bat was a soprano pipistrelle seen passing from NW - NE. | N/A |

| <i>IR position</i> | The footage reflected the view of the surveyor. No emergences were observed. | |

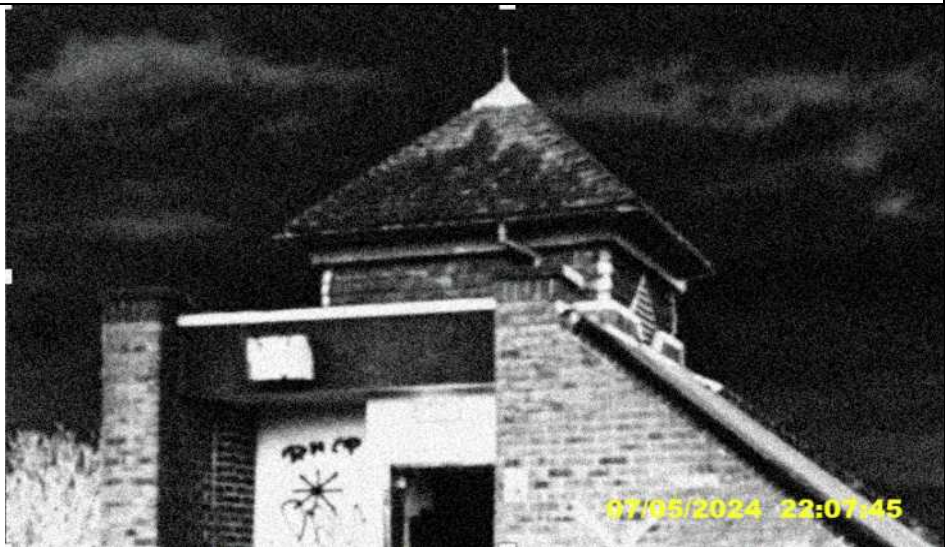
| <i>Surveyor 3</i> | <b>No emergences observed.</b> The first bat was a Noctule heard but not seen at 20.46. This was the only bat activity observed. | N/A |
| <i>IR position</i> | The footage reflected the view of the surveyor. No emergences were observed. | |

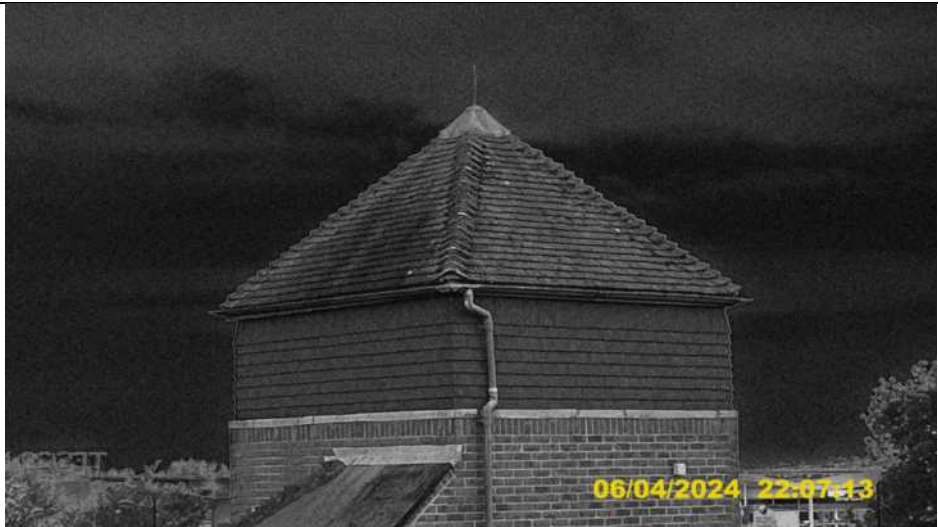
| <i>Surveyor 4</i> | <b>No emergences observed.</b> The first bat was a Noctule heard but not seen at 20:46. This was the only bat activity observed. | N/A |
| <i>IR position</i> | The footage reflected the view of the surveyor. No emergences were observed. | |

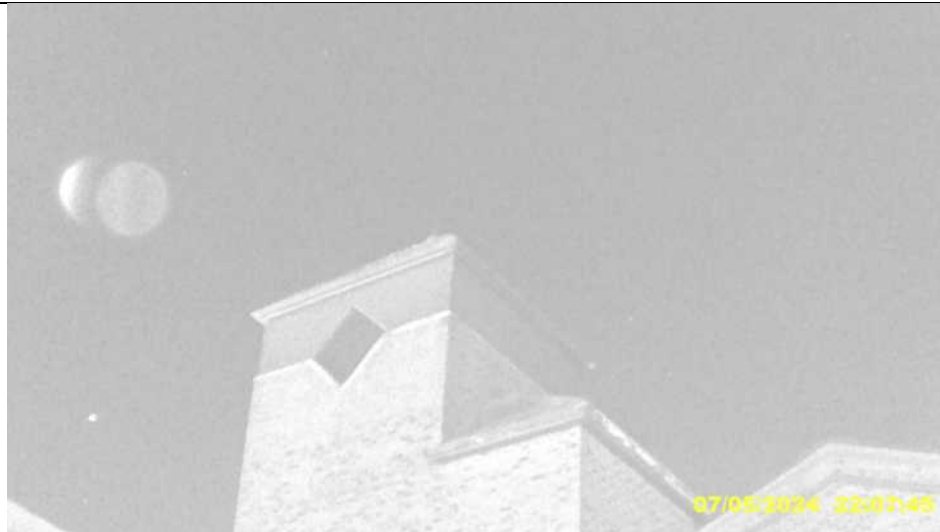
| <i>Surveyor 5</i> | <b>No emergences observed.</b> The survey started at 20:20. No bat activity was recorded during the survey. Survey ended at 22:05. | N/A |

| <i>IR position</i> | The footage reflected the view of the surveyor. No emergences were observed. | |

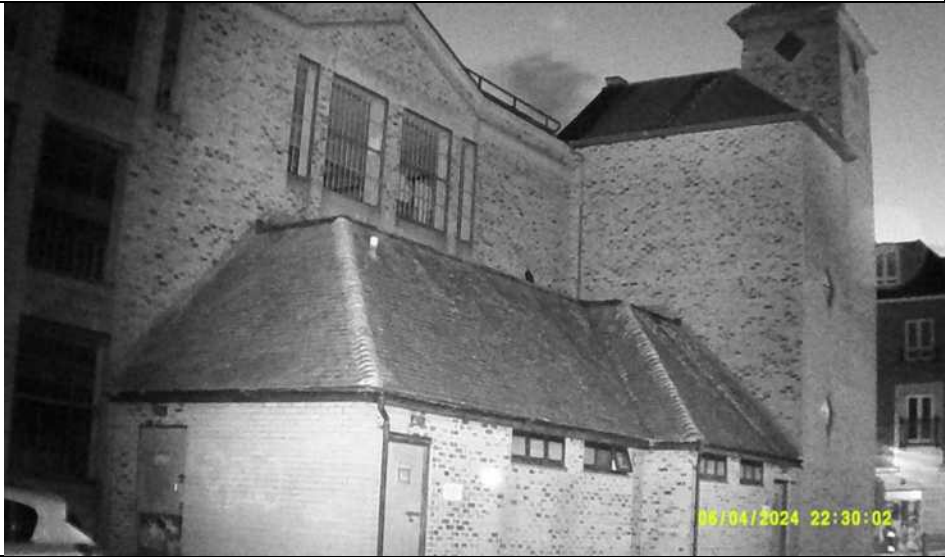
| <i>Surveyor 1</i> | <b>No emergences observed.</b> The first bat was a Noctule seen flying from the northeast passing over the top on B1 heading to the south. heard but not seen at 21.33. At 21:42 a Common Pipistrelle was heard but not seen. No further bats observed | | | | | N/A | |
| <i>IR position</i> | The footage reflected the view of the surveyor. No emergences were observed. | | | | | | |

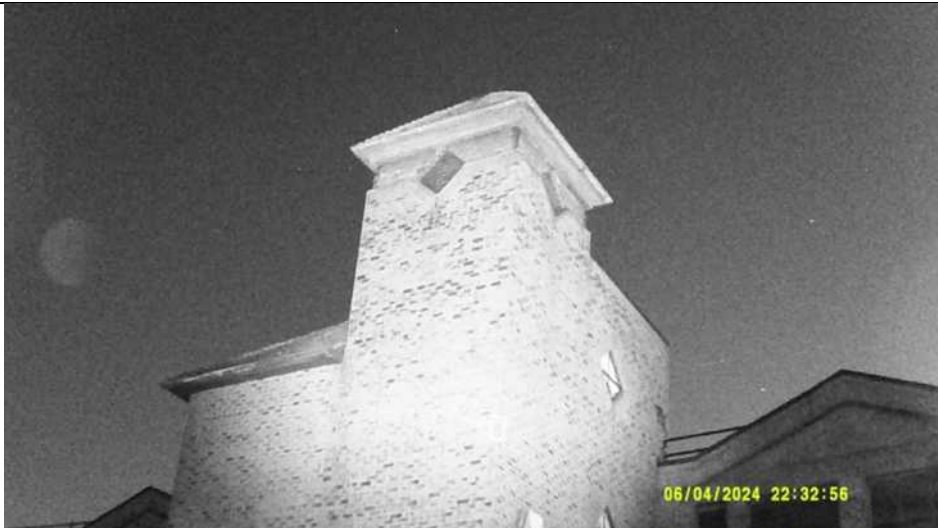
| <i>Surveyor 2</i> | <b>No emergences observed.</b> The first bat was a Noctule heard but not seen at 21.33. At | | | | | N/A | |

| | 21:40 a Common Pipistrelle was heard but not seen. At 21:42 a Common Pipistrelle passing over B1 from the south to north of the site. | |
| <i>IR position</i> | The footage reflected the view of the surveyor. No emergences were observed. | |

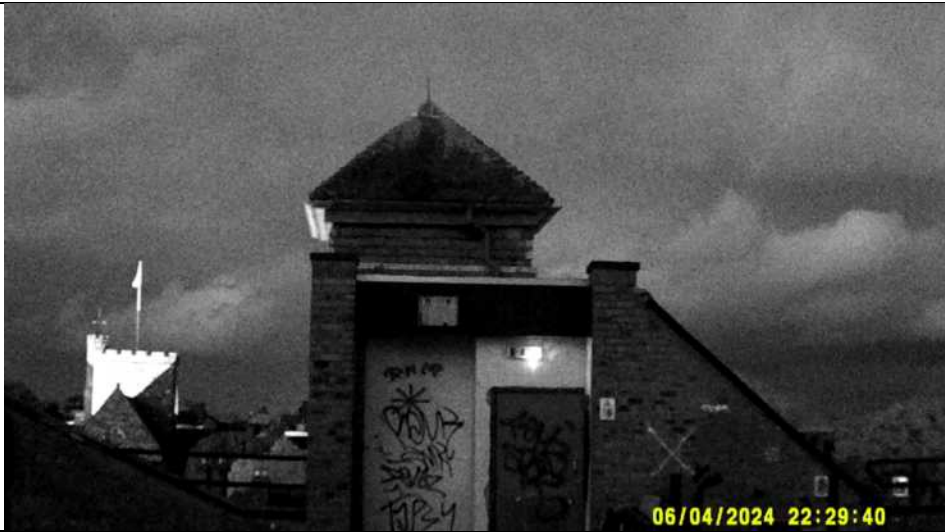
| <i>Surveyor 3</i> | <b>No emergences observed.</b> The first bat was a Noctule heard but not seen at 21.33. At 21:40 a Common Pipistrelle was heard but not seen. No further bats were observed. | <b>N/A</b> |

| <i>IR position</i> | The footage reflected the view of the surveyor. No emergences were observed. | |

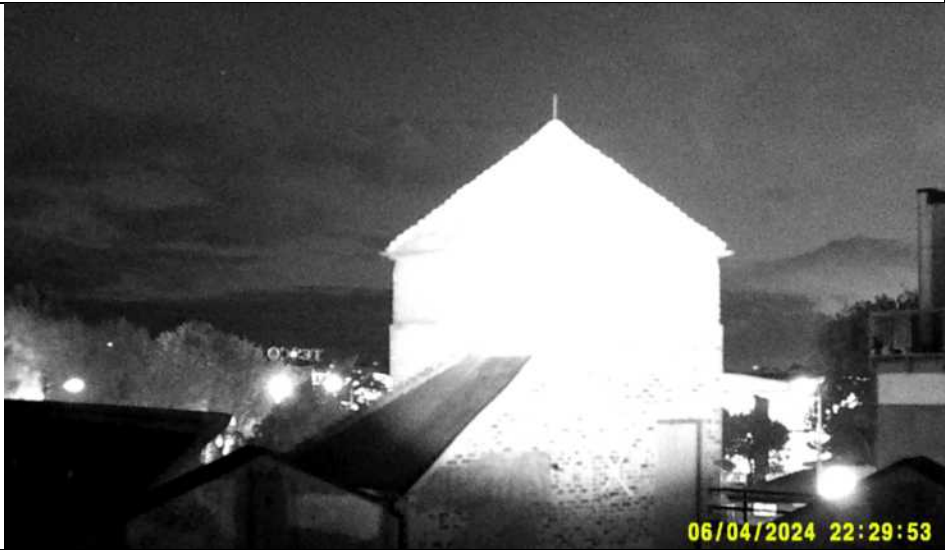
| <i>Surveyor 4</i> | <b>No emergences observed.</b> The first bat was a Noctule heard but not seen at 21.33. This was the only bat activity observed. | N/A |
| <i>IR position</i> | The footage reflected the view of the surveyor. No emergences were observed. | |

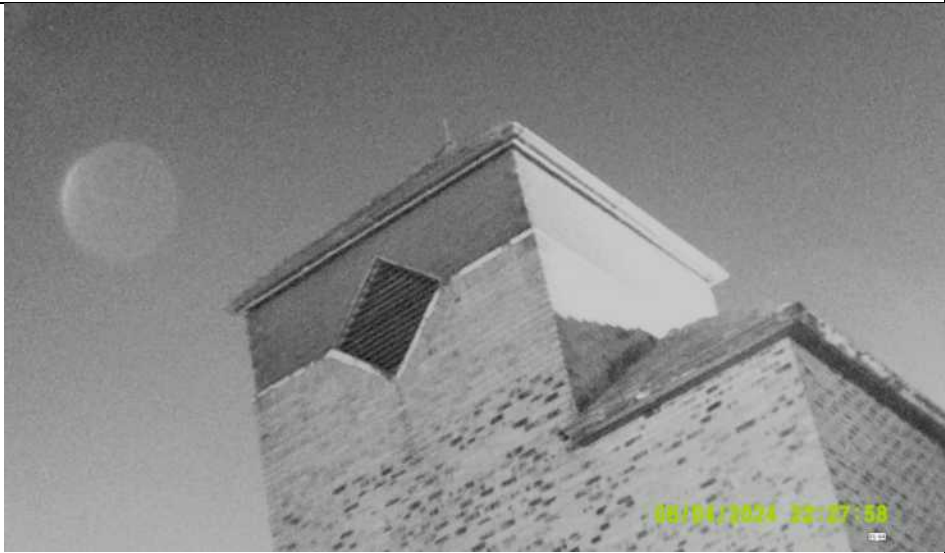
| <i>Surveyor 5</i> | <b>No emergences observed.</b> The first bat was a Noctule heard but not seen at 21.33. This was the only bat activity observed. | <b>N/A</b> |
| <i>IR position</i> | The footage reflected the view of the surveyor. No emergences were observed. | |

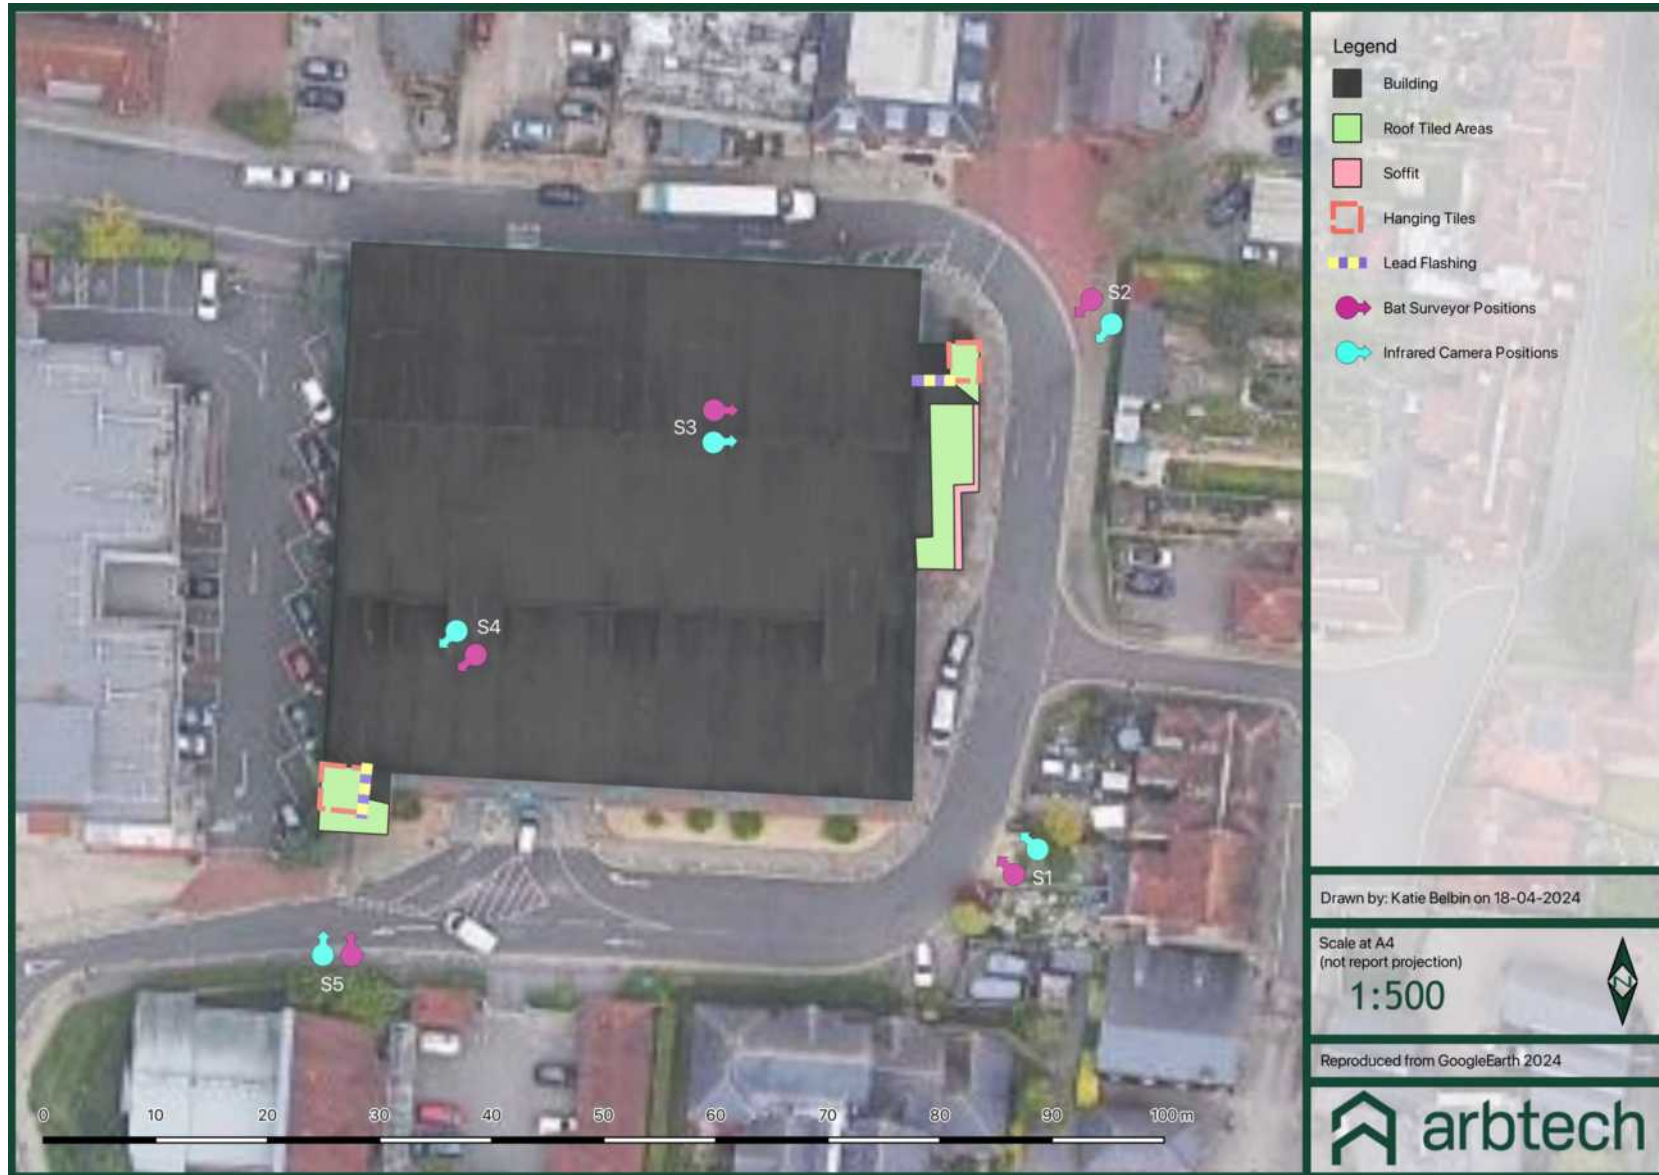
## Appendix 2: BERS Plan

| <ul style="list-style-type: none"><li>• <b>See site location in the Site Location Appendix 1</b></li><li>• <b>See surveyor locations and roosting features in BERS Plan Appendix 2.</b></li><li>• <b>See surveyor locations and bat activity in BERS Results Appendix 3.</b></li></ul> | |

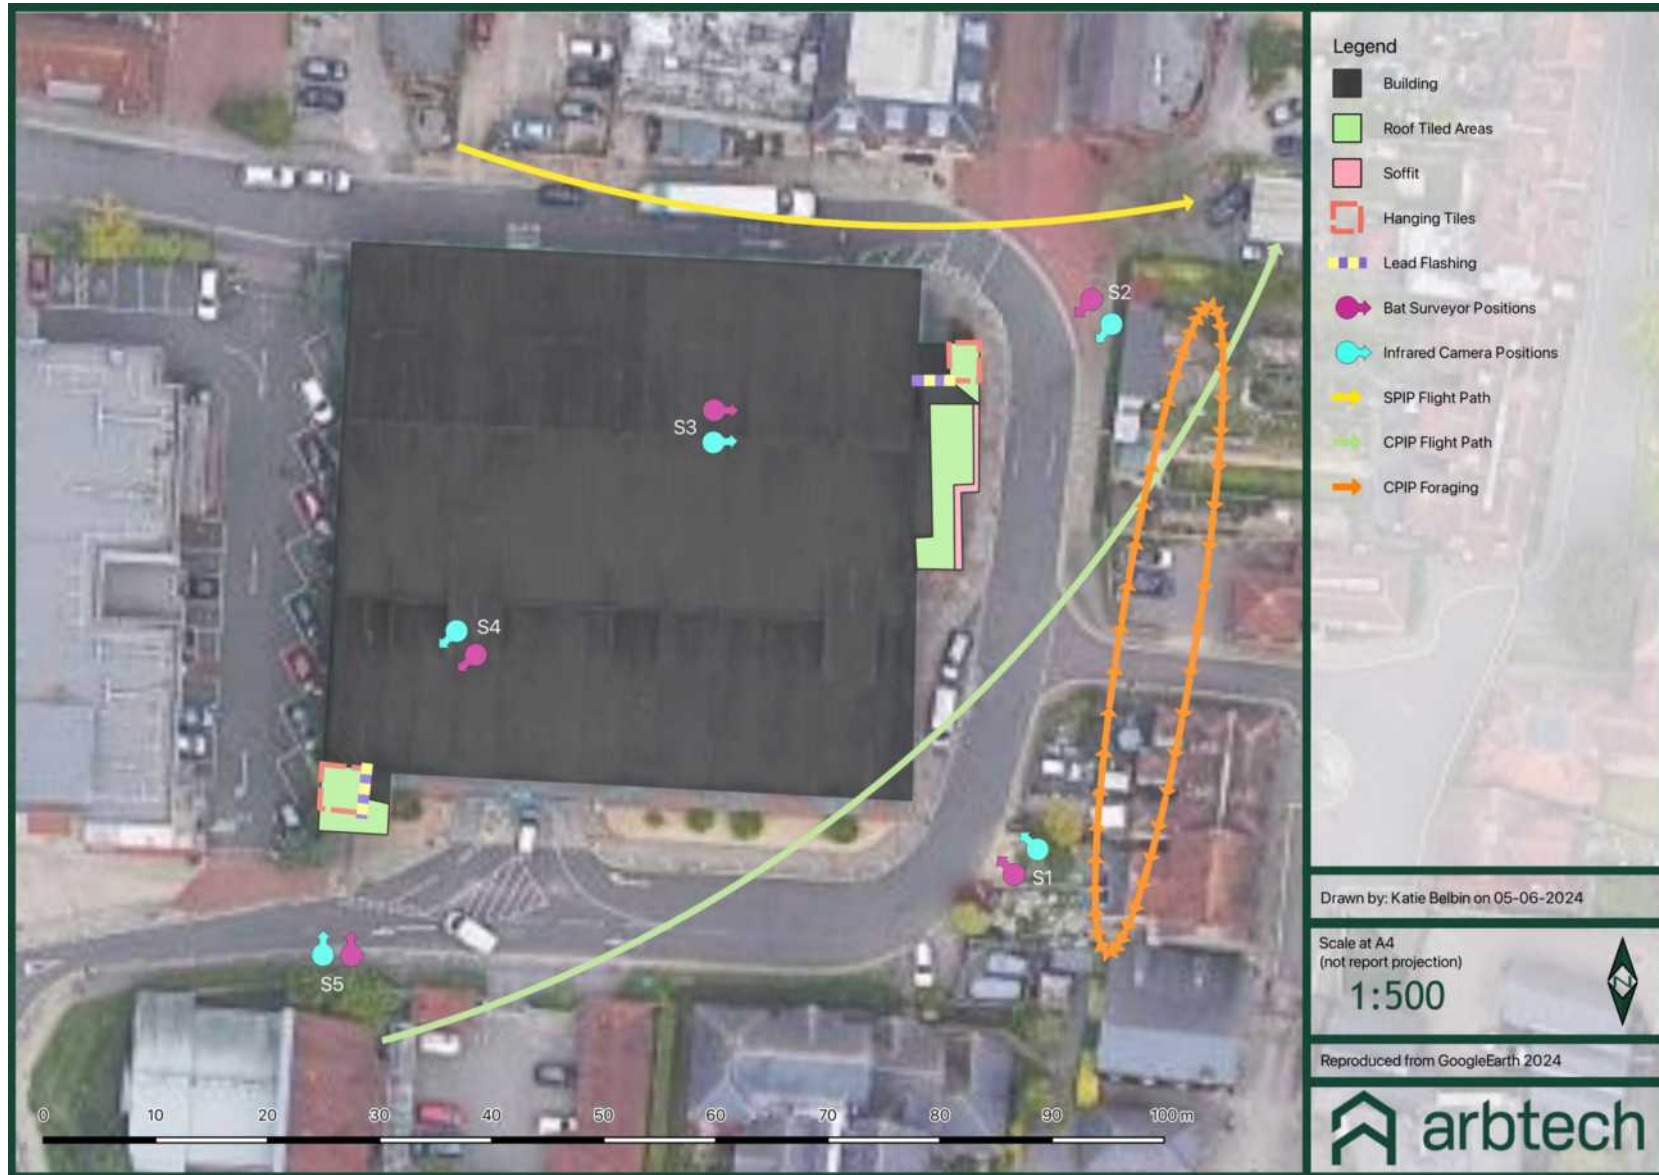
## Appendix 2: BERS Results

| Conclusions, Impacts and Recommendations | |
|---|---|
| <i>Survey Results Summary</i> | <p>No bat roosts were identified during the survey.</p> <p>Foraging and passing bats were seen using the site and nearby area.</p> |
